## Specialist site visit - headwater streams running off the South Downs

Tuesday 2 June 2015

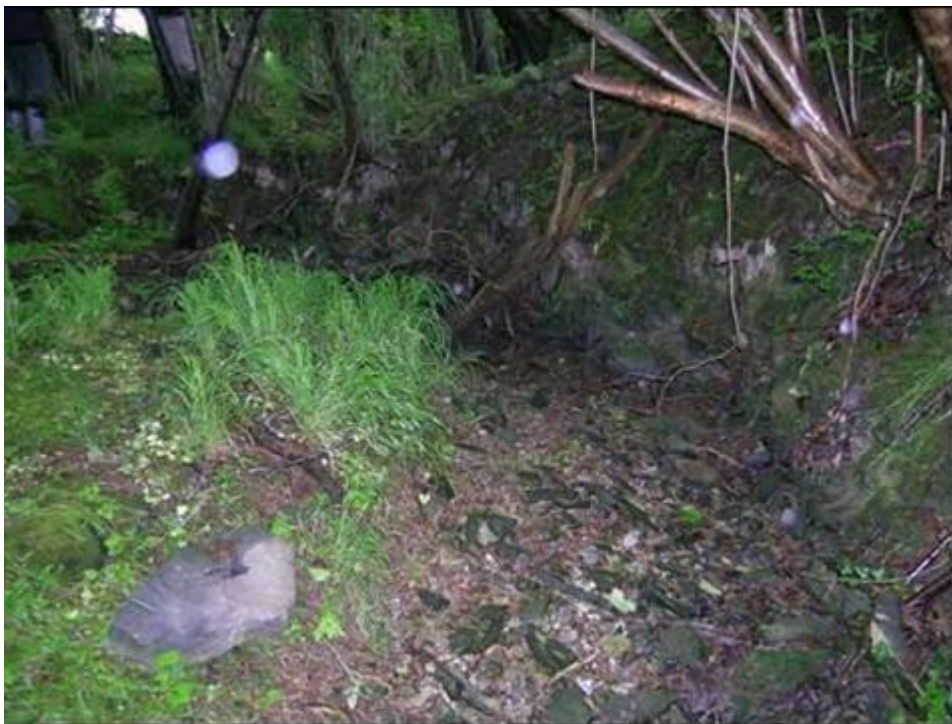
The main stream is hidden within an incised channel covered in a dense canopy from a thin zone of riparian trees. The channel is very geomorphologically active, with a bed of greensand cobbles and a very sinuous planform (Figures 1.1 and 1.2). The stream clearly experiences high flows and considerable hydraulic forces in the winter and early spring.

**Figure 1.1 Greensand cobble bed of the Harting Stream.**

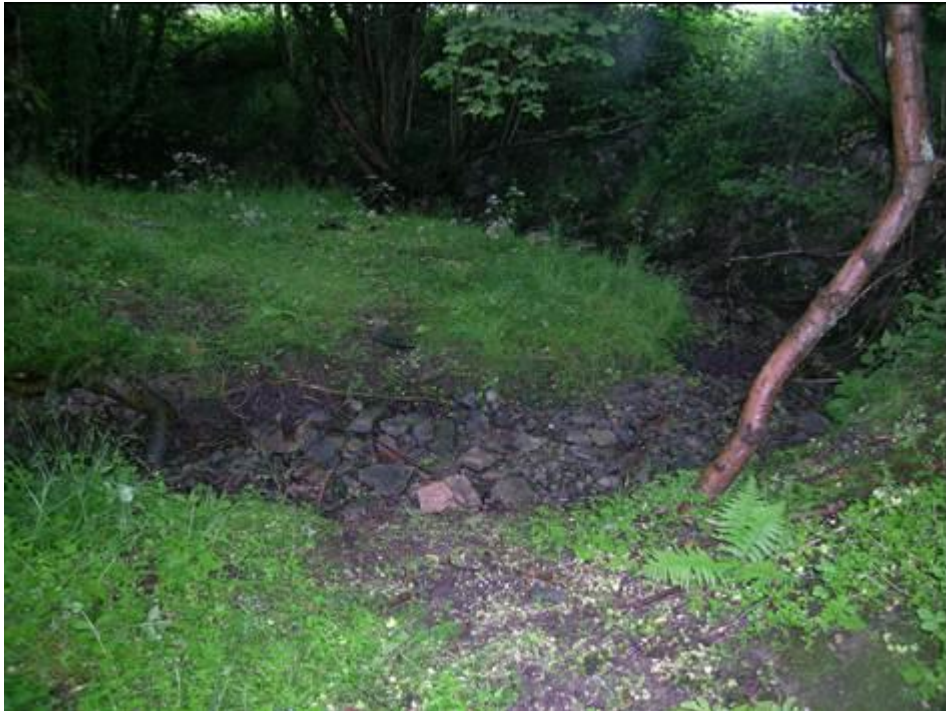
**Figure 1.2 Highly accentuated meander loop.**

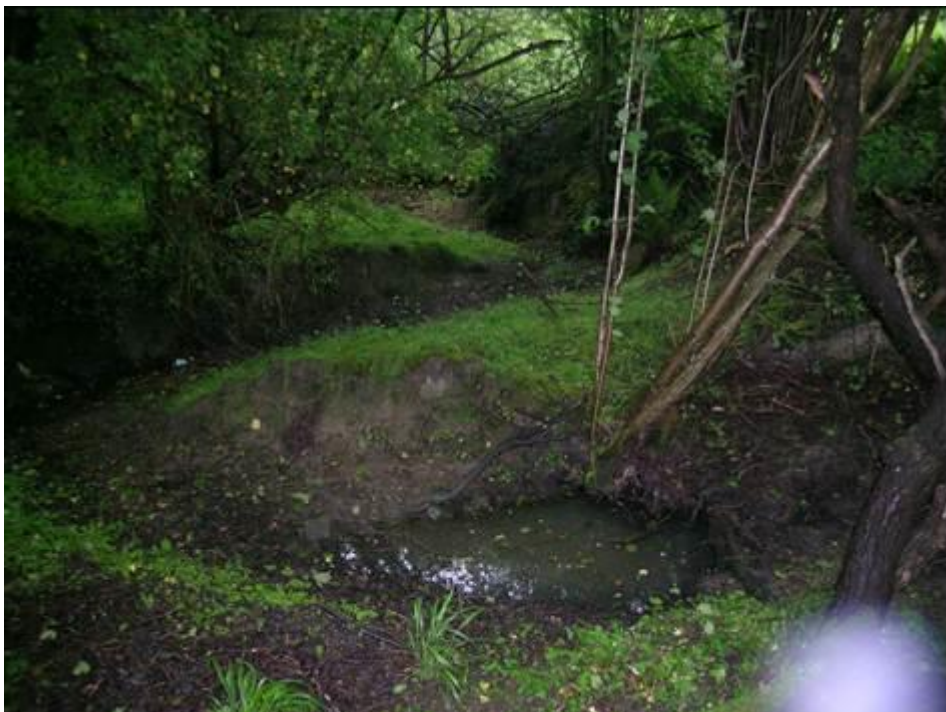
There is a good level of interaction between the channel and riparian trees, in terms of both root systems and woody debris (Figures 1.3 and 1.4). This contributes considerably to habitat heterogeneity of the channel and banks.

**Figure 1.3 Extreme channel meandering and a major debris dam generating a scour pool downstream.**

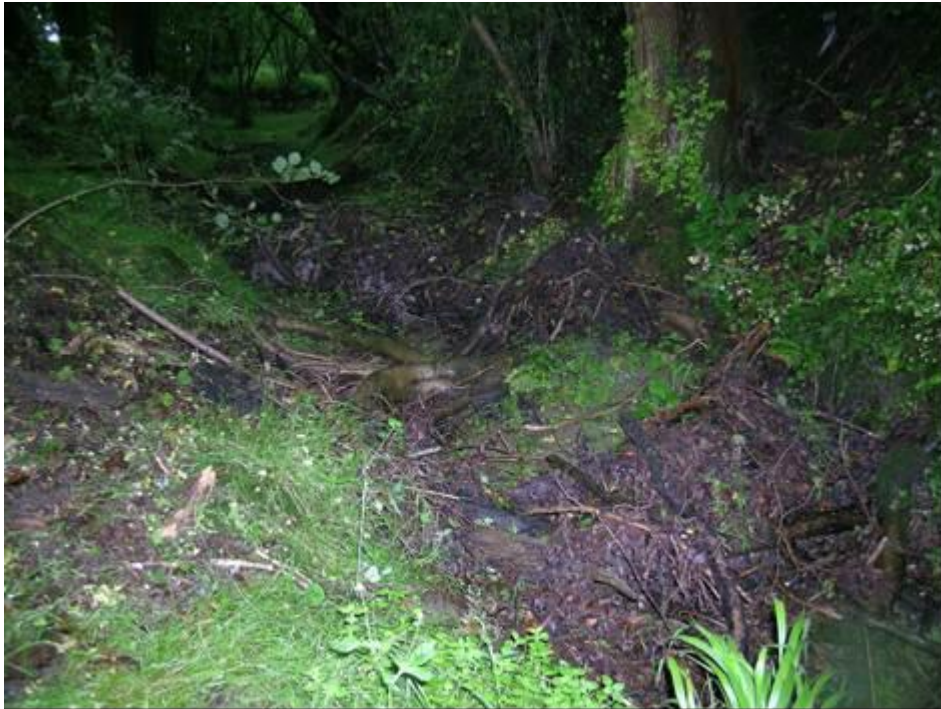
**Figure 1.4. Debris dam.**

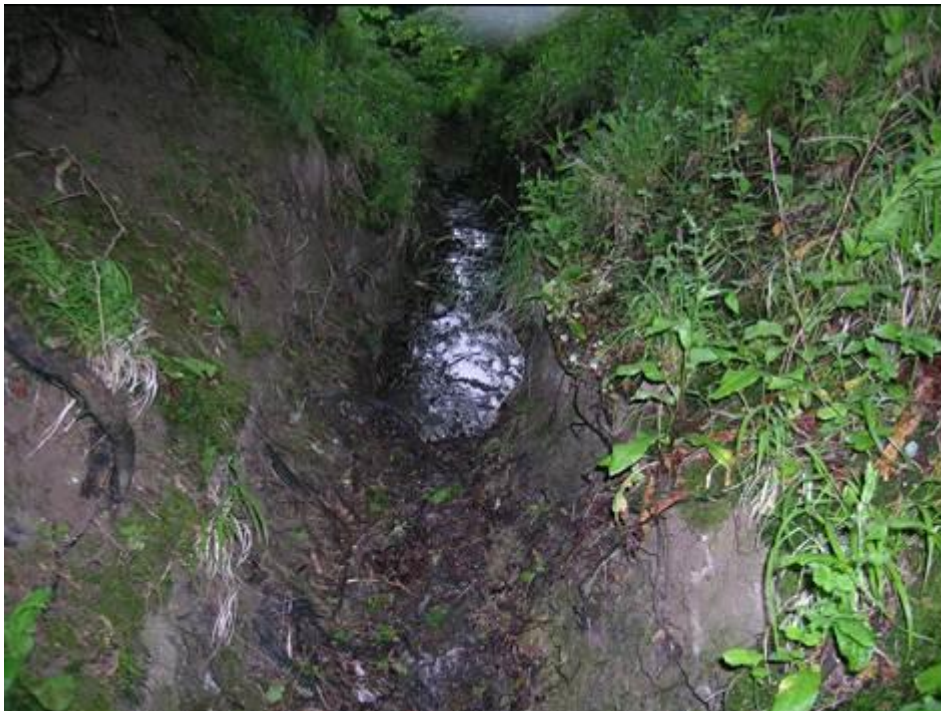
The main channel is fed by three headwater channels which converge at a point some 100 metres upstream from the Elsted to East Harting Road. We walked a short distance up one of these channels, which flows southwards taking drainage waters from the wooded scarp slope and intervening arable land (on greensand). The channel has been heavily ditched and is devoid of natural habitat (Figure 1.5).

**Figure 1.5. Ditched headwater channel flowing south from the base of the Downs into Harting Stream.**

The degraded state of the headwater channels feeding into the main stream affects its suitability as a candidate for notifying as a headwater-only river habitat SSSI. Streams with connectivity to intact stream/mire transitions would be favoured for notification, although it may be that no such sites remain in the area and this is the most natural example that remains. The headwater channels could be restored through the arable fields, which would greatly improve the case for notification.

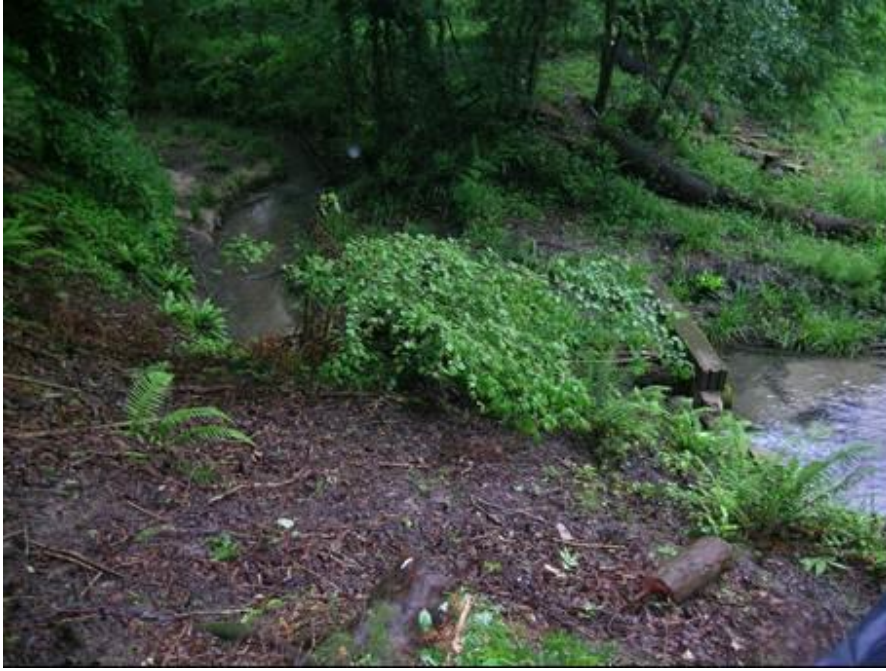
Figure 2.1 shows the remains of an impounding structure associated with an old fish farm, abandoned some time ago. Whilst the impoundment has not been totally removed, it has been partially removed to reduce its effect. Downstream of the structure, in a more open area with plenty of light, characteristic marginal plants such as water-cress and water speedwells show classic encroachment into the channel as seasonal flows recede. This encroachment not only provides an important biotope in its own right, but it maintains current velocities in the centre of the channel and thereby sustains habitat for rheophilic species. This is the type of seasonal habitat evolution that is lost when stream channels are impounded.

**Figure 2.1 Partially removed structure associated with an abandoned fish farm.**

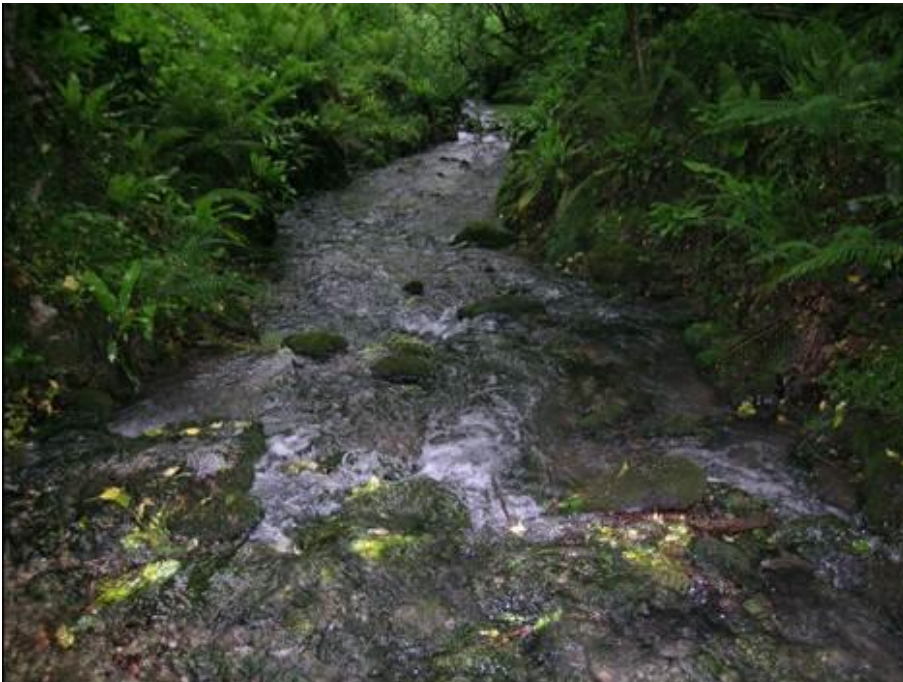
**Figure 2.3 Strong flows, coarse substrates and moss-covered exposed boulders.**

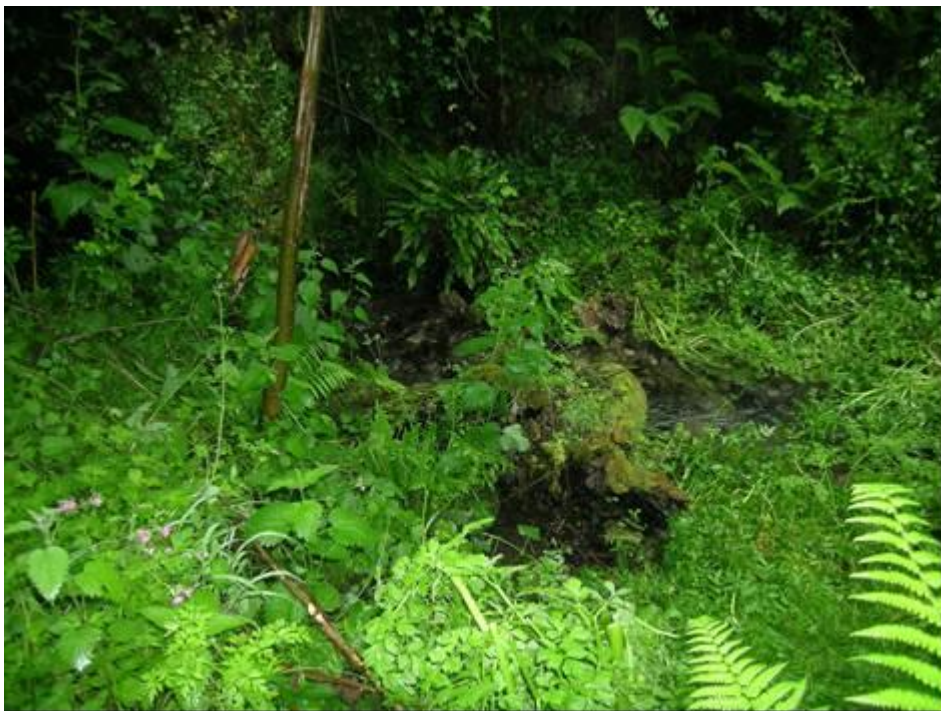
In a few places there was significant interaction between the stream channel and riparian trees (Figure 2.4), creating additional instream habitat diversity.

**Figure 2.4 Tree trunk generating flow constriction and added habitat diversity.**

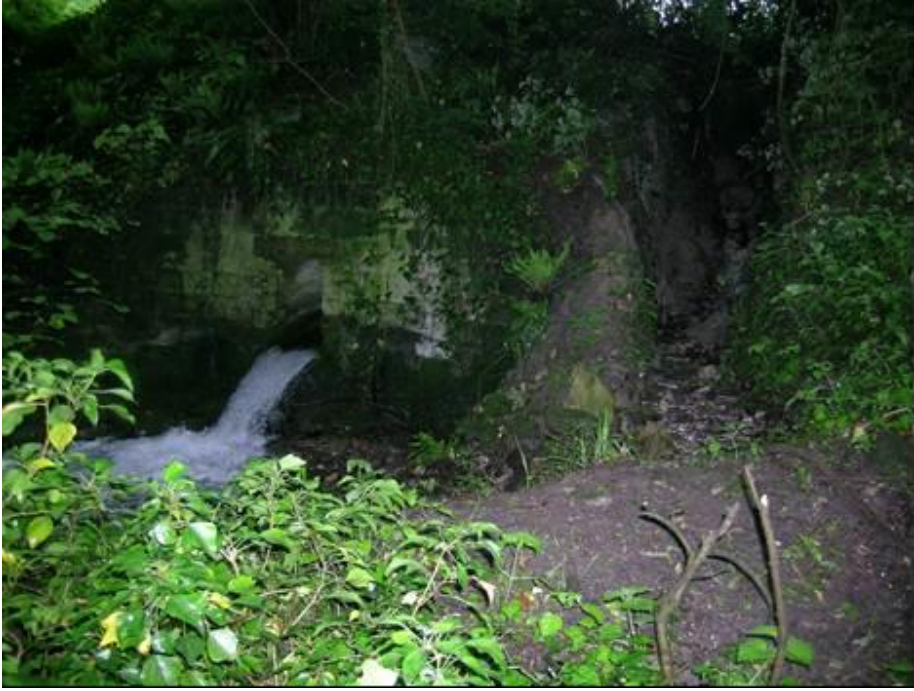
The upstream point of the walk was an impoundment for an on-line pond (Figure 2.5). This generates a massive discontinuity in the stream, and eliminates stream habitat through the impounded section. The impoundment is deteriorating – a breach has eroded a channel to the right of the main outlet (visible in the right hand side of Figure 2.5).

**Figure 2.5 The impoundment at the top end of the walk, showing the breach.**

- It seems possible to address the effects of the most upstream impoundment on Beechwood Lane by restoring flow to what appears to be the original channel. A proper investigation would be required, but it seems possible to divert the majority of flow away from the on-line pond into the channel. This would not affect the quality of the pond but would restore the natural function and therefore habitats of the stream.

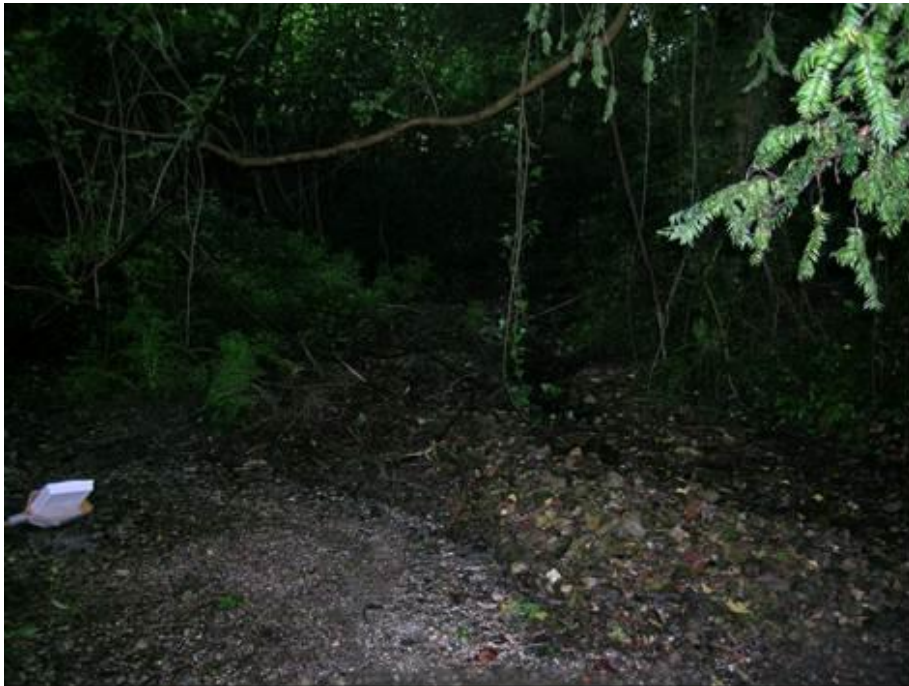
What looks to be the original channel can be seen entering the stream downstream of the impoundment (Figure 2.6). It is possible that the impoundment was originally off-line but that over time the full flow has been diverted through the pond.

**Figure 2.6. Dry channel meeting the stream immediately downstream of the impoundment.**

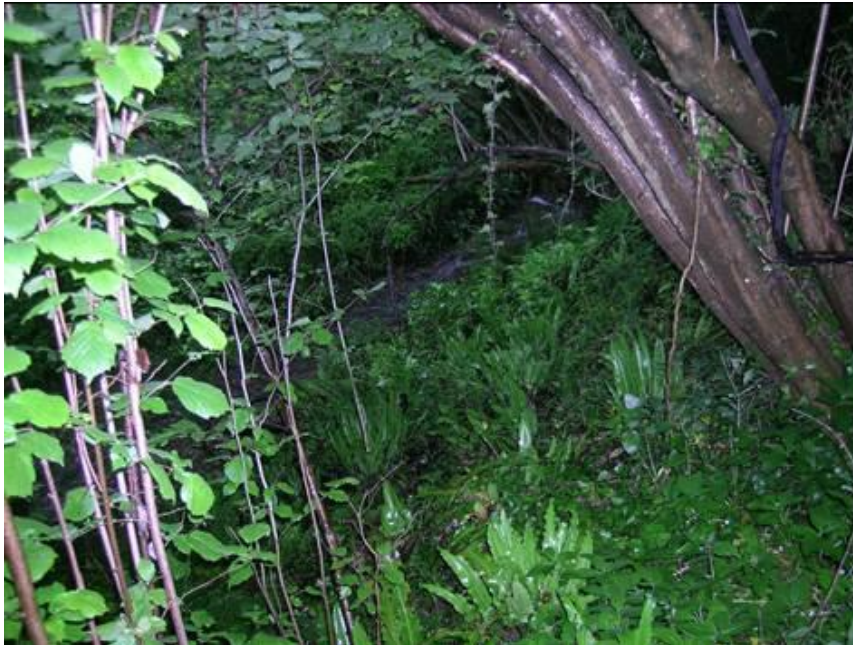
Walking back downstream, along the top of the gorge, the depth of the gorge and the abundance of the lower plant flora is more apparent (Figure 2.7).

**Figure 2.7 The fern-filled gorge.**

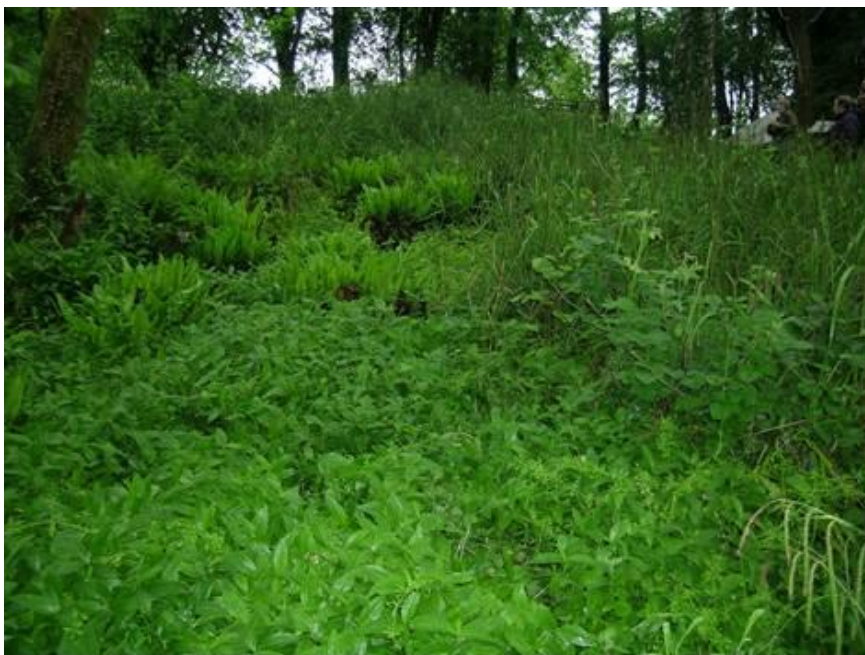
Tufa formation was evident in some of the springs seeping down into the channel, and was extensive in some areas (Figure 2.8).

**Figure 2.8. Hart's tongue fern and dog's mercury growing on a tufa mound.**

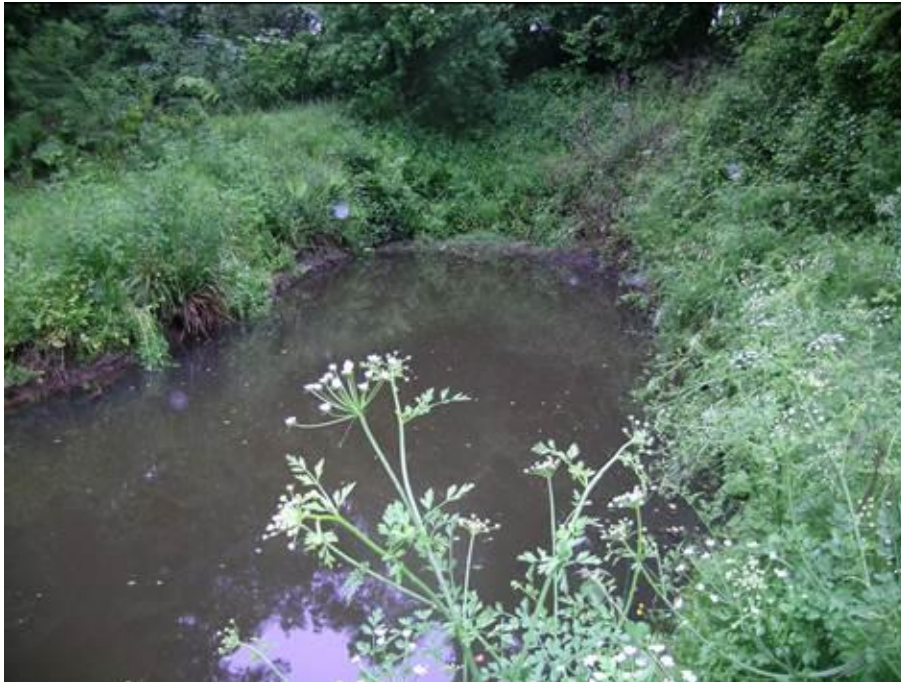
Back down at the downstream end of the stream, the old fish farm ponds are still in place alongside the stream channel (e.g. Figure 2.9). These currently provide limited habitat. Alongside these ponds, stream gradient declines and the channel starts to meander and lay down finer marginal sediments. The main channel supports submerged plants (*Callitriche stagnalis* and *Berula erecta*), whilst characteristic encroaching plants invade the channel from the margins (*Veronica beccabunga* and *Rorippa nasturtium-aquaticum*).

**Figure 2.9 Abandoned fish farm pond.**

- The abandoned fish farm ponds could be improved by shallowing the bank profile and allowing encroaching marginal plants species characteristic of chalk streams (such as watercress, fool's watercress and brooklime) to colonise. Some submerged plants characteristic of chalkstream habitat will grow happily in these ponds, such as water starwort and lesser water-parsnip, and can be harvested directly from the stream, so no import of plant species is necessary.

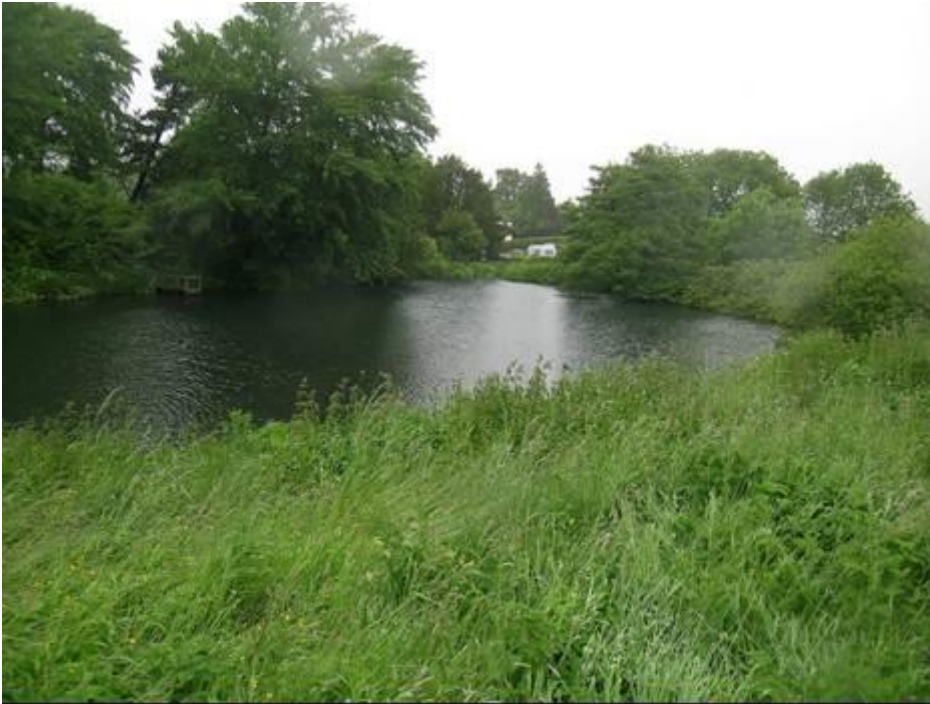
At the downstream end of the walk, immediately upstream of the A285, there is a further impoundment for an on-line fishing lake (Figure 2.10). This is long-established but has eliminated chalkstream habitat through a long stretch. The impounding effect is still evident 100 metres upstream (Figure 2.11). Flushes still feed into the lake from the rough pasture on the north bank.

**Figure 2.10. On-line fishing lake.**

- The impoundment associated with the fishing lake, upstream of the A285 seems more problematic because of its on-going use and the existing goodwill of the angling club who fish there. In practical terms, there seems no reason why sediment could not be pumped out of the lake and the impoundment removed, which would restore around 100 metres of stream to high quality chalkstream habitat. Alternatively, it may be possible to take the lake off-line, if the topography of the land permits. Given the high flow on the stream and the shallower gradient of this stretch, it is quite possible that this sort of restoration would create classic chalkstream habitat that would be highly desirable to native brown trout. It is worth investigating the practical options and views of those involved. The stream section immediately upstream of the impounded reach, with its meanders, submerged and encroaching marginal vegetation, and diversity of water depths and substrates, gives an indication of the habitat that could be restored.

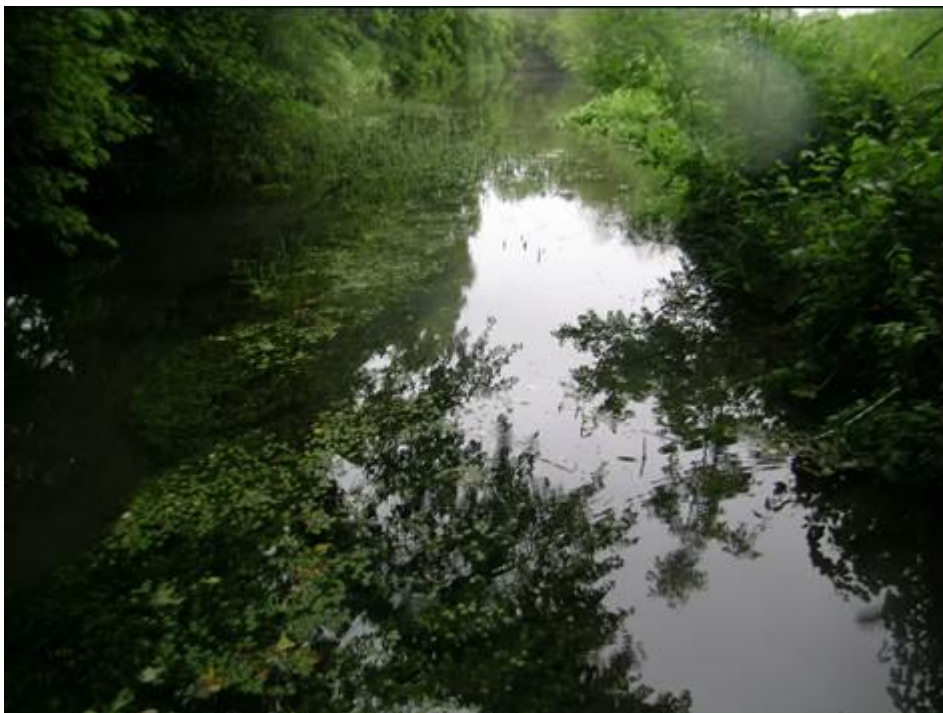
**Figure 2.11 Signs of impoundment in the stream 100 metres upstream on the fishing lake impoundment.**

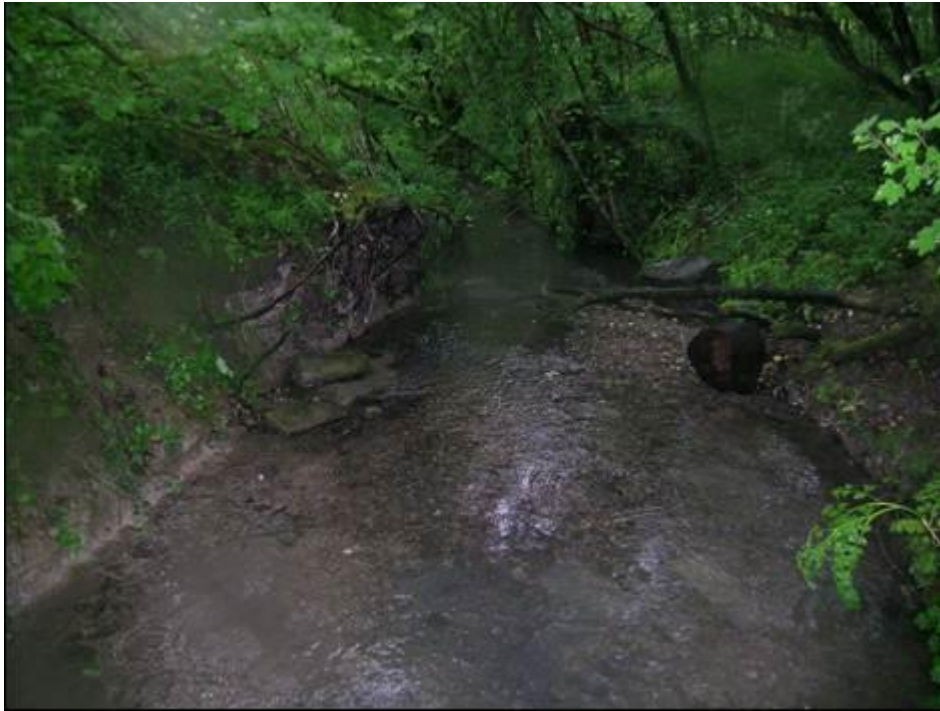
The small tributary had a steep gradient and incised channel, with abundant woody debris. The main stream along the section we walked had abundant gravel substrate but relatively limited habitat diversity (Figure 3.1). This was possibly due to the limited amount of woody debris in the channel. However, areas of exposed gravel substrate were evident (Figure 3.2), which is a rare biotope in chalk streams generally.

**Figure 3.1 Limited habitat diversity in Sutton stream.**

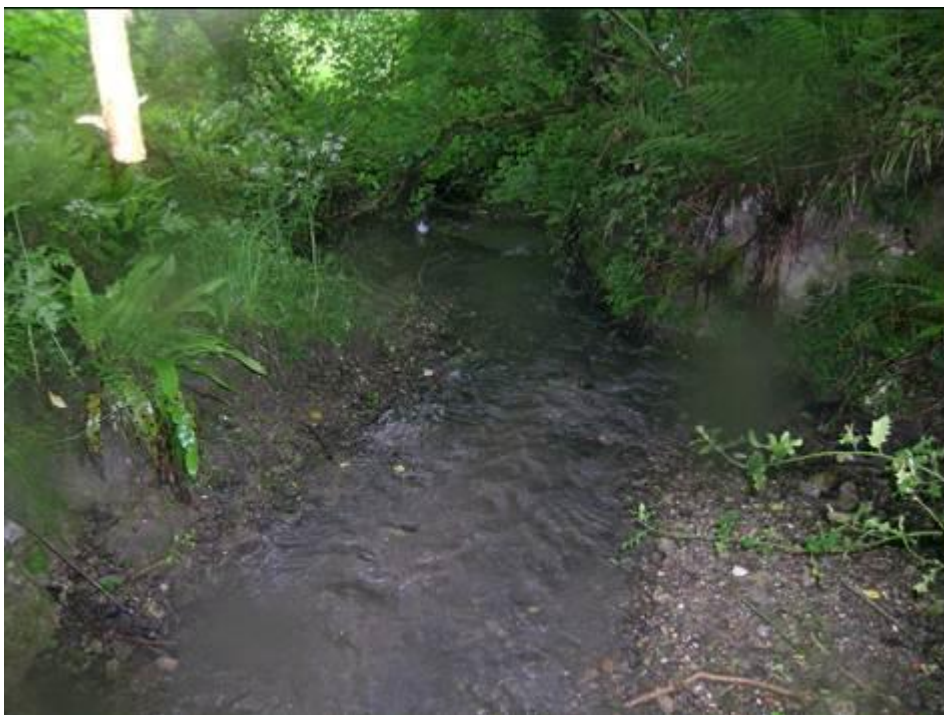
**Figure 3.2. Exposed gravels on Sutton stream.**

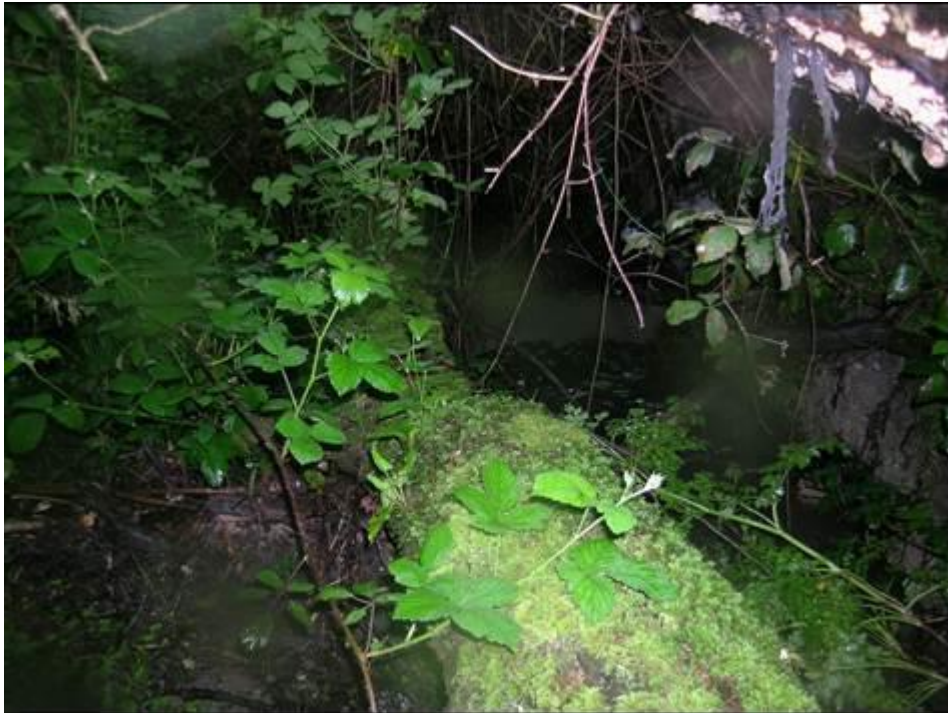
The general lack of woody material in the main stream did not appear to be related to active removal – there was a fallen tree across the channel at the lower end of the reach (Figure 3.3), which presumably would have been removed if there were on-going management.

**Figure 3.3. Fallen tree across Sutton stream, collecting woody debris upstream and forming a scourpool downstream.**

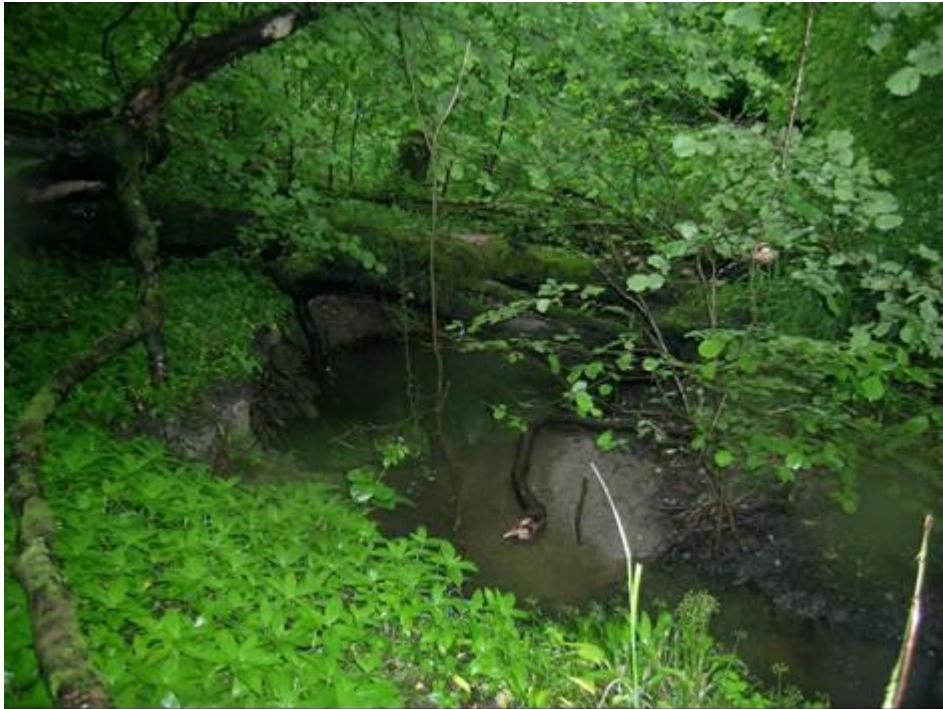
**Figure 4.1 Bignor stream.**

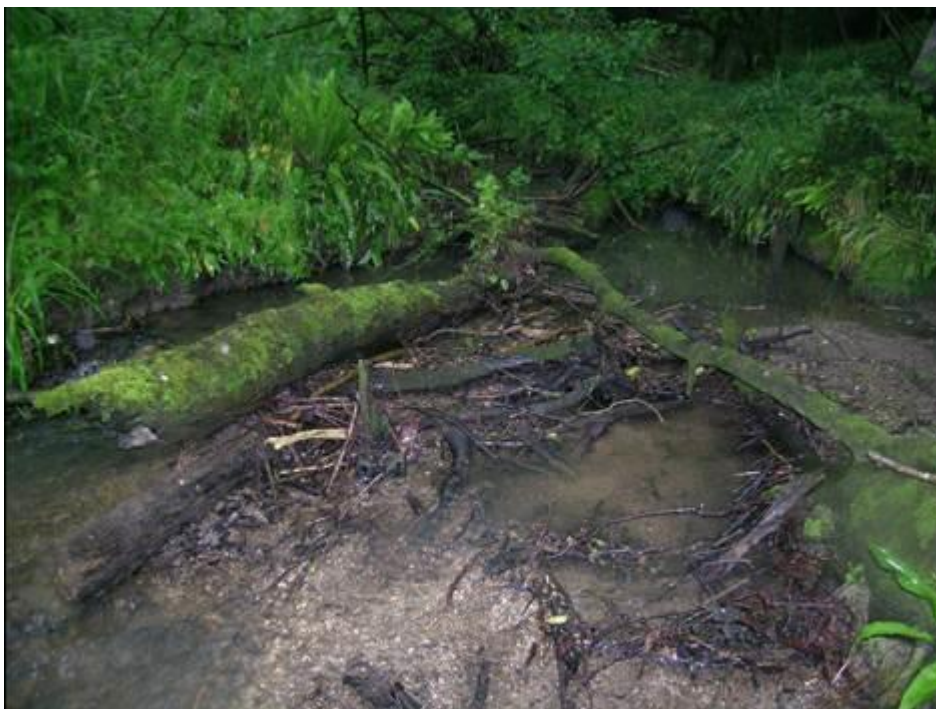
**Figure 4.2 Woody material creating a diverse natural biotope mosaic in Bignor stream.**

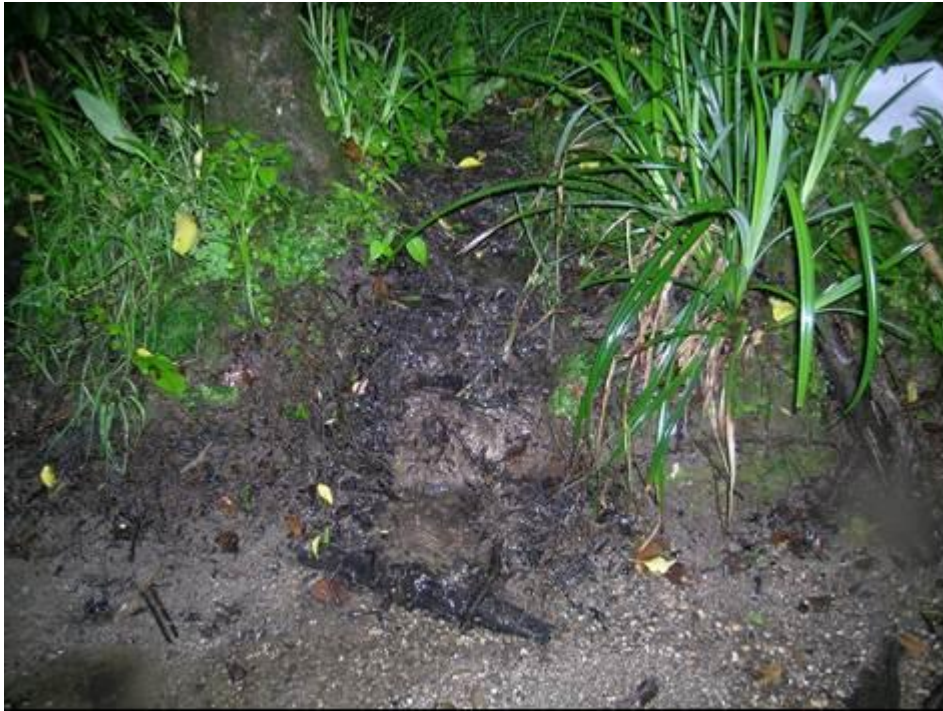
Tufa springs are evident feeding into the stream (Figure 4.3), which are generating a significant proportion of the coarser substrate in the channel.

**Figure 4.3 Tufa spring entering the stream.**

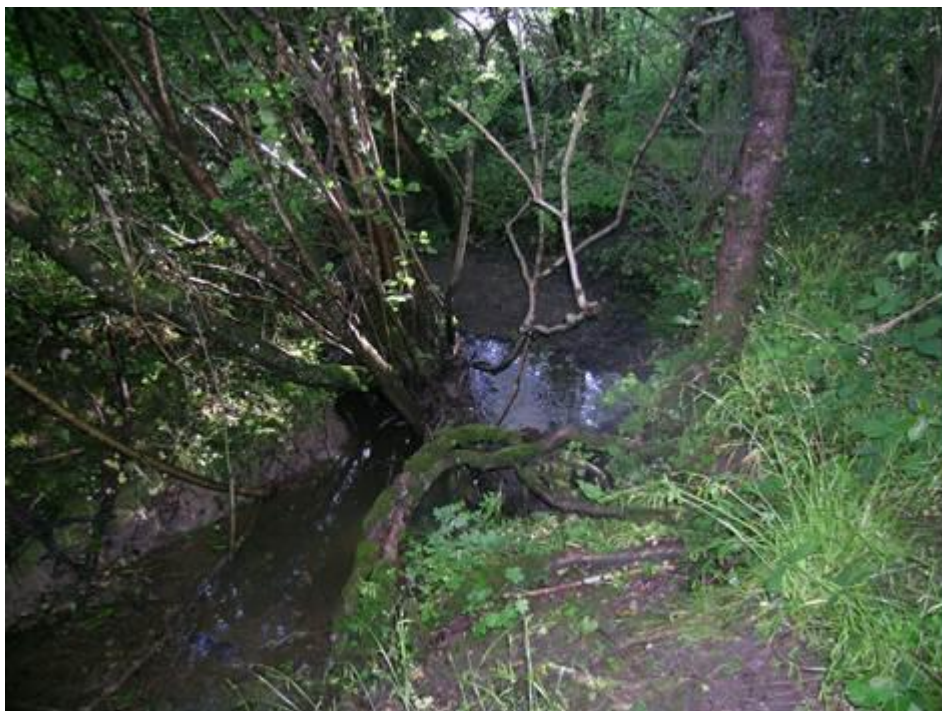
The stream through this section is naturally functioning and very close to its source running off the Downs. The channel has high levels of interaction with tree root systems and fallen wood, creating a physically diverse channel (Figure 5.1 and 5.2).

**Figure 5.1 Strong morphology of the Lag Stream.**

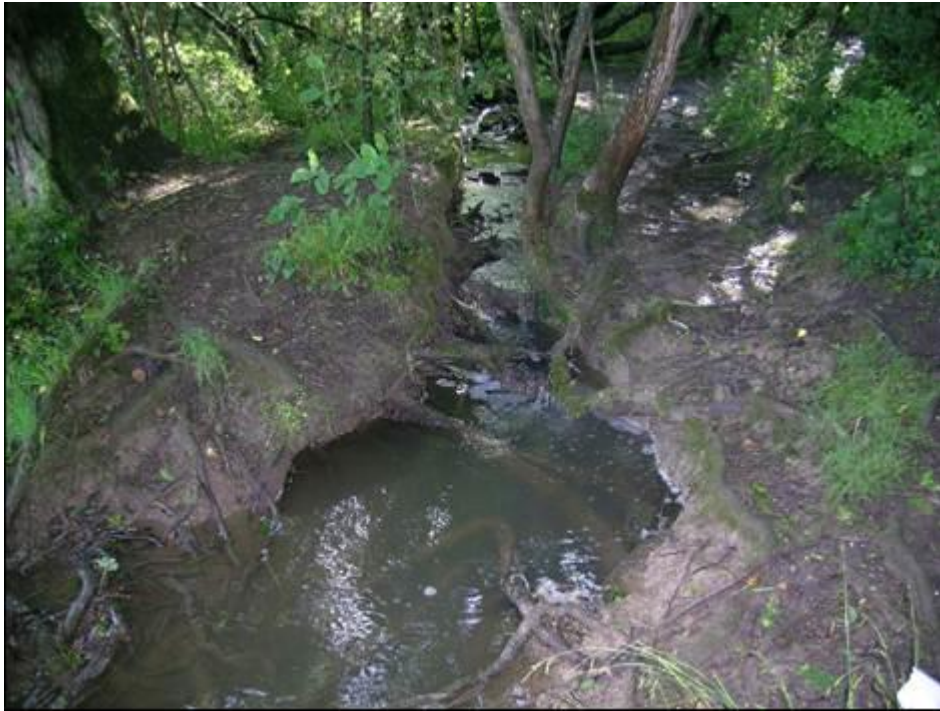
**Figure 5.2 Exposed tree root systems adding biotope diversity.**

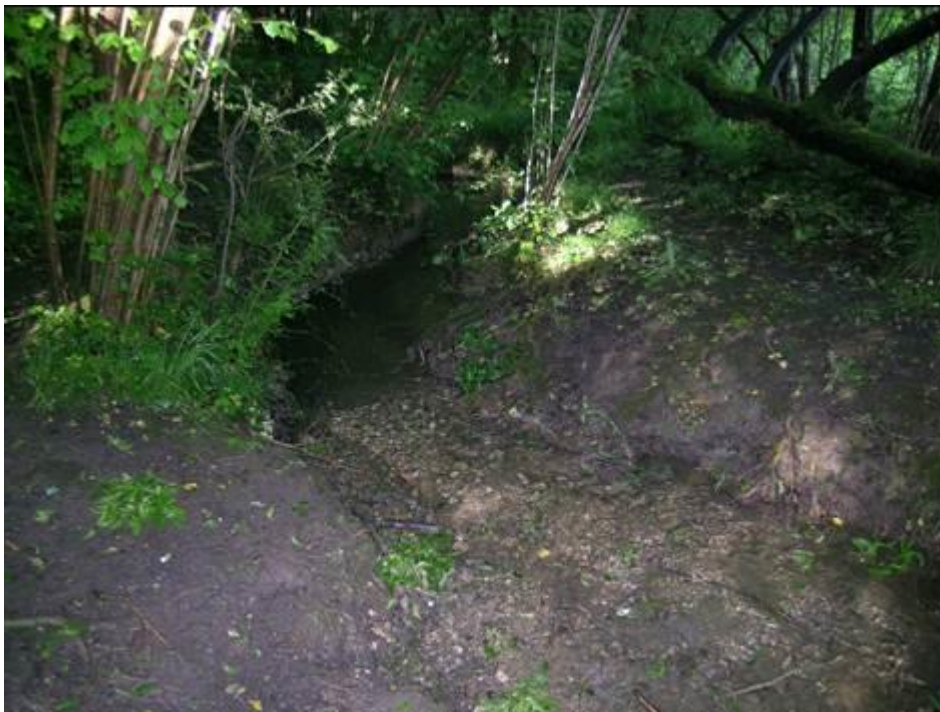
The stream is fed by tufa forming springs, and the tufa contributes strongly to the coarser bed substrates in the channel (Figure 5.3). This provides habitat for a range of invertebrate species dependent on open-structured sediments.

**Figure 5.3 Tufaceous deposits on the streambed.**

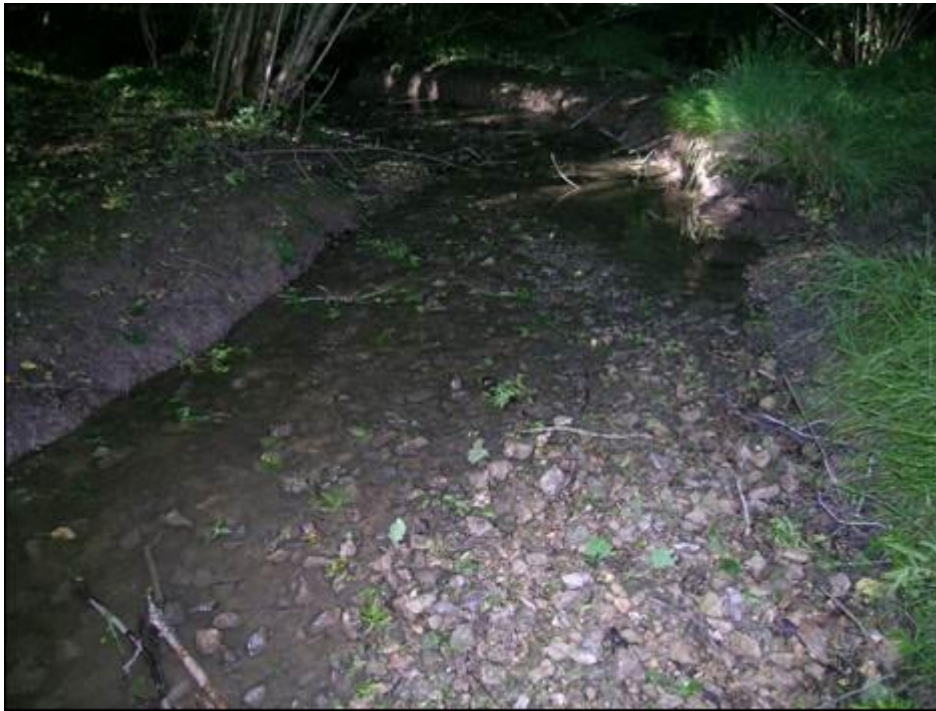
The bed substrates also include extensive flint cobble in some areas (Figure 5.4), drawn from the clay/flint deposits on the Downs. It is these deposits that generate the finer gravel base of classic chalkstreams.

**Figure 5.4 Flint cobbles in the stream bed.**
