Annex II - Examples of allocating sites to naturalness classes

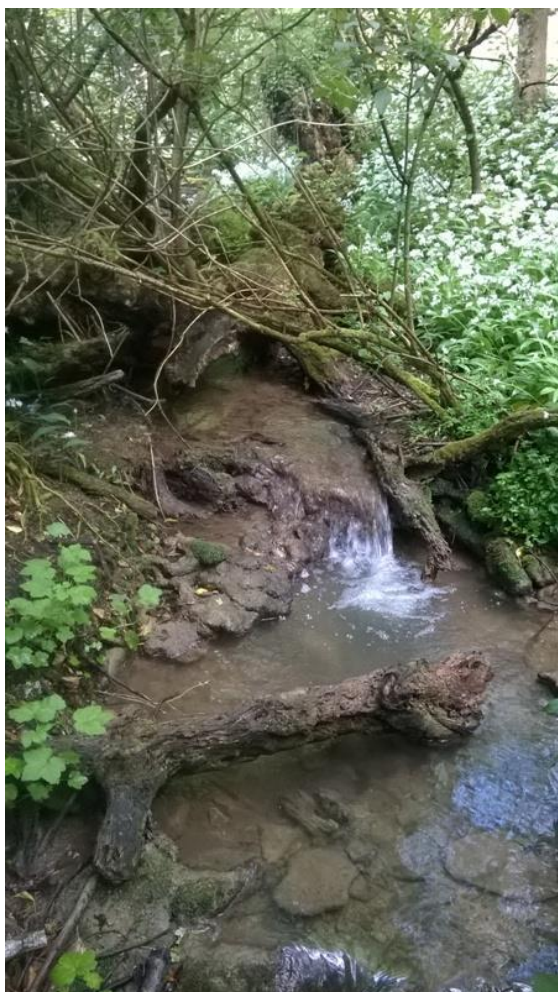
Example A

Component	Naturalness	Confidence
Physical	1	1
Hydrological	1	3
Chemical	1	3
Biological	1	2

Physical – No evidence of physical modifications, patchy riparian tree cover with good interaction between tree roots/fallen wood and the channel, semi-natural riparian vegetation.

Hydrological – No evidence of direct abstractions or other hydrological modifications. Low confidence because there may be groundwater abstraction.

Chemical - No visible indications of pollution (sewage fungus, heavy algal growths). Low confidence because no test kit used and less visible forms of pollution may be present.

Biological – No non-native species in evidence. Moderate confidence because the channel was checked for non-native crayfish

Other comments – Grey coating on stones is natural deposition of calcium carbonate (tufa) from the very hard water from the limestone aquifer.

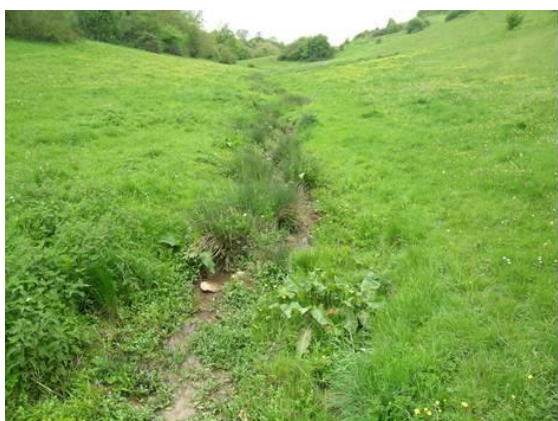
Example B

Component	Naturalness	Confidence
Physical	3	1
Hydrological	1	3
Chemical	1	3
Biological	1	2

Physical – No evidence of physical modifications but complete absence of riparian tree cover and the riparian zone is not semi-natural (improved pasture).

Hydrological – No evidence of direct abstractions or other hydrological modifications. Low confidence because there may be groundwater abstraction.

Chemical - No visible indications of pollution (sewage fungus, heavy algal growths). Low confidence because no test kit used and less visible forms of pollution may be present.

Biological – No non-native species in evidence. Moderate confidence because the channel was checked for non-native crayfish

Other comments – Whilst there are no obvious physical modifications the complete absence of influence of riparian trees means that the in-channel habitat mosaic lacks natural diversity.

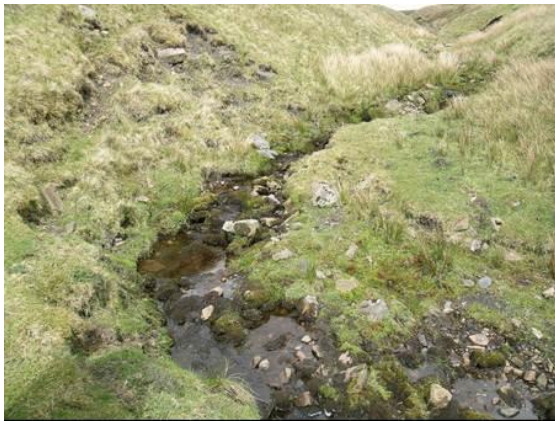
Example C

Component	Naturalness	Confidence
Physical	3	1
Hydrological	1	3
Chemical	1	3
Biological	1	2

Physical – No evidence of physical modifications but complete absence of riparian tree cover and the riparian zone is very heavily grazed

Hydrological – No evidence of direct abstractions. Moorland above has been hydrologically restored so should provide a natural flow regime. Moderate confidence because the likelihood of being affected by wider groundwater abstraction appears low.

Chemical - No visible indications of pollution (sewage fungus, heavy algal growths). Low confidence because no test kit used and less visible forms of pollution may be present.

Biological – No non-native species in evidence. Moderate confidence because the site is very remote.

Other comments – This is quite a typical moorland stream, where prolonged intensive sheep grazing has eliminated trees and scrub and limited riparian herbaceous vegetation. Bedrock and boulders create some natural in-channel diversity but the lack of influence of trees is a major missing element.

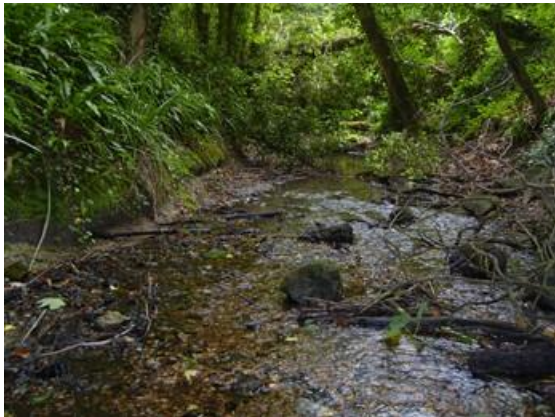
Example D

Component	Naturalness	Confidence
Physical	2	1
Hydrological	3	2
Chemical	1	3
Biological	1	2

Physical – Small amounts of physical modification (including a broken weir), but good riparian tree cover and woody material in channel, natural riparian zone.

Hydrological – Pumping station located towards the upstream end of the channel. Seems to be well-maintained and actively used. Moderate confidence because extent of use is unknown and there may be wider groundwater abstraction effects.

Chemical - No visible indications of pollution (sewage fungus, heavy algal growths). Low confidence because no test kit used and less visible forms of pollution may be present.

Biological – No non-native species in evidence. Only moderate confidence because no check was undertaken for non-native stream invertebrates (e.g. signal crayfish).

Other comments – A hidden gem of a chalkstream headwater hidden in a dense tree-covered ravine (very unusual for the stream type). Physical modifications are easily removed but the pumping station may be more difficult to resolve

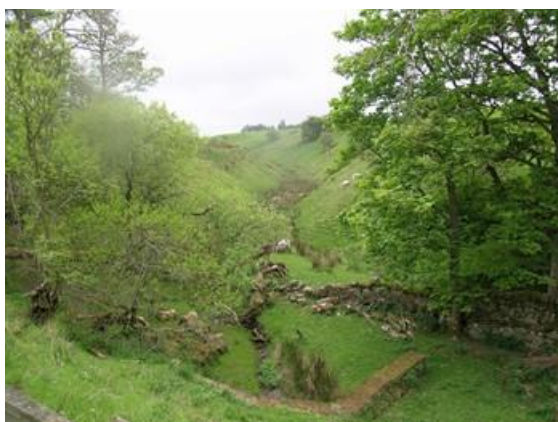
Example E

Component	Naturalness	Confidence
Physical	3	1
Hydrological	1	3
Chemical	1	3
Biological	1	2

Physical – Total absence of riparian trees caused by heavy and prolonged sheep grazing. This generates a very degraded in-channel habitat mosaic. Riparian vegetation is degraded by overgrazing.

Hydrological – No evidence of direct abstraction or other flow modification. Low confidence because the condition of the moorland upstream is unknown and there may be wider groundwater abstraction pressure.

Chemical - No visible indications of pollution (sewage fungus, heavy algal growths). Low confidence because no test kit used and less visible forms of pollution may be present.

Biological – No non-native species in evidence. Only moderate confidence because no check was undertaken for non-native stream invertebrates (e.g. signal crayfish).

Other comments – This site is typical of upland streams with high sheep numbers.

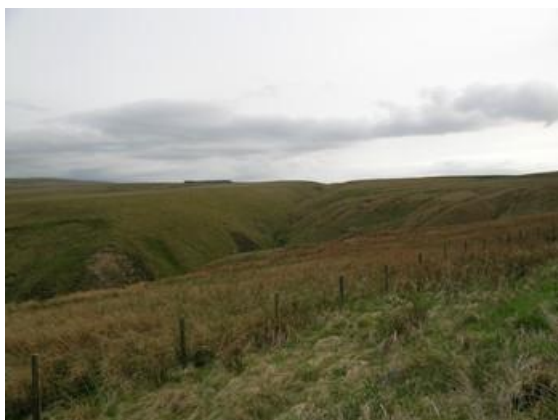
Example F

Component	Naturalness	Confidence
Physical	3	1
Hydrological	1	3
Chemical	1	3
Biological	1	2

Physical – Total absence of riparian trees caused by heavy and prolonged sheep grazing. This generates a very degraded in-channel habitat mosaic. Riparian vegetation is degraded by overgrazing.

Hydrological – No evidence of direct abstraction or other flow modification. Low confidence because the condition of the moorland upstream is unknown and there may be wider groundwater abstraction pressure.

Chemical - No visible indications of pollution (sewage fungus, heavy algal growths). Low confidence because no test kit used and less visible forms of pollution may be present (e.g. acidification).

Biological – No non-native species in evidence. Moderate confidence because the site is very remote.

Other comments – This site is of similar naturalness to Example E but at higher altitude. There is no climatological reason why riparian trees should not be present (note forestry plantation in background).
