Specialist site visit – The streams of Ashdown Forest, East Sussex

Thursday 4 June 2015

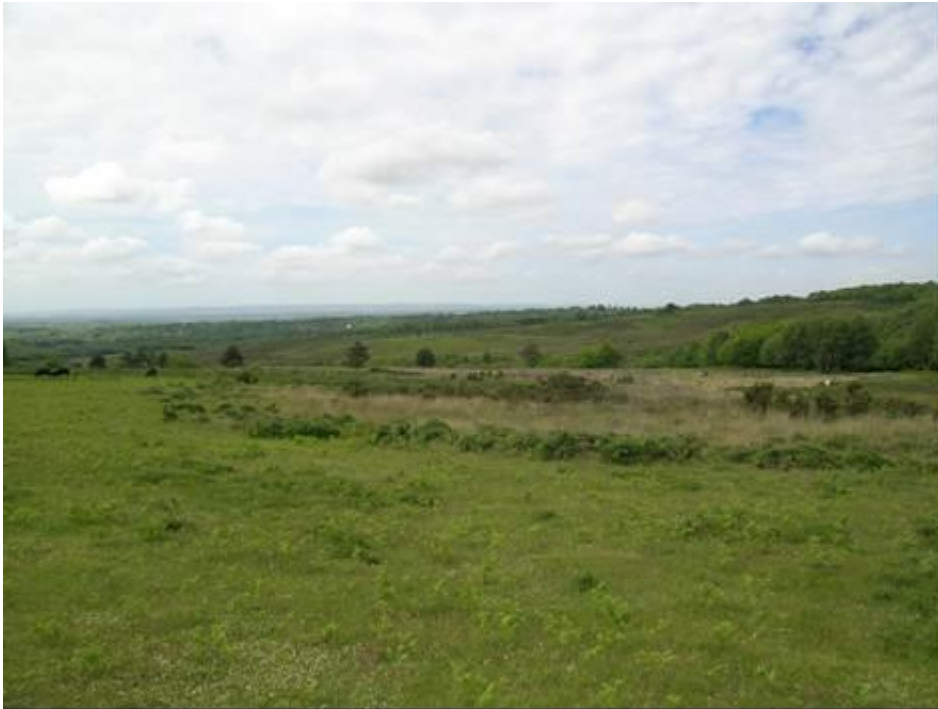
This is a highly natural example of a south-flowing ghyll, draining into the Ouse system. We walked from the top of the catchment at Holly car park (TQ 461 287) and walked downstream through the headwater mires and flushes and along the stream side for about 500 hundred metres to TQ 458 280. Figure 1.1 shows the heathland character of the catchment.

Figure 1.1 The catchment of Duddleswell Ghyll.

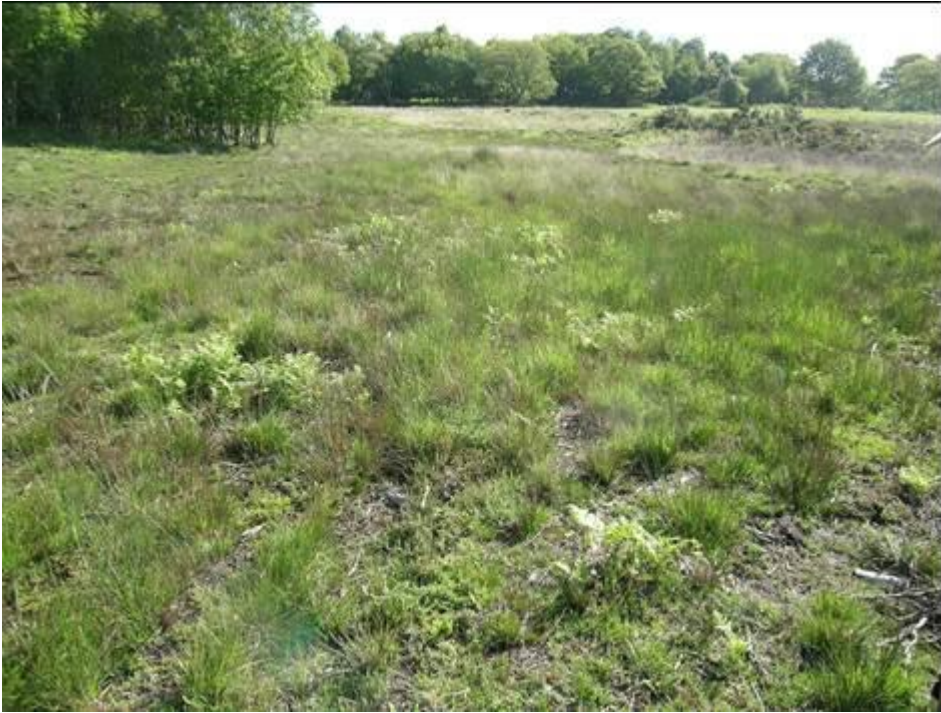
The headwater mires are intact without any signs of drainage (Figure 1.2), transitioning into flushes and seepages with abundant Sphagnum and patchy willow cover (Figure 1.3), as well as *Molinia*, *Eriophorum* and sedges such as yellow sedge. These give way to pools amongst tussock-forming species (Figure 1.4), and finally into a defined channel (Figures 1.5 and 1.6).

Figure 1.2 The start of mire vegetation in the headwater catchment near Holly car park.

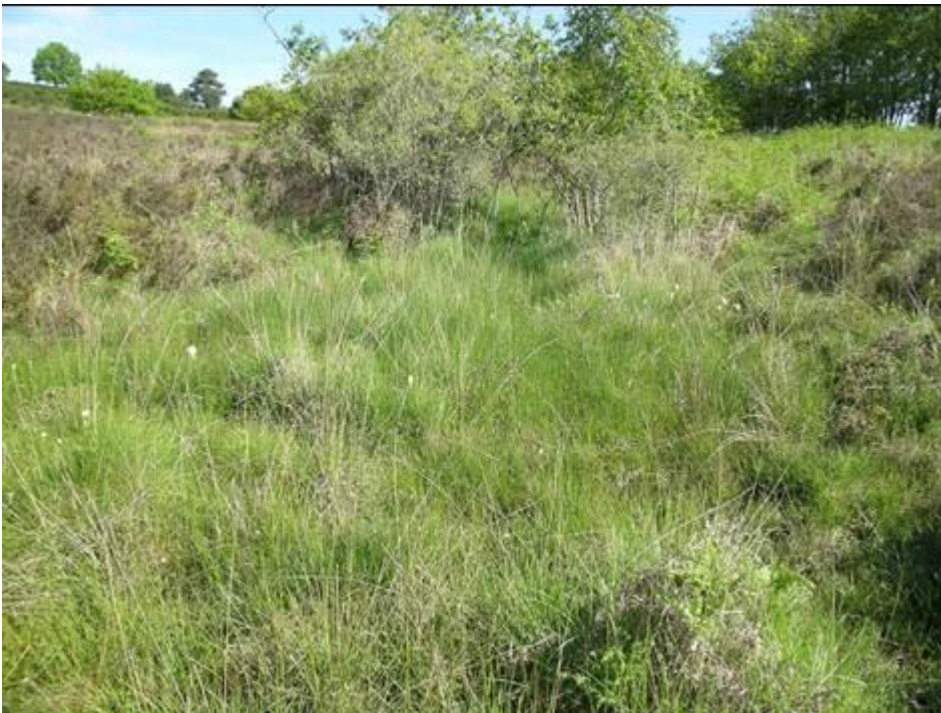
Figure 1.3 Flush habitat at the upstream end of the ghyll.

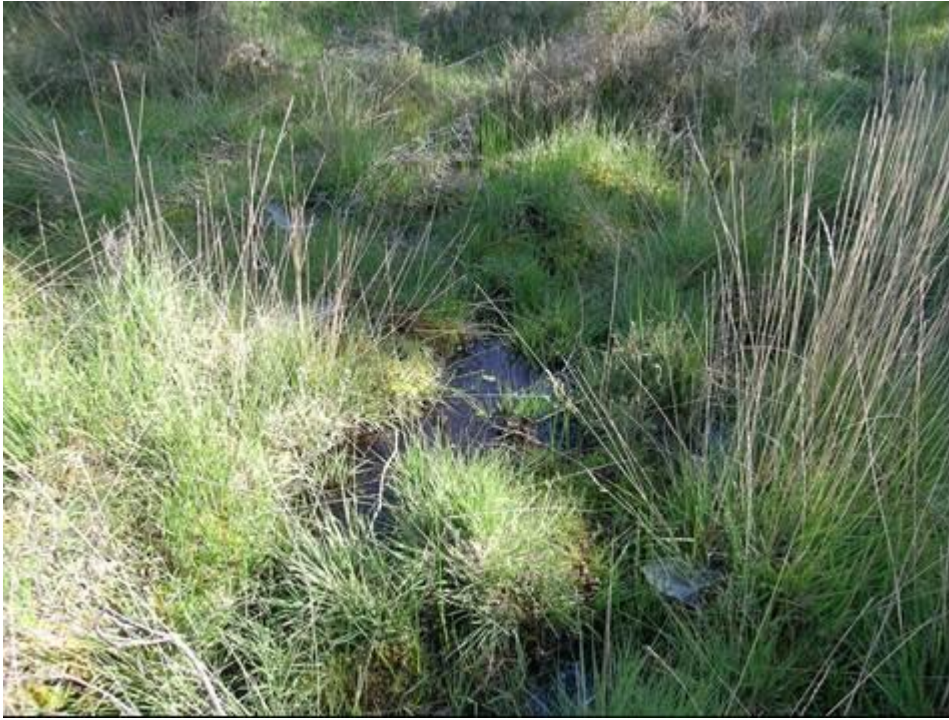
Figure 1.4 Pool formation at the upstream end of the ghyll.

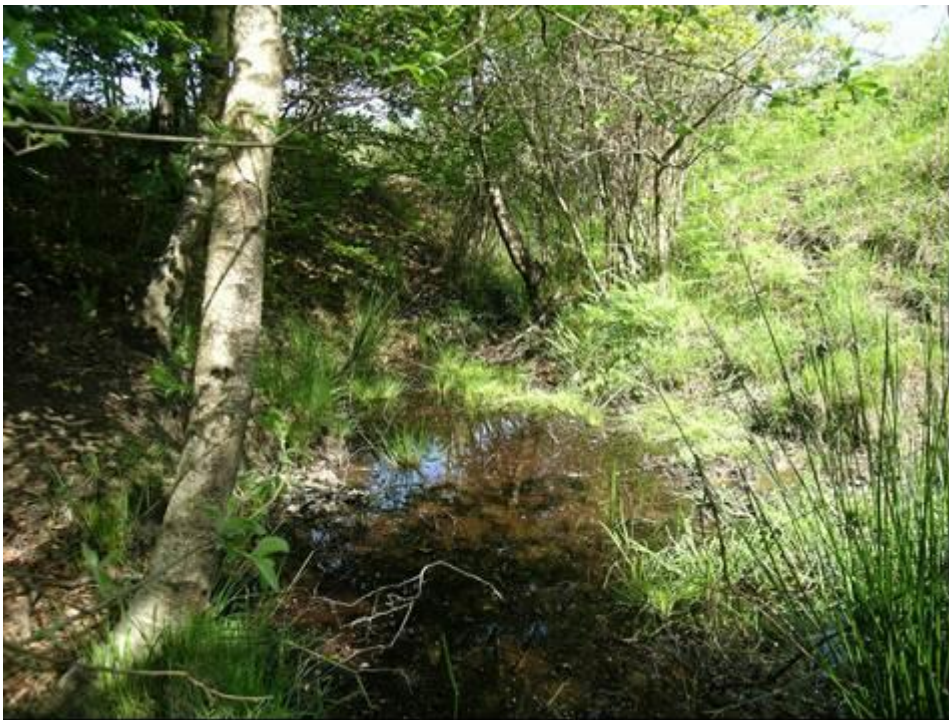
Figure 1.5 Initiation of the stream channel.

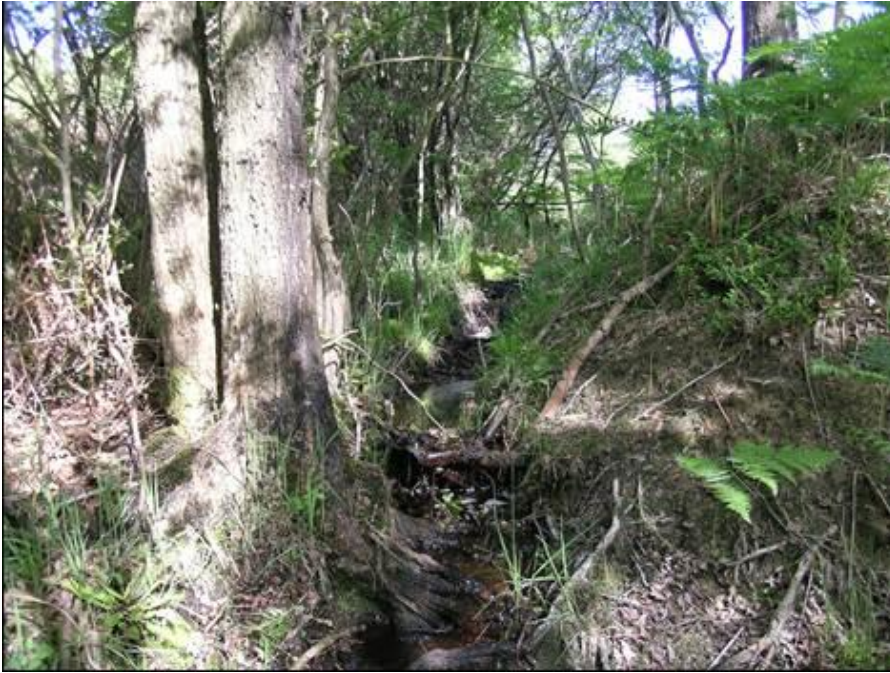
Figure 1.6 The recognisable stream in the ghyll.

The stream channel is highly natural in structure, with high levels of riparian trees providing root systems and woody debris that generate debris dams and associated habitat mosaics (Figure 1.6). A plentiful supply of leaf litter provides characteristic habitat for leaf-shredding invertebrates that are so characteristic of wooded headwater streams. As the stream continues downstream, intact flushes continue to feed into the channel (Figure 1.7).

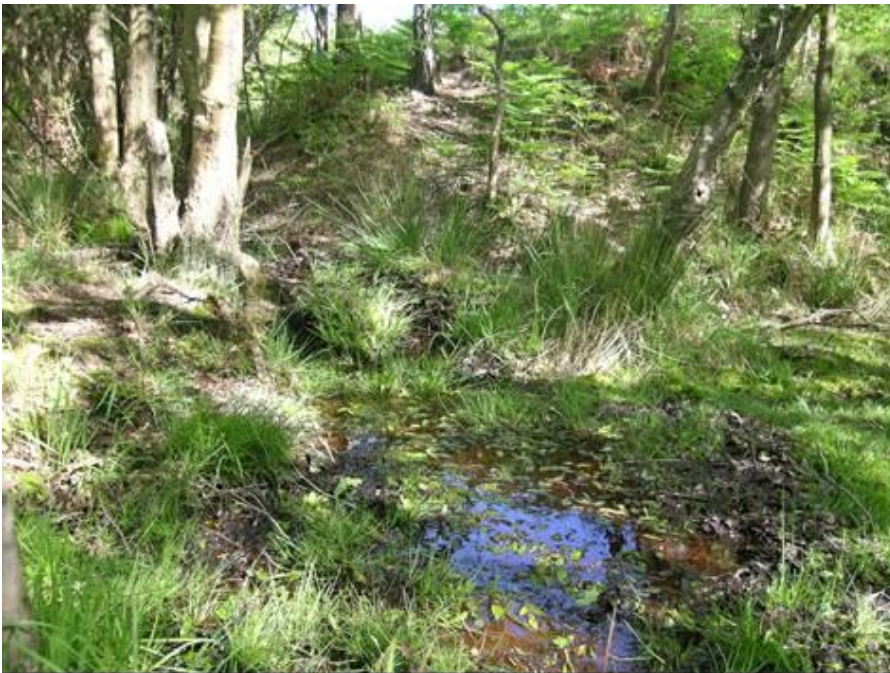
Figure 1.7 A flush feeding into the channel.

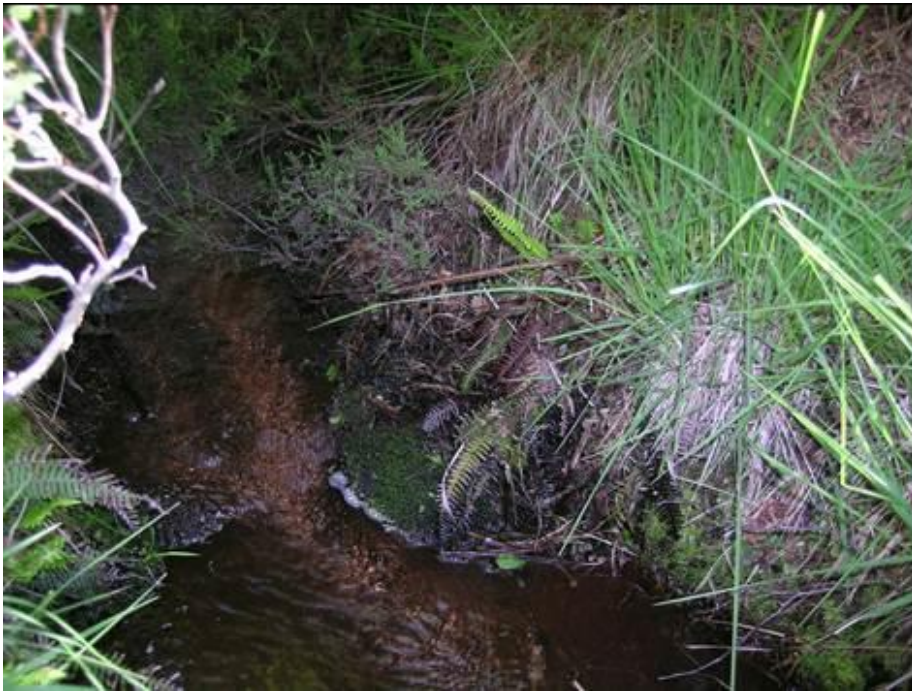
The streambed in the upper stream is dominated by bedrock overlain with peat deposits, although in some places mixed mineral substrates are evident (Figure 1.8). Bryophytes form on the channel sides (Figure 1.8), including rare species such as *Nardia compressa* (typically an upland species) and *Hyocomium armoricum* (a western oceanic species but also very characteristic of High Weald ghyll streams – pers comm Tom Ottley).

Figure 1.8 Occasional mixed mineral substrates forming in the channel, alongside the rare bryophyte *Nardia compressa*.

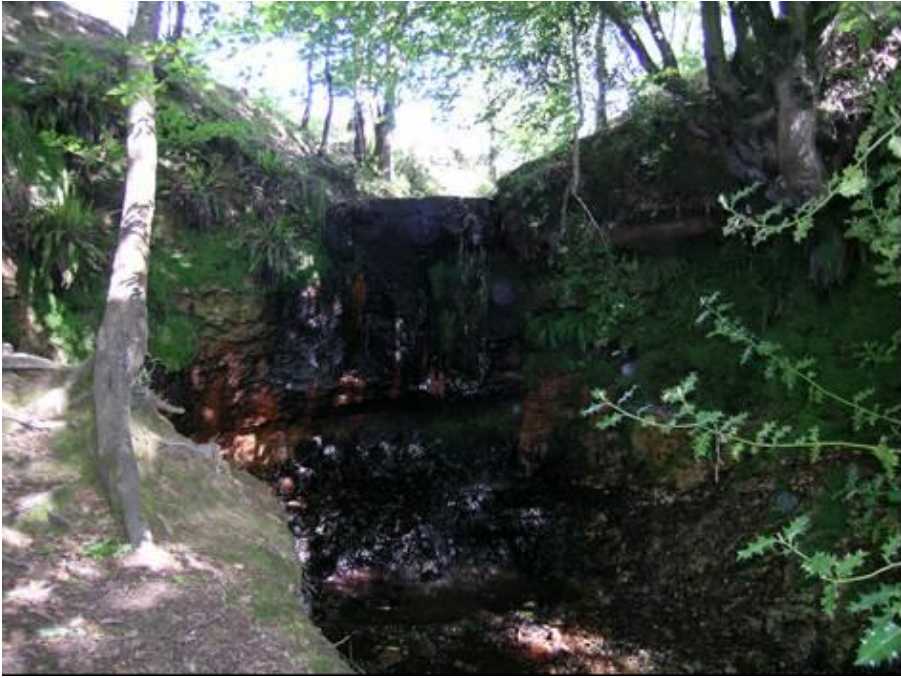
Bedrock on the streambed is impressively displayed at Breakneck Fall (Figure 1.9), which supports a range of ferns, mosses, liverworts and algae (Figure 1.10). Downstream of the waterfall the bedrock domination of the streambed begins to give way to boulders, cobbles and gravels (Figure 1.11) largely generated by erosion of the bedrock of the waterfall. These substrates are still extensively overlain with debris dams with considerable amounts of leaf litter from the extensive riparian tree canopy, and abundant peaty organic deposits originating from upstream and lateral mires and leaf breakdown (Figure 1.12). This generates a complex mosaic of meso-scale habitats that caters for a range of characteristic invertebrates.

Figure 1.9 Breakneck Fall.

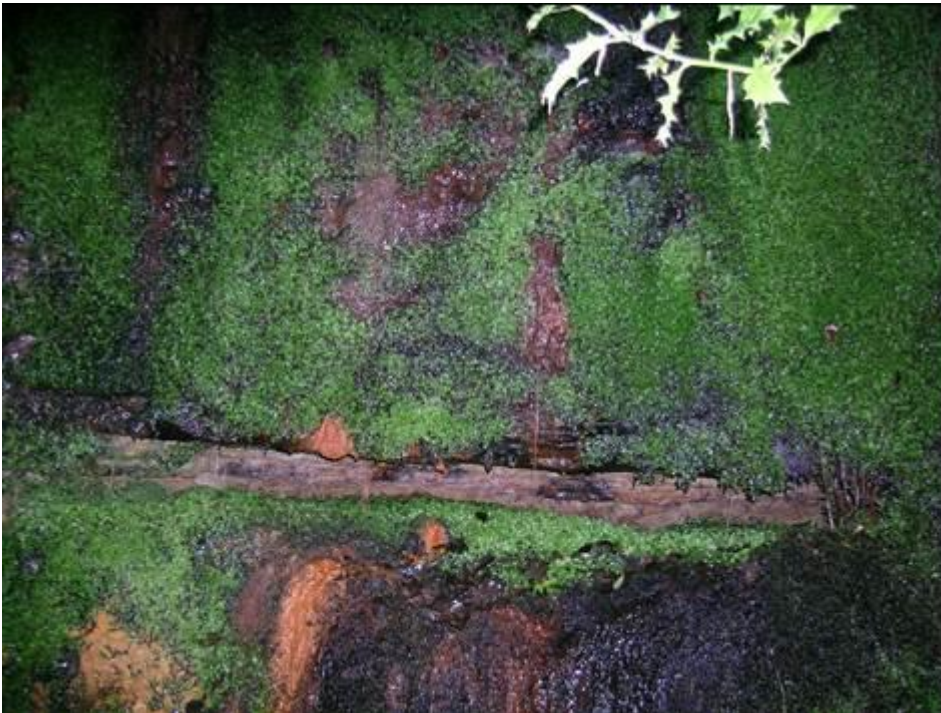
Figure 1.10 Liverworts and algae at Breakneck Fall – mainly *Pellia epiphylla* (pers comm Tom Ottley).

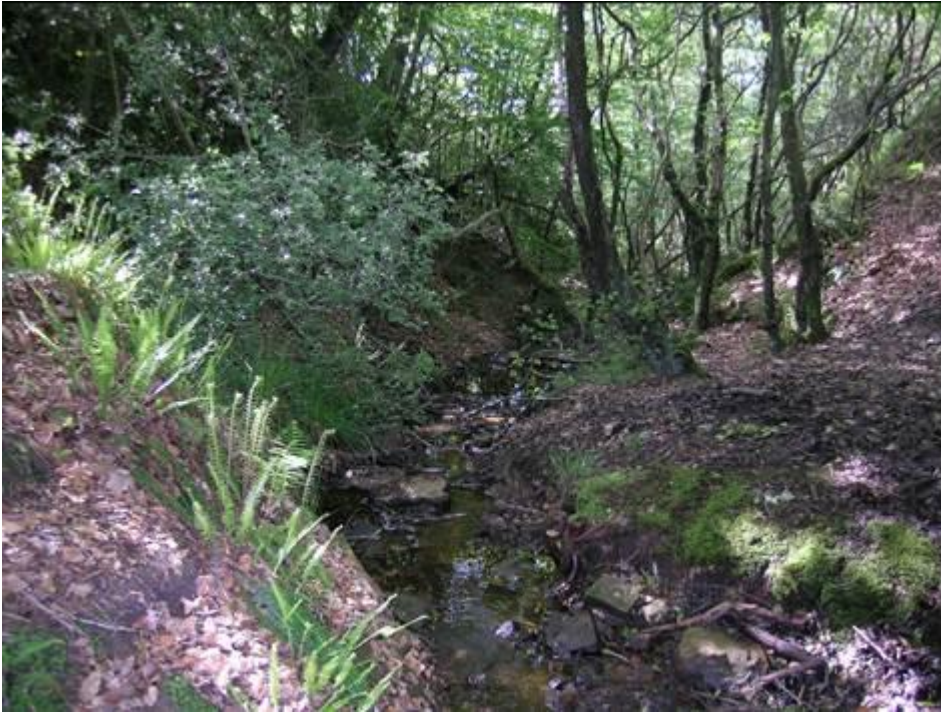
Figure 1.11 The stream immediately downstream of Breakneck Fall.

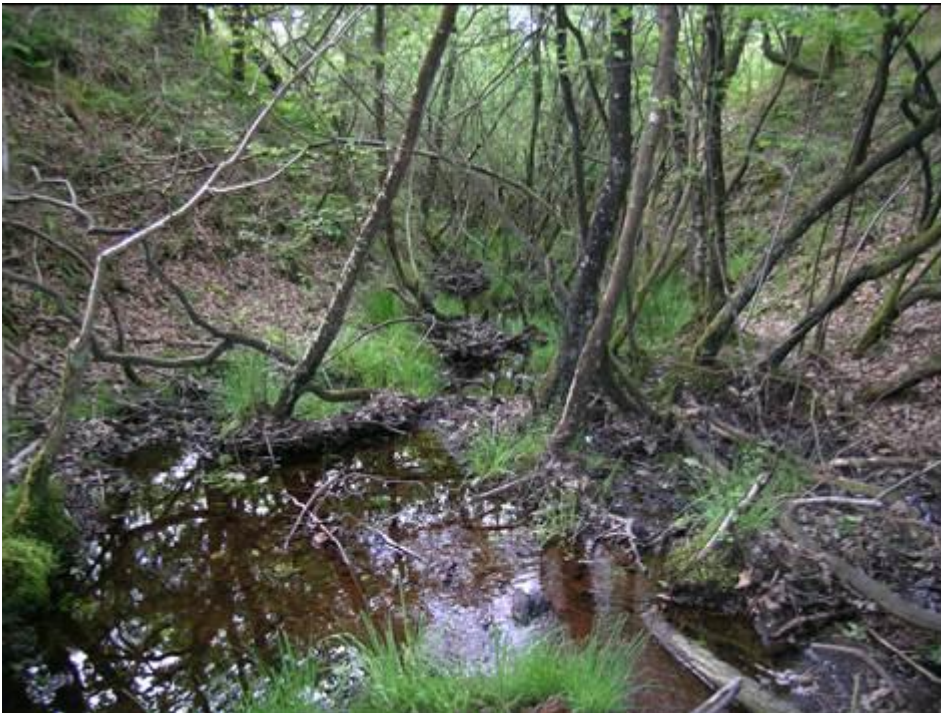
Figure 1.12 Organic deposits, leaf litter, woody debris and debris dams in the stream channel downstream of Breakneck Fall.

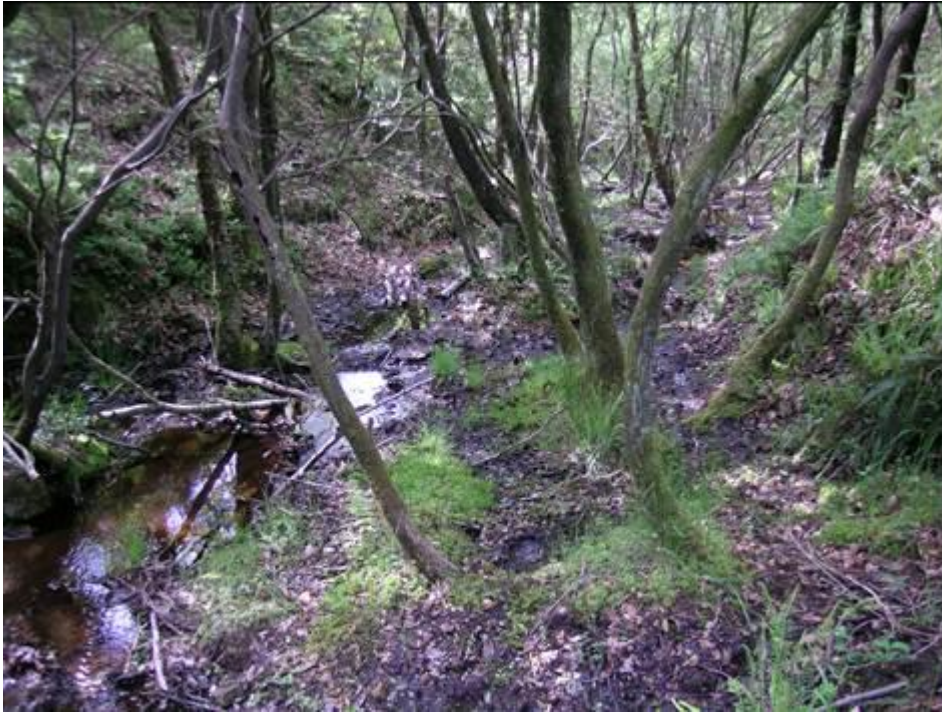
Lateral flushes continue to feed into the channel, including from further impressive bedrock falls that support an extensive lower plant flora (Figures 1.13 and 1.14).

Figure 1.13 A lateral flush feeding into the main ghyllstream.

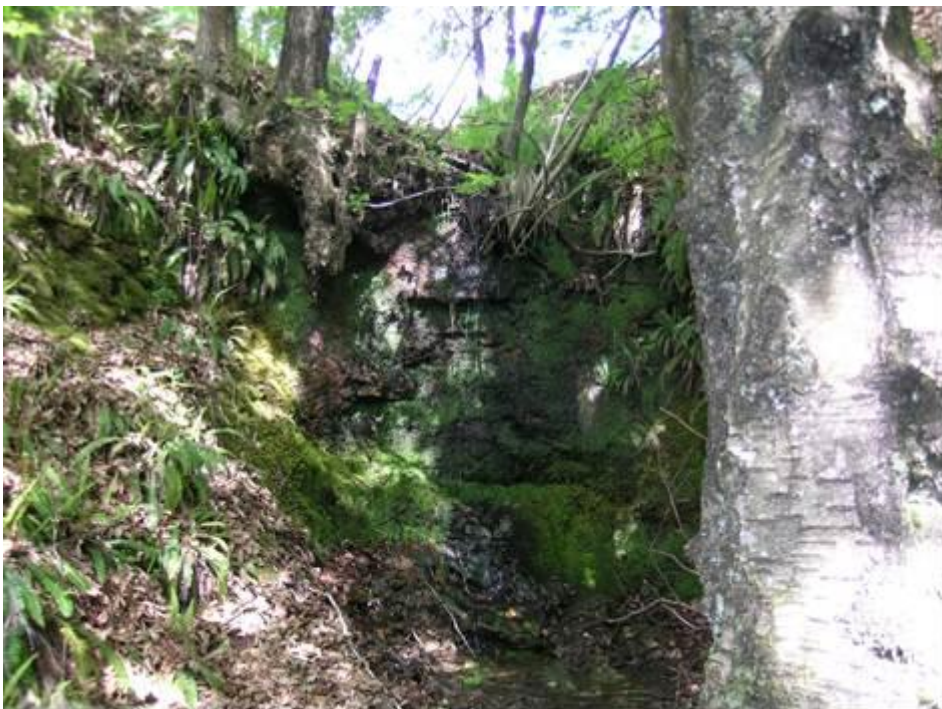
Figure 1.14 A lateral flush feeding into the main channel via bedrock.

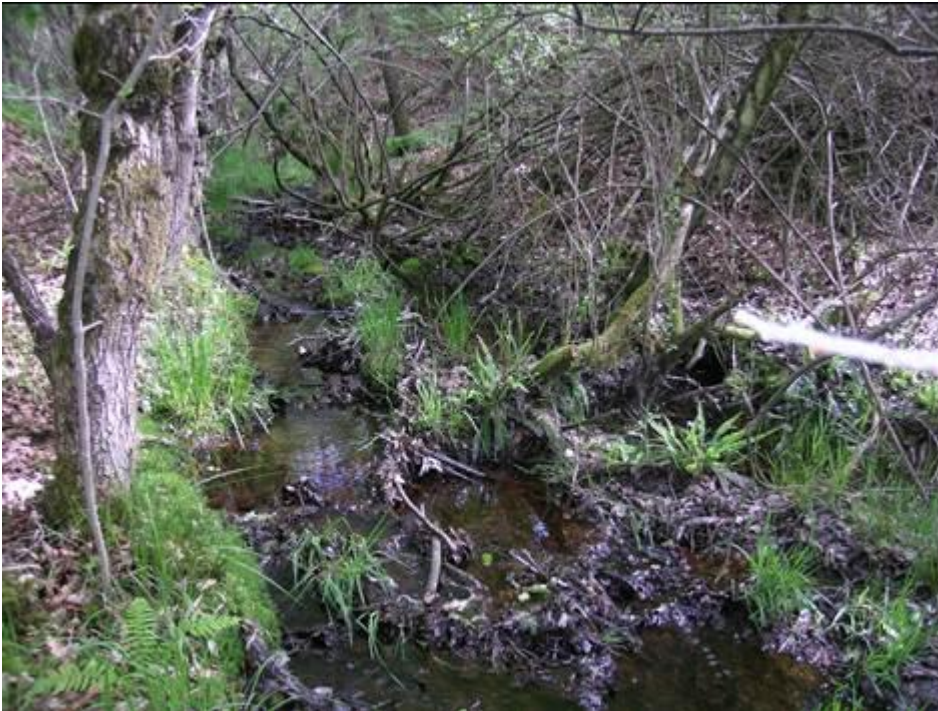
As we walked downstream, the same stream habitat mosaic of debris dams, organic sediments and occasional outcropping bedrock and mixed mineral substrates was evident (Figure 1.15). Tom Ottley explained that the stream continues with this character for some distance downstream (at least a kilometre), transitioning in and out of mire (Figure 1.16). These transitions relate to stream gradient and are probably largely bedrock-controlled, as has been evident in ghyll streams visited elsewhere in the vicinity

Figure 1.15 Characteristic habitat mosaic continuing downstream.

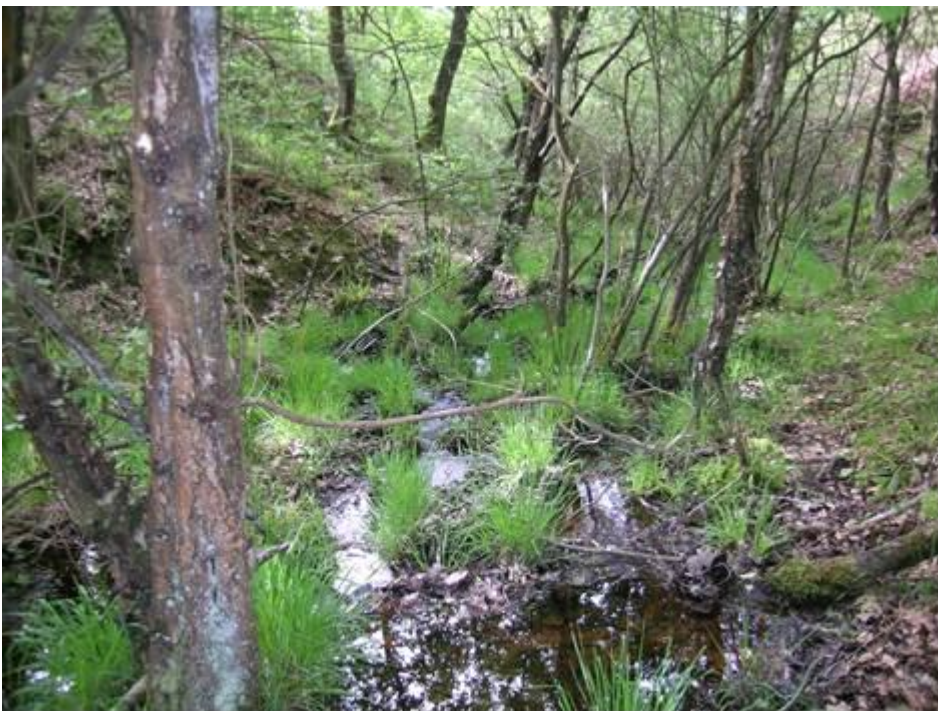
Figure 1.16 Stream reverting to mire in shallower gradient sections.

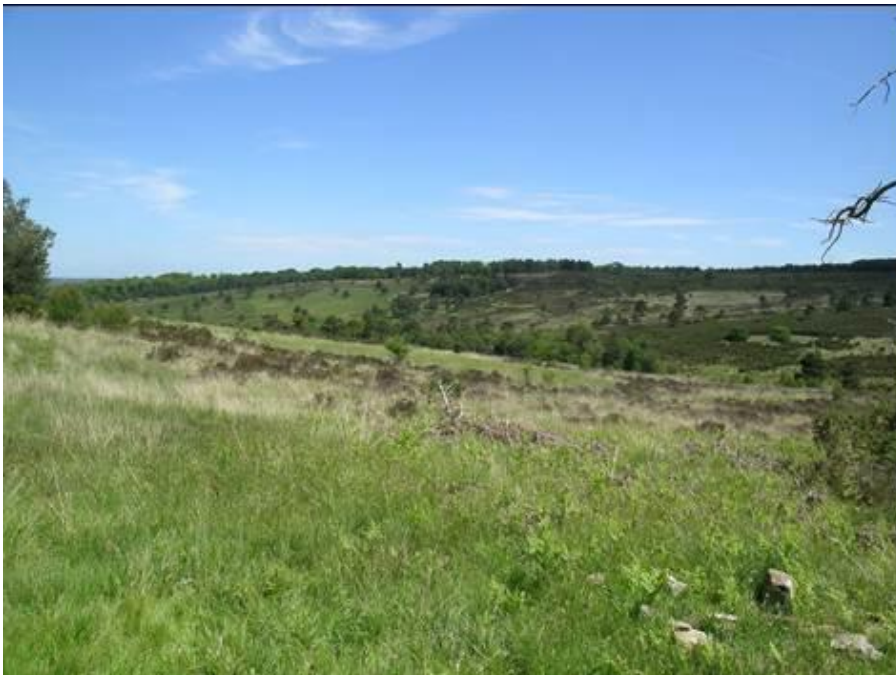
This is a north-flowing stream draining into the Medway system. We walked from a car park on the B2026 at TQ 471 326, meeting the ghyll at TQ 474 327. We walked upstream to the headwater flushes around TQ 473 317. Figure 2.1 shows the heathland character of the catchment. Tom Ottley reports that this stream is characteristic of many of the ghyll streams within the forest.

Figure 2.1 The catchment of Five Hundred Rough Ghyll.

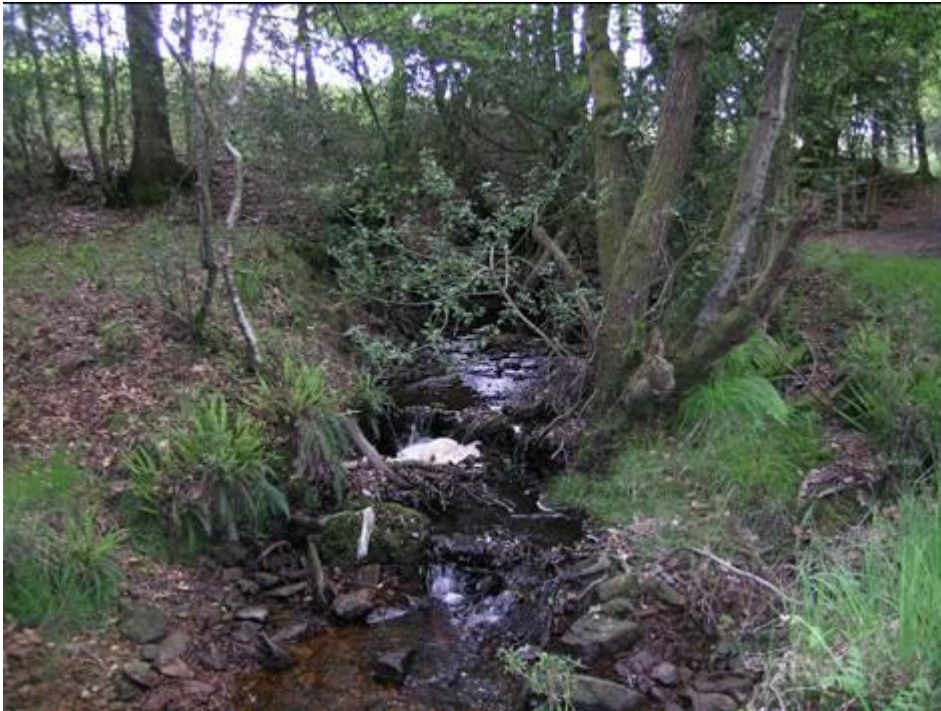
The downstream end of the stream exhibited an excellent natural habitat mosaic, consisting of boulders, cobbles, gravels and finer substrates with woody debris, leaf-litter and debris dams (Figure 2.2). Again, tree root systems and debris dams are instrumental in shaping the habitat mosaic, along with the larger mineral substrate elements.

Figure 2.2. The habitat mosaic at the downstream end of the walk.

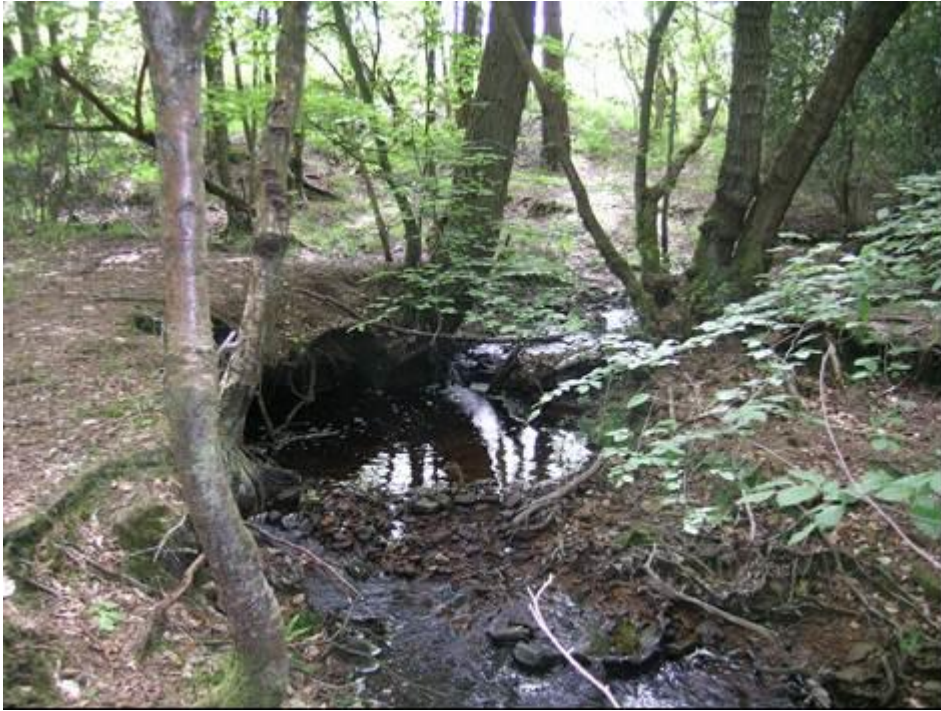
The importance of larger debris dams and fallen trees in shaping channel morphology was very evident (e.g. Figure 2.3). Bed levels are raised above the obstruction, whilst a scour-pool forms below the obstruction which throws up a shallow riffle of coarse substrate below the pool. This process is often accompanied by a lateral deflection of the flow that generates planform movement, which creates a sinuous channel that increases stream length (habitat extent) and adds greater meso-scale habitat variation. The resultant habitat mosaic is vital for characteristic biological assemblages, creating a range of conditions exploited by different species and (within a species) life stages. Different species and life stages have evolved to exploit this variation in habitat conditions, acquiring a range of behavioural and morphological traits that are suited to different parts of the mosaic.

Figure 2.3 Stream dynamics in action – the effect of a debris dam on the provision of instream habitat.

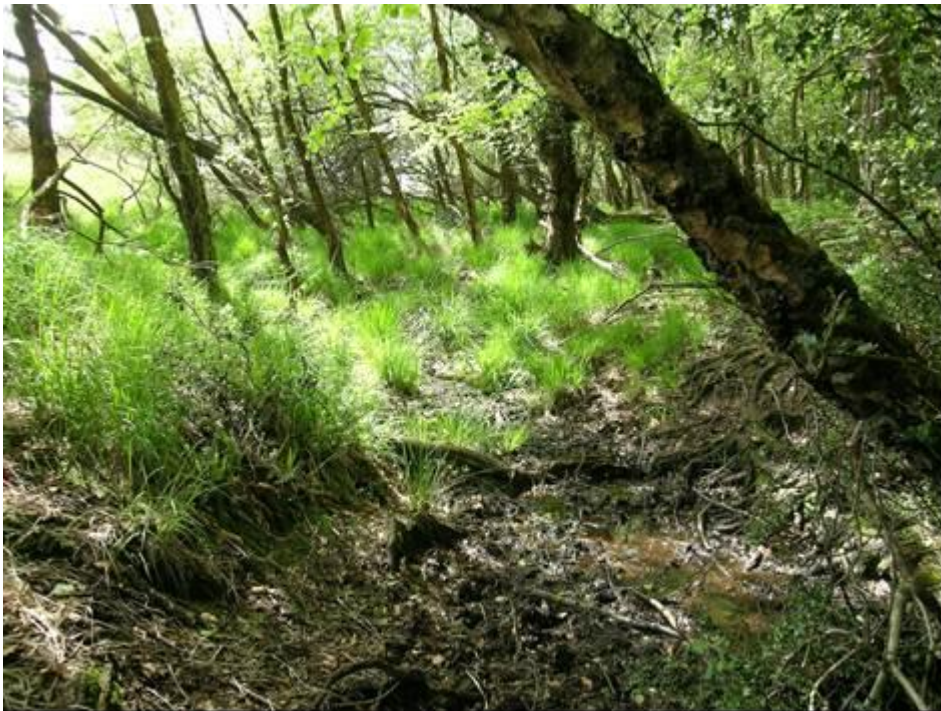
Lateral flushes feed into the stream channel at various points (e.g. Figure 2.4). The ghyll is broader than at Duddleswell, which facilitates more lateral movement of the stream in response to flow deflections cause by fallen trees and debris dams. This has sometimes resulted in secondary channels forming (Figure 2.5).

Figure 2.4 A lateral flush feeding into the stream.

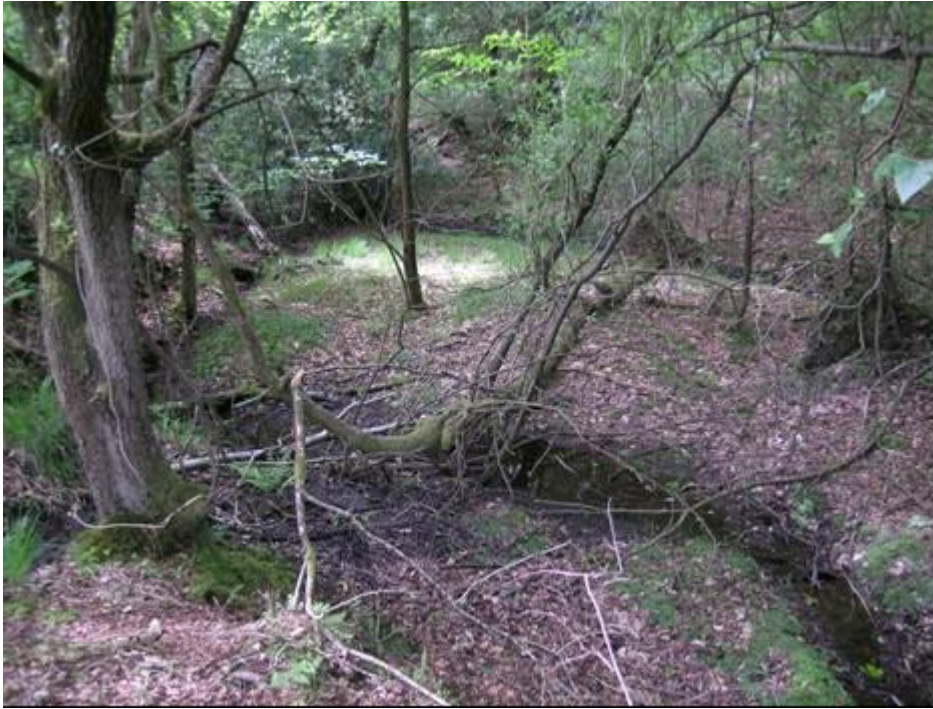
Figure 2.5. Secondary channel (the main channel can just be seen running parallel in the upper part of the image).

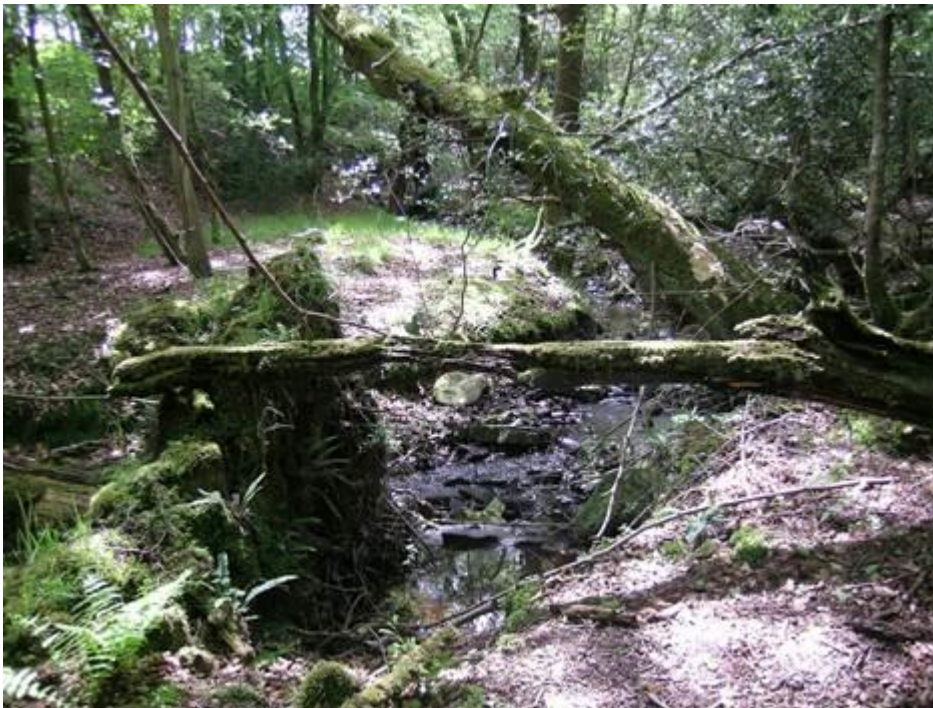
In some places the action of fallen trees and large woody debris has also generated significant amounts of seasonal exposed lateral sediments in the channel (Figure 2.6), which constitute a further habitat niche which can be exploited by a range of invertebrate species (particularly specialist beetles).

Figure 2.6. Areas of seasonally exposed sediment associated with the sinuous channel created by the action of trees and their debris.

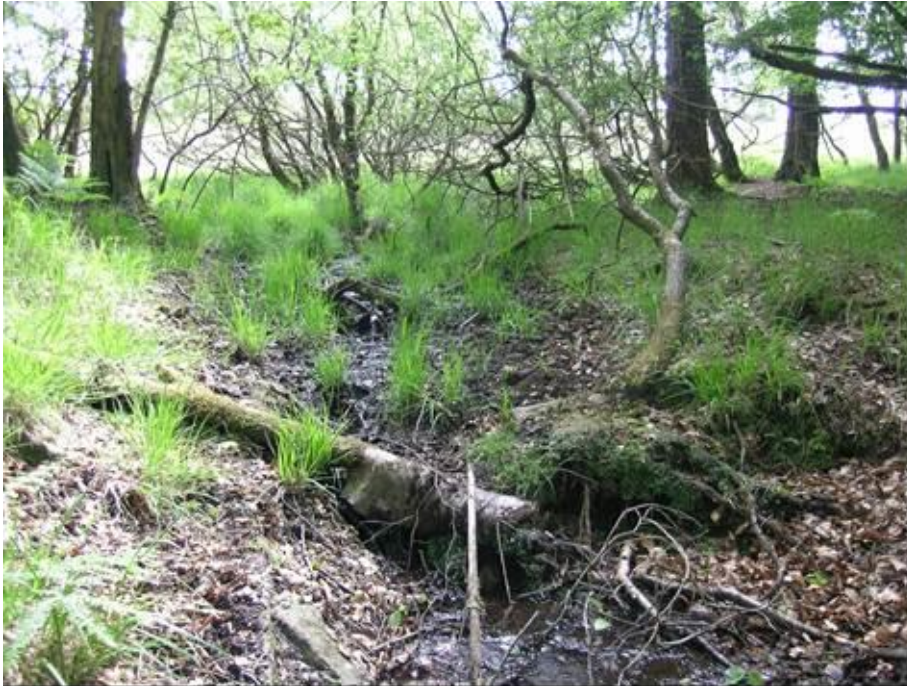
Some of the lateral flushes are very clearly sustained by large woody debris, acting to retain wetness and allow accumulation of peat. Figure 2.7 shows the point of mire-stream transition in one of these lateral flushes, directly associated with woody debris.

Figure 2.7 Lateral flush sustained by large woody debris.

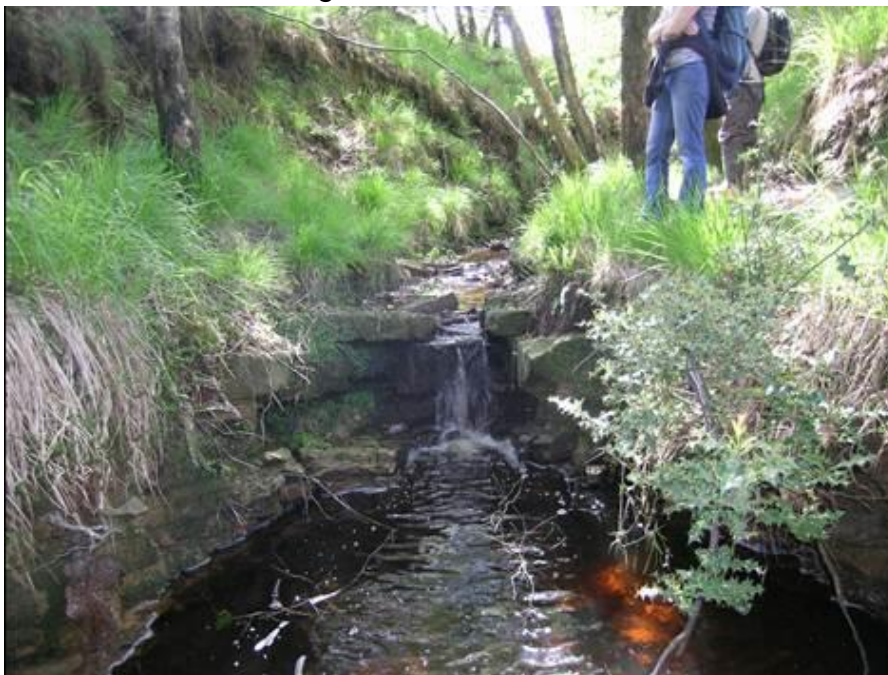
Further upstream, bedrock becomes a more predominant controlling factor on stream morphology (Figures 2.8 and 2.9). The uniform vertical fracturing of the bedding planes has the appearance of artificial modification. It is this fracturing that is generating the boulders, cobbles and gravels further downstream.

Figure 2.8 Increasing bedrock control of stream morphology.

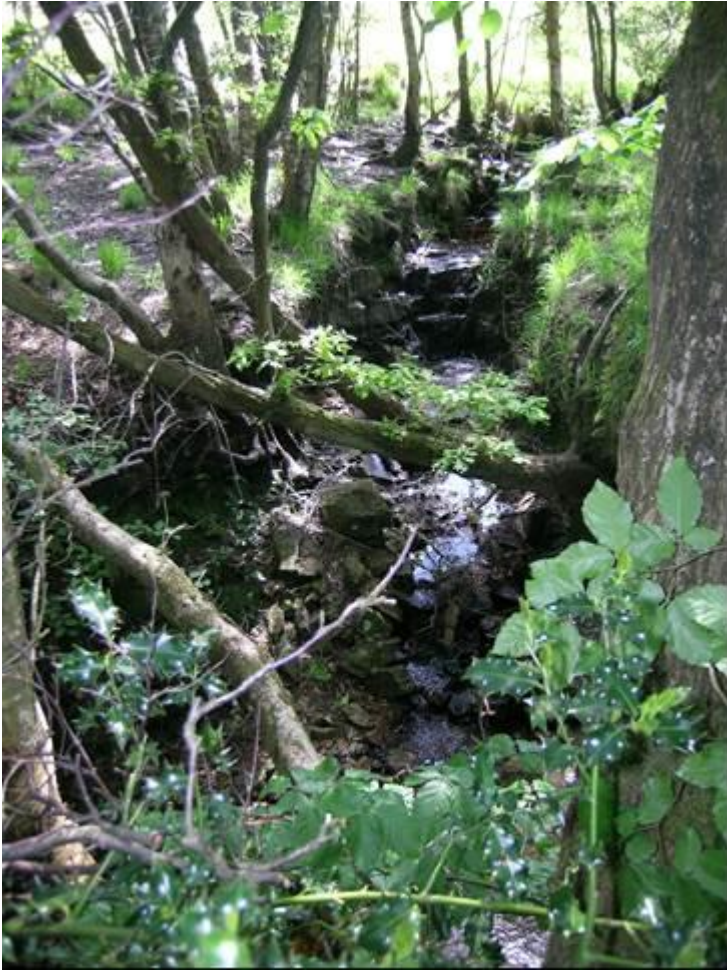
Figure 2.9. Bedrock control further upstream.

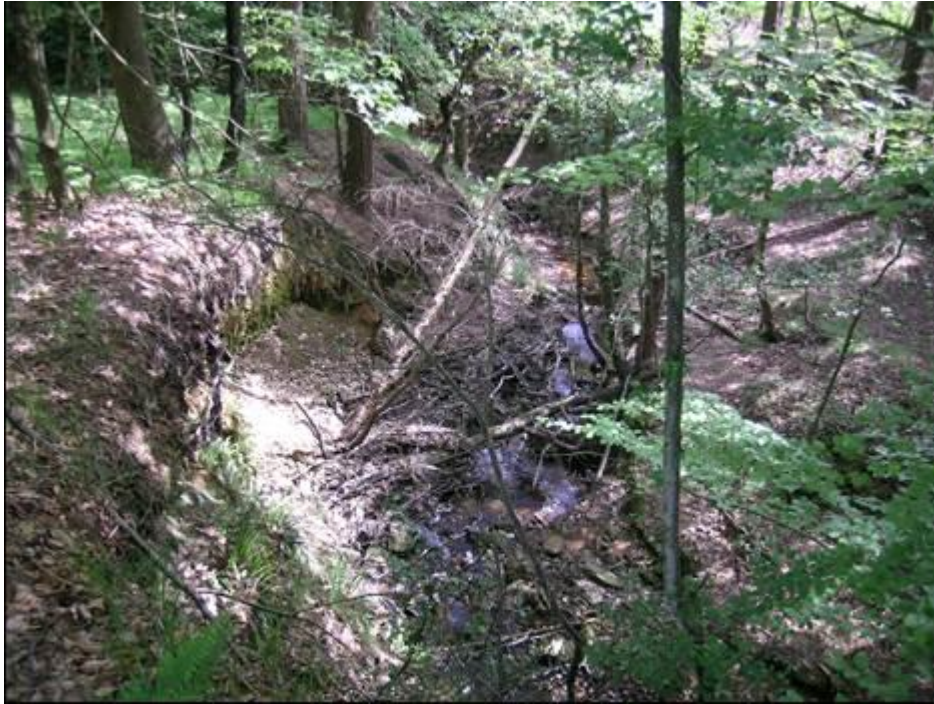
Riparian landslips were evident in some places (Figure 2.10), revealing the mechanism responsible for broadening the ghyll. Whilst this can be exacerbated by over-grazing to a level at which the disturbance levels are damaging to stream ecology, there is no evidence that this is happening in this instance. These landslips are in fact important in allowing the stream to move laterally and generate greater sinuosity, which supports a more diverse habitat mosaic and greater overall stream habitat.

Figure 2.10 Riparian landslip.

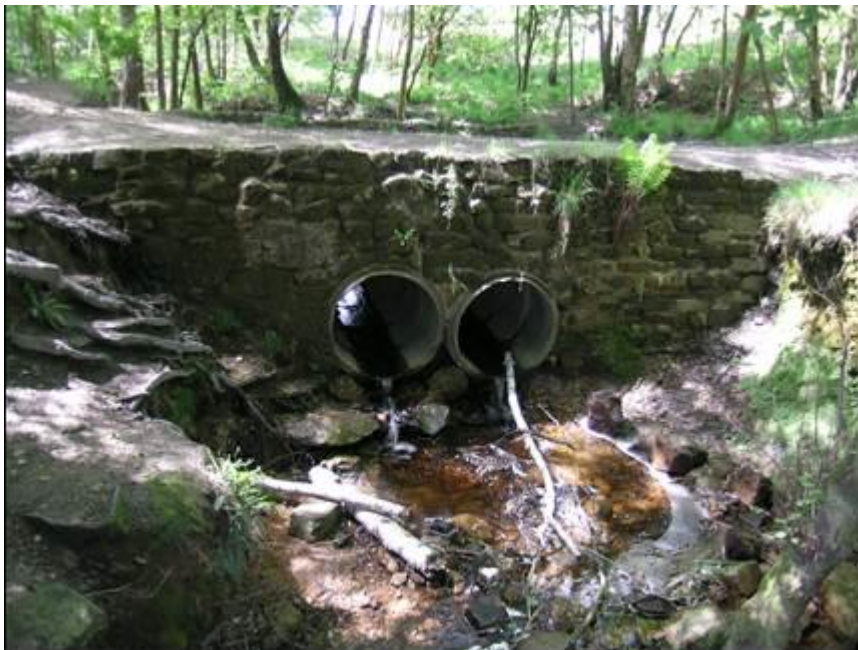
Further upstream, a major crossing has been built in stone (Figure 2.11). This is unsympathetic to the stream habitat, restricting the stream to two concrete pipes. It is particularly incongruous in such a naturally functioning stream. Widespan bridges that do not affect stream habitat, or just fords if the traffic frequency is low, are preferred options.

Figure 2.11 Stone-built crossing.

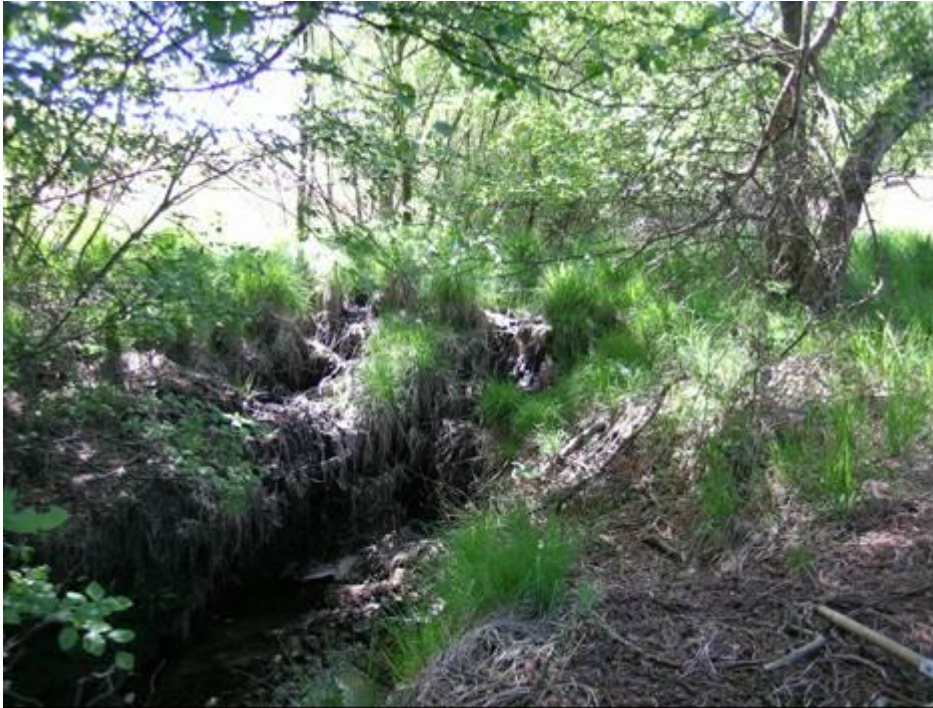
Further upstream we arrived at the first mire-stream transition (Figure 2.12). The role of bedrock versus wood debris in creating the obstruction necessary for the mire to develop upstream was not clear, due to over-growing vegetation. It seems probably that

in this instance the obstruction is a combination of the two. Closer investigation was not possible since it appeared that the transition was on the verge of disintegrating, which would result in at least a minor blow-out of mire (back to bed-rock control).

Figure 2.12. The most downstream mire/stream transition.

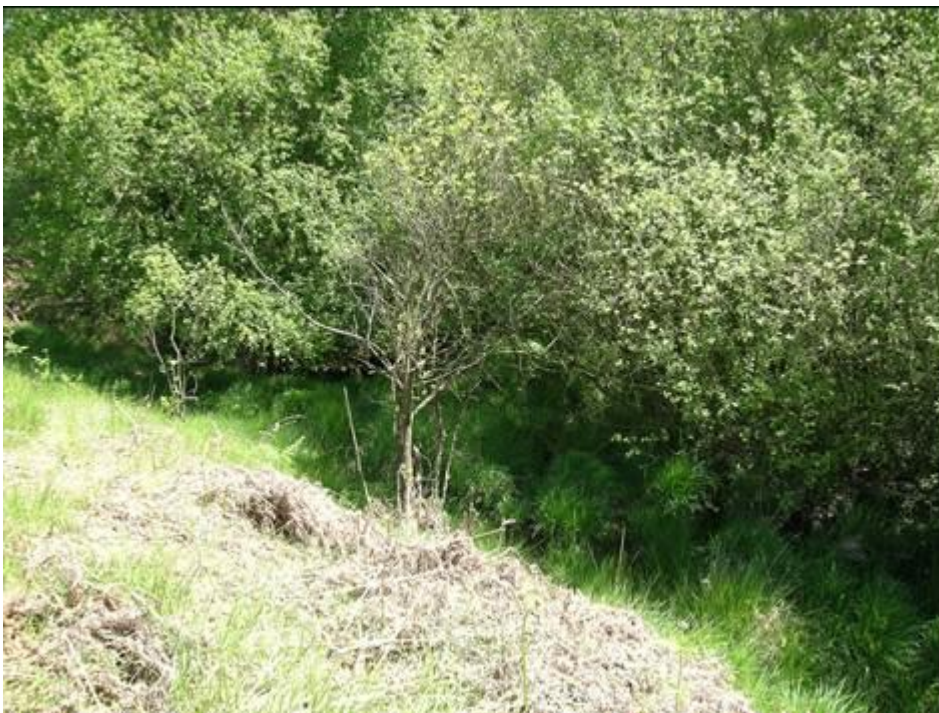
Within the upstream mire, the vegetation was dominated by tussock grasses and sedges underneath a willow canopy (Figure 2.13). Moving further upstream the habitat reverted to a distinct stream channel with drier banks (Figure 2.14).

Figure 2.13. Mire vegetation upstream of the mire-stream transition.

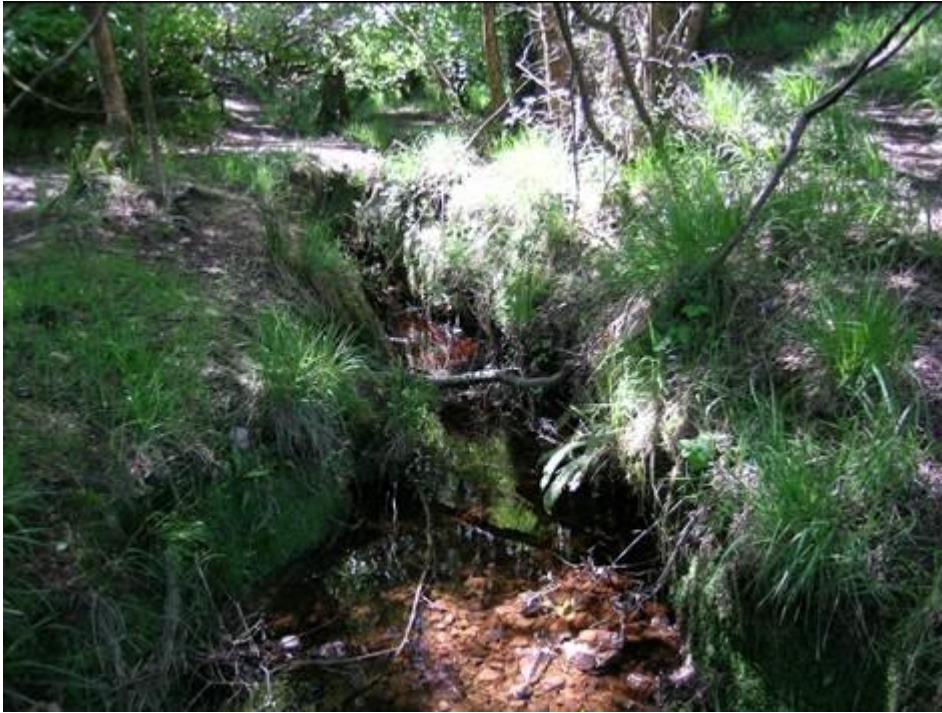
Figure 2.14. Transition back to stream channel again (upstream of the mire in Figure 2.13).

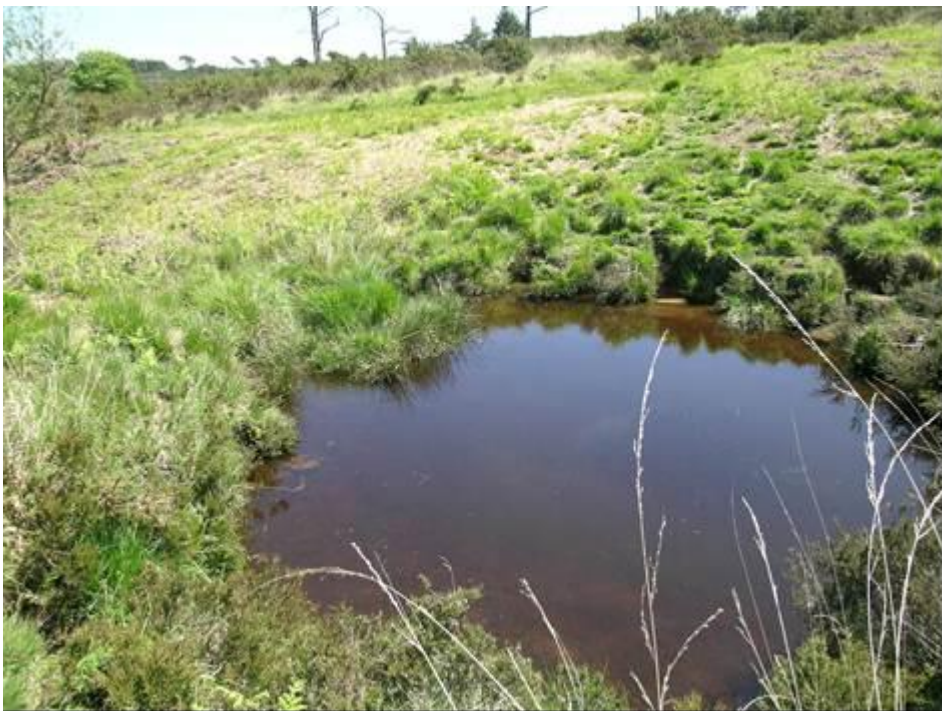
Further upstream, the stream-mire system comes out of the ghyll and into open heathland. The system forms a significantly sized pool (Figure 2.15), presumably controlled by bedrock and providing a valuable additional habitat. Upstream again and the stream channel is evident, before another mire-stream transition (Figure 2.16), seemingly bed-rock controlled.

Figure 2.15. Pool formed in the mire-stream system.
