Specialist site visit – The streams of Ashdown Forest, East Sussex

Thursday 4 June 2015

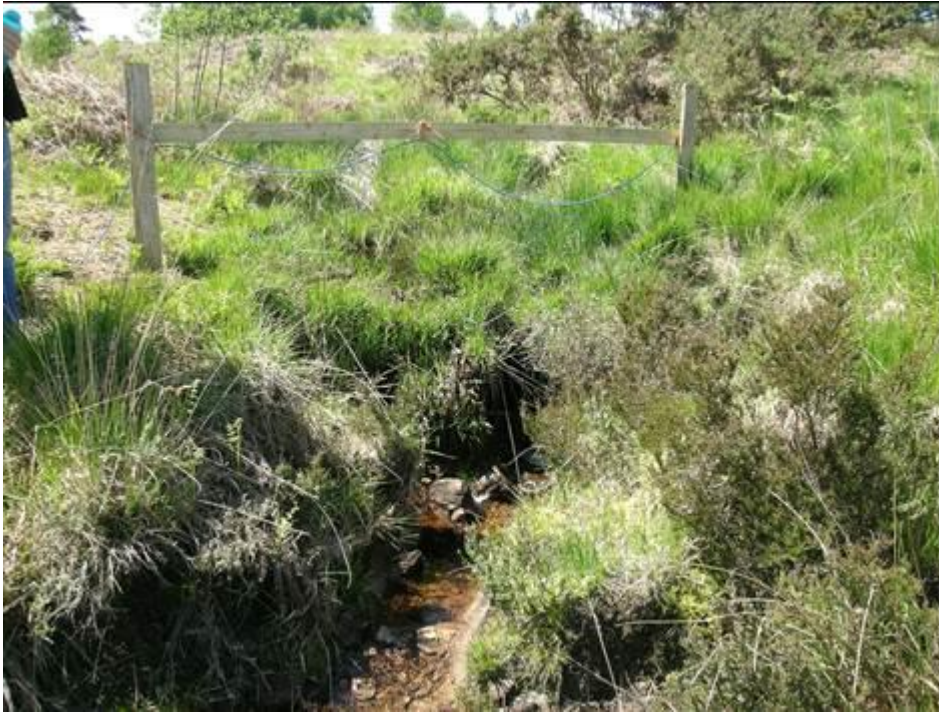
Further upstream, the stream-mire system comes out of the ghyll and into open heathland. The system forms a significantly sized pool (Figure 2.15), presumably controlled by bedrock and providing a valuable additional habitat. Upstream again and the stream channel is evident, before another mire-stream transition (Figure 2.16), seemingly bed-rock controlled.

Figure 2.16. Second mire-stream transition.

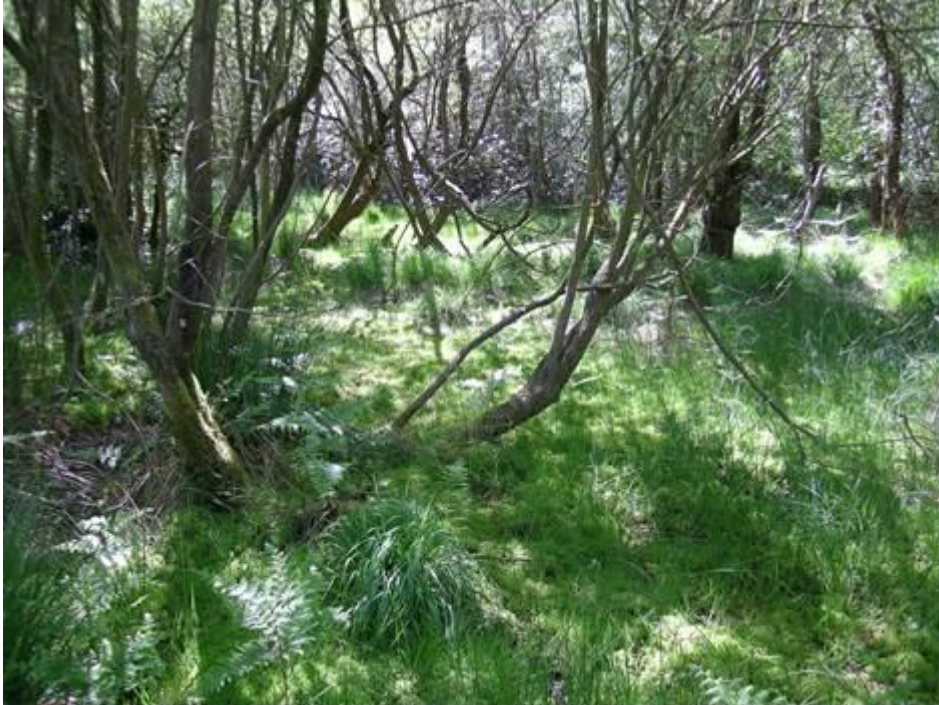
The source of the east ghyll is surrounded by Sphagnum beds under alder (Figure 3.1). Runnels drain out of this flush zone to create the distinct channel.

Figure 3.1. Sphagnum beds around the source of the east ghyll.

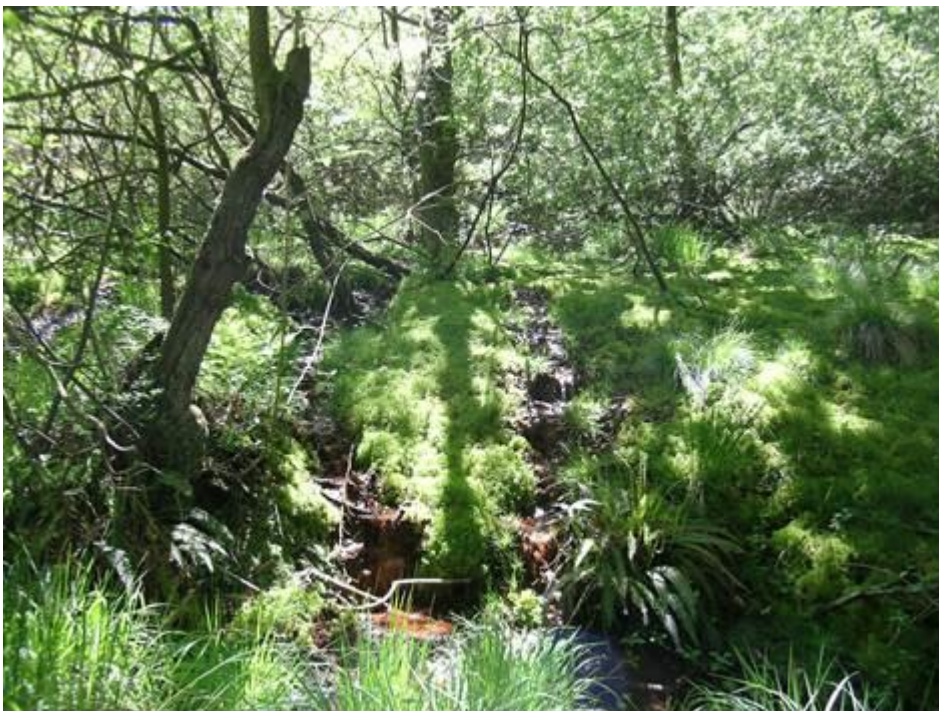
Figure 3.2 Chalybeate springs draining out of the Sphagnum beds to form the stream channel.

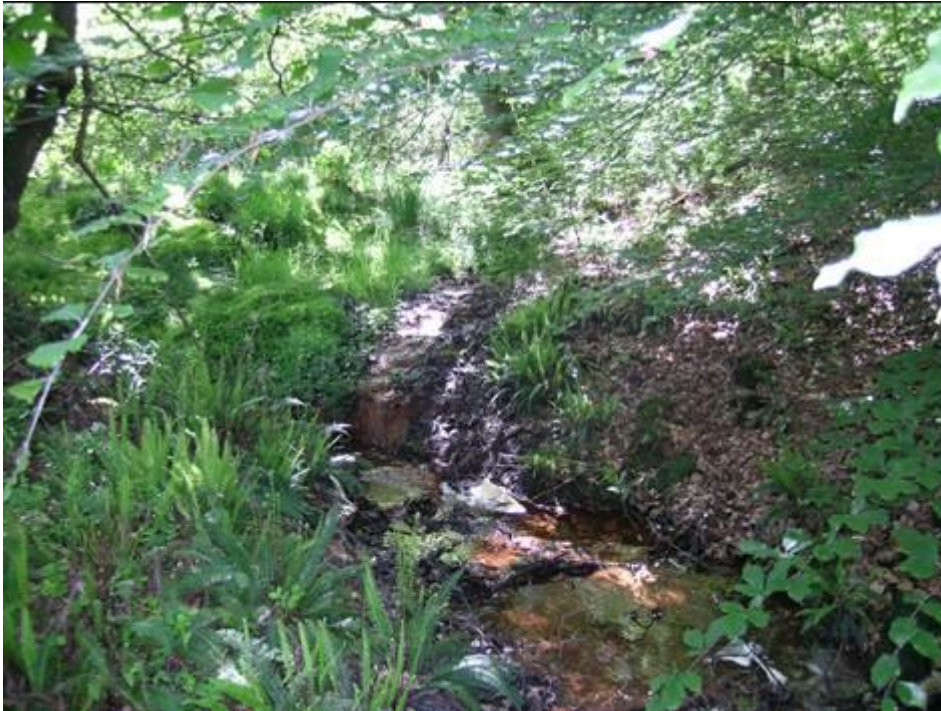
All the way down the east ghyll, chalybeate springs continue to drain into the stream from lateral flush zones covered in Sphagnum (Figure 3.3). As a result, the stream bed is thickly coated in ochre precipitate, which through its smothering and light-reducing effects on the stream bed limits the invertebrate assemblage. An *ad hoc* composite sample of aquatic macroinvertebrates was taken as we walked down the east ghyll. The fauna is largely reflective of acidic conditions, slow flow, fine silts and leaf litter, comprising small numbers of nymphs of *Cordulegaster boltonii*, alder-fly (Sialidae), and Leuctrid and Nemourid stoneflies. Larvae of the caseless-caddis-fly genus *Plectrocnemia* were also present (again probably *P. conspersa*).

Figure 3.3. Lateral flush and ochre precipitate coating the streambed.

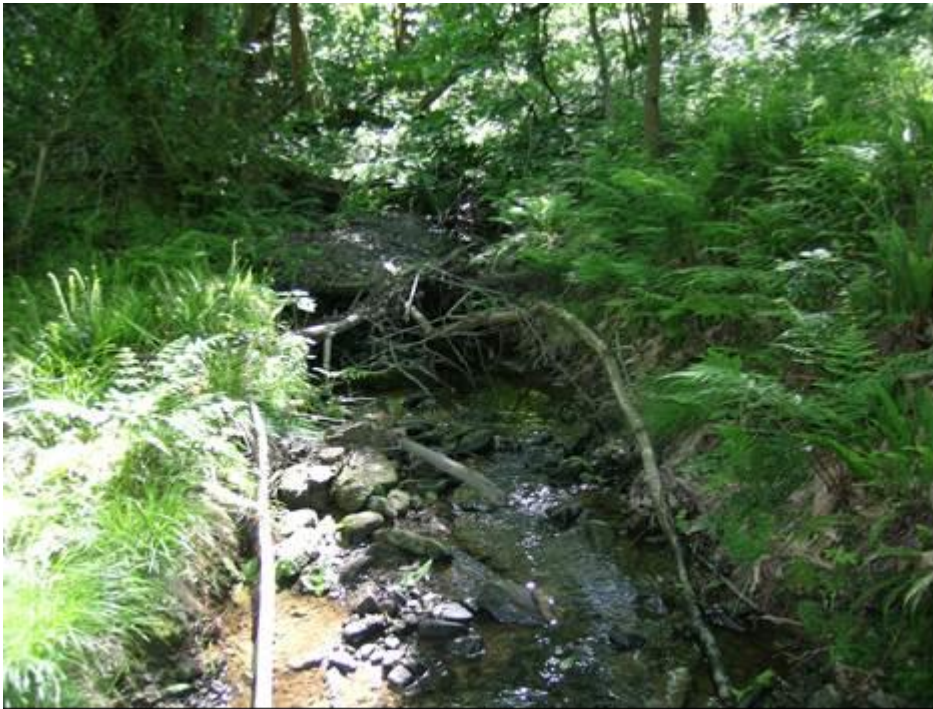
Walking back up the west ghyll, the contrast in habitat conditions is stark. The exposed cobble and gravel substrate provides more diverse habitat opportunities for the invertebrate fauna (Figure 3.4), and allows a fuller expression of the habitat mosaic generated by the action of tree roots and large woody debris (Figure 3.5).

Figure 3.3. Clean cobble and gravel substrates in the west ghyll.

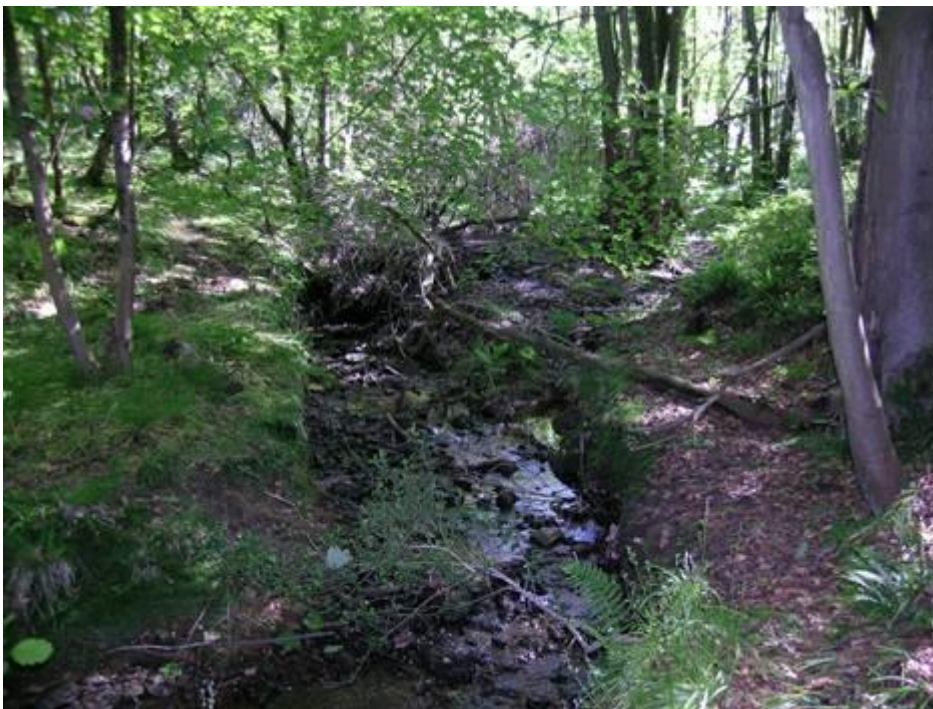
Figure 3.4. Debris dams forming on the west ghyll generating added diversity in the habitat mosaic.
