Gloucestershire headwater streams – site visits, May 2015

Cranham Woods

Chris Mainstone (Senior Freshwater Habitat Specialist) Iain Diack (Senior Wetland Specialist) Natural England

April 2017

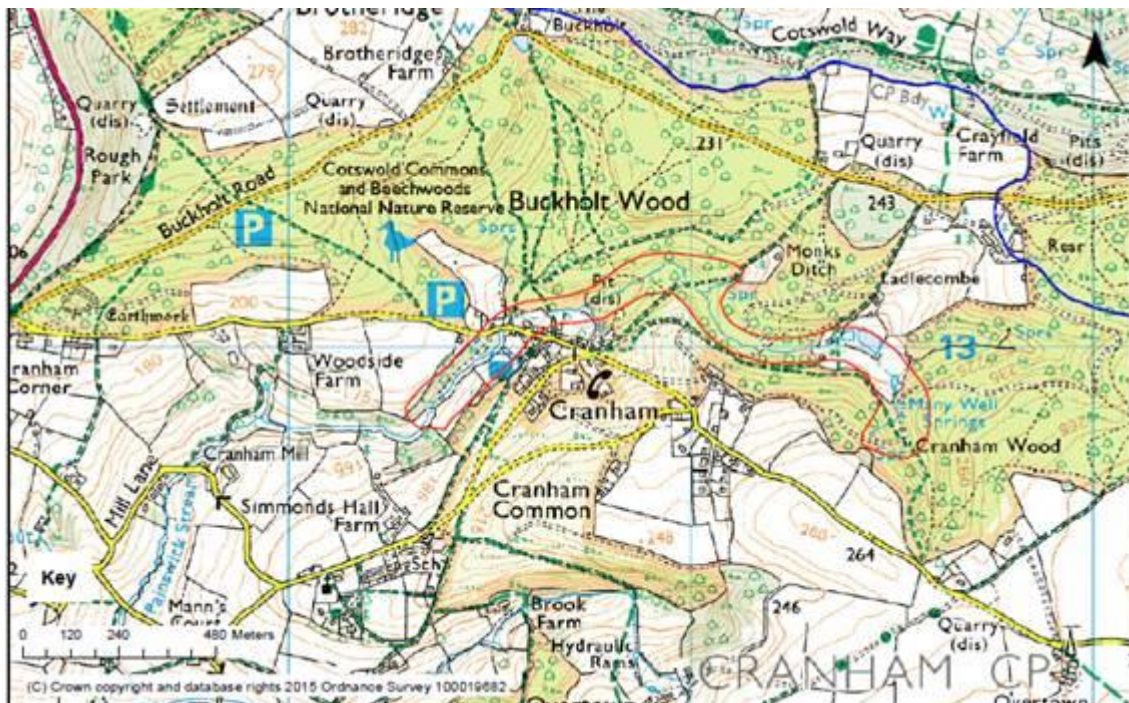
The stream we inspected is the most upstream section of the Painswick Stream, which has its source in Cranham Wood. We walked from Cranham village upstream to the tufa springs at the stream head (Figure 1).

Figure 1. The top end of the Painswick Stream. We walked along most of the section shown in red, to the east of Cranham village.

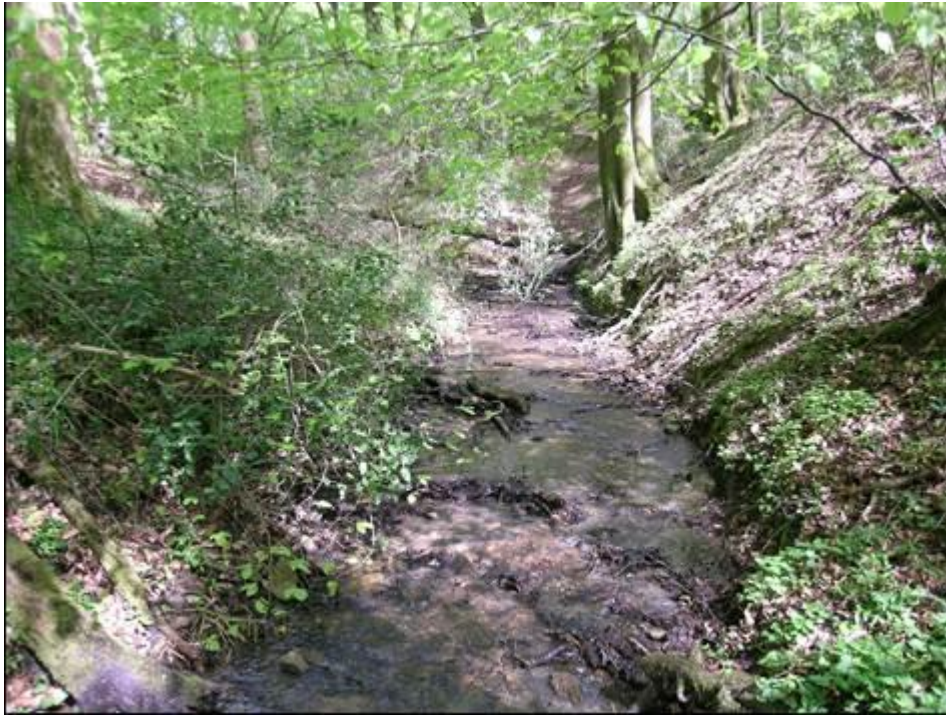
This is a managed beechwood, but relatively low intensity. The stream bed has abundant coarse substrates with plenty of leaf litter (Figure 2), providing habitat suitable for a good invertebrate assemblage. There is a considerable amount of woody debris around the stream, but much of it is not actively interacting with the channel (e.g. Figure 3).

Figure 2. Coarse substrates and leaf litter in the stream channel.

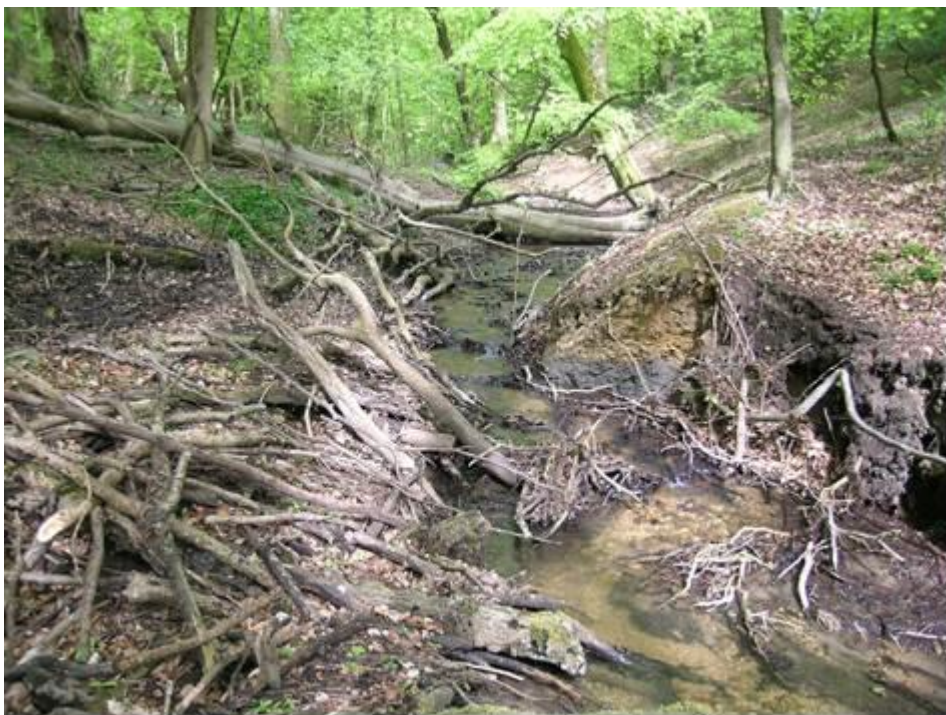
Figure 3. Woody debris on the stream bank.

Woody material (tree root systems of bankside trees, fallen trees, debris dams) is fundamental in shaping stream habitat through modifying flow patterns and creating variation in hydraulic scour. This generates characteristic habitat mosaics of scour pools, riffles, substrates of different coarseness, slack waters with fine silts and leaf litter, all within a sinuous channel planform that adds more variation. All of these different biotopes are habitat niches for different species, and life stages of the same species. However, if the woody

material is not creating partial obstacles to flow then the characteristic habitat mosaic will not develop.

Trees and woody debris - The importance of the interaction between standing and fallen wood and stream habitat is clear here as it is elsewhere in the headwater stream systems recently visited in Sussex and Kent. Fallen trees across mire and stream habitat should be left in place to generate characteristic habitat mosaics and provide dynamism in the stream/mire system. Debris dams should be allowed to develop and decay naturally.

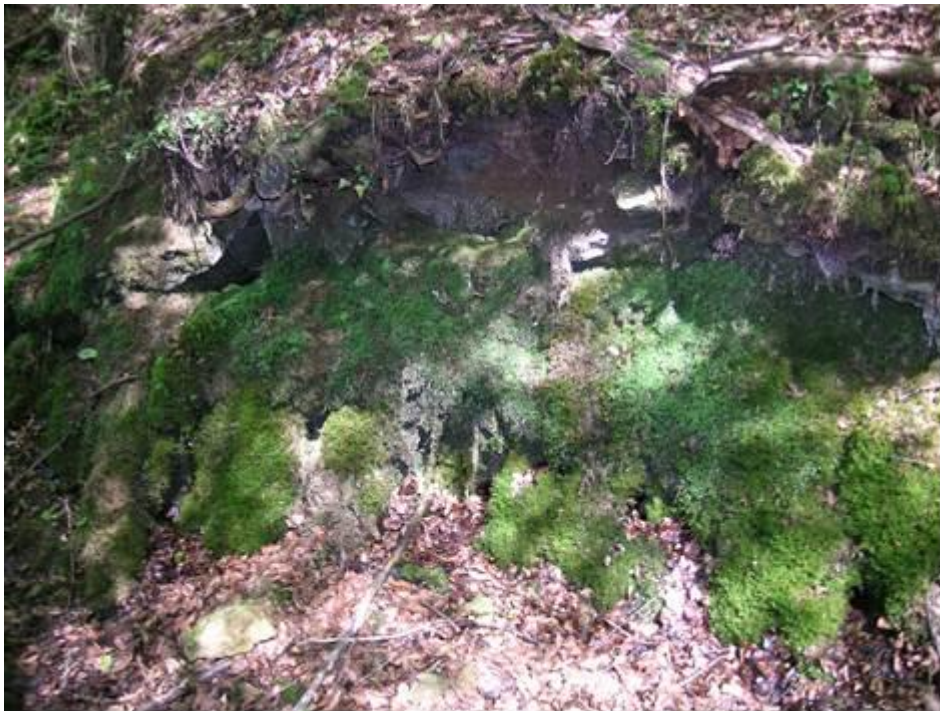
Further upstream, tufa springs emerge from the valley sides and run down to the main stream (Figure 4). These areas are covered in mosses and liverworts, including the moss *Palustriella commutata*. One spring has created a large tufa mound (Figure 5).

Figure 4. Tufa spring emerging from the valleyside, supporting an abundant moss and liverwort flora.

The stream and banks adjacent to the tufa spring in Figure 4 have been subjected to heavy disturbance, associated with drainage and a stream crossing. The stream has been culverted in a pipe under the crossing. The spring head in Figure 4 has been historically exploited for water supply (the remains of the pump and pipework are still in place). The pipework has been damaged in recent earth-moving operations, and it is not clear if the supply is still used.

Works affecting channel integrity – Woodland management operations should try and avoid damage to the stream channel and its banks, and springs/flushes. Depending on the nature and frequency of use, widespan bridges or fords should be used instead of culvert pipes.

Abstraction – If the off-take on the upstream spring head is no longer in use it would be beneficial to block the pipework to ensure there is no unnecessary continuing hydrological impact.

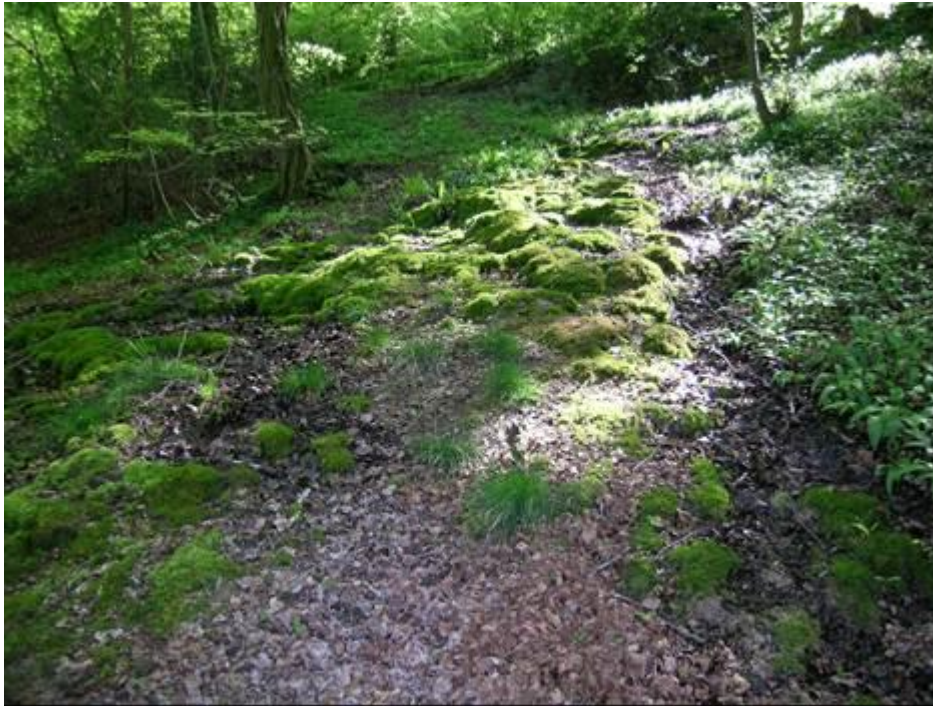
Figure 5. Tufa mound covered in mosses including abundant *Palustriella commutata*.
