Specialist site visit – Forest of Dean, Tuesday 3 – Thursday 5 May 2016

Chris Mainstone, Ruth Hall, Iain Diack and Isabel Alonso

April 2017

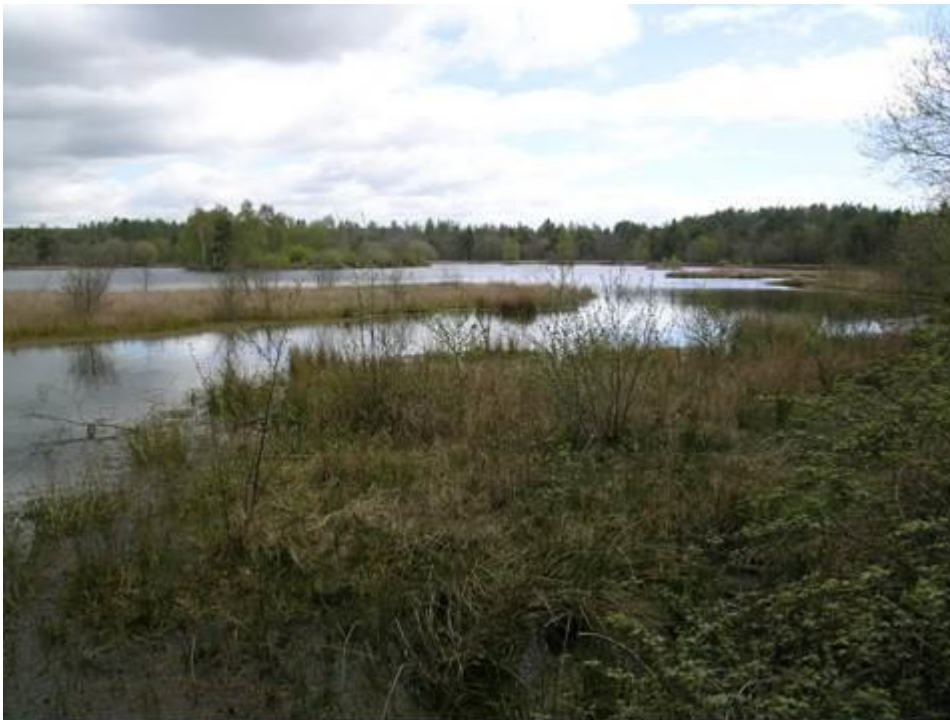
Figure 1.1 Woorgreens Lake.

There are few aquatic plant species recorded from the lake, and none particularly notable. Brief inspection by grapnel revealed a previously unrecorded charophyte (*Nitella* sp.), *Elodea* sp and *Potamogeton pectinatus* suggesting that current volunteer recording might be enhanced by the use of a grapnel. Notwithstanding the lack of detailed survey, the lake appeared to support limited interest; this may well in part be due to the recent management of the lake and a lack of propagules in the post-quarry landscape. The lake has been drained 2 or 3 times in an attempt to eliminate carp that have been introduced without permission. Carp persist however, either by surviving the drainage or by further unpermitted introduction. There are no angling rights on the lake and it is not fished.

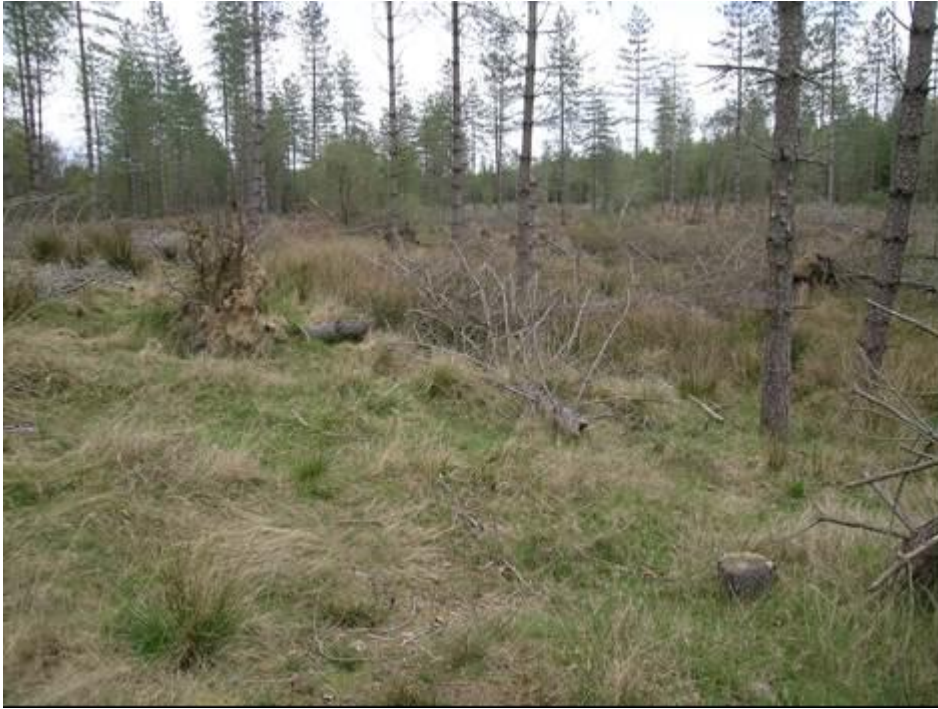
Figure 1.2 Land-forming to the east of the lake. The line of rushes running top left to bottom right indicates a trough, showing the orientation of the large-scale undulation.

The large-scale land-forming to the east of the lake has generated a highly unnatural landscape, with poor-quality dry habitat on the ridges and troughs running downslope into a deep ditch where erosion is evident (Figure 1.5). The drainage efficiency this landscape is creating precludes the restoration of a natural mire/flush/pool/runnel habitat mosaic that might have been expected in this area. Of interest was the presence of wetland bryophytes indicative of both acid (*Sphagna* and *Aulacomnium palustre*) and base-rich (*Bryum pseudotriquetrum*, *Pellia endiviifolia* and *Riccardia multifida* (?)) conditions in the bottom of some of the troughs, suggesting that restoration of these areas could result in a highly diverse wetland.

- **Woogreens to the east of the lake** - Given this area is of limited forestry interest, the best course of action would be to shift the surface soils from the ridges and deposit them into the troughs, in an irregular fashion to create a poorly drained landscape with substantial and random microtopography. This would allow the area to be rewetted to provide a high quality mosaic of running, standing and wetland habitats without needing to direct water to these habitats via ditches. See also the discussion and recommendations section which refers to similar work undertaken elsewhere.

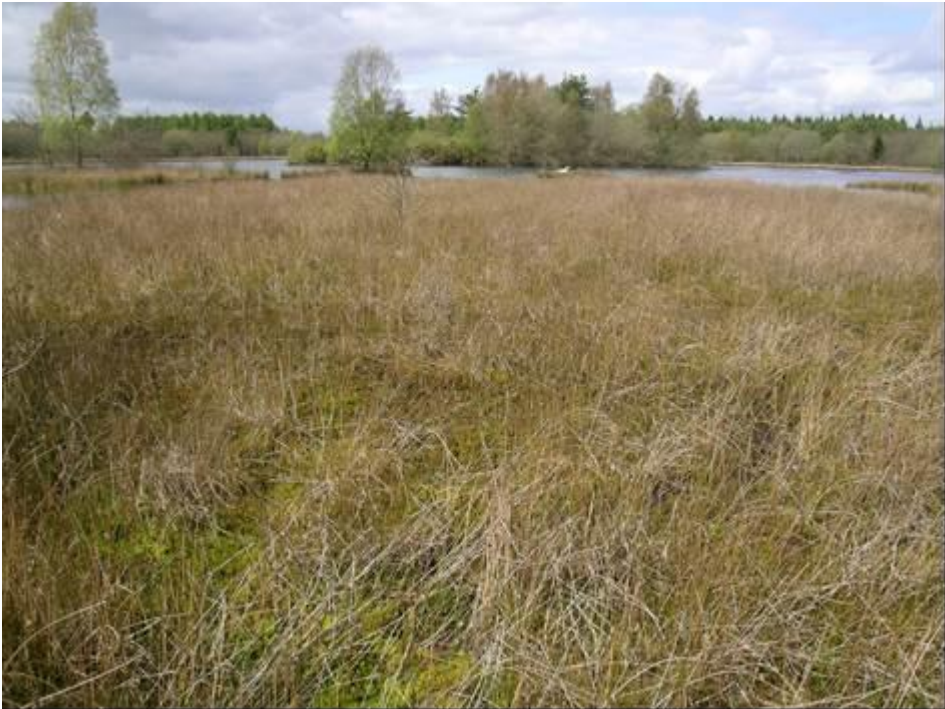
The composition of the fringing transitional mire (Figure 1.3 and Figure 1.4) is of much greater conservation interest, probably reflecting the nature of the seedbank from the pre-impact wetland landscape (which is unlikely to have contained large open standing water areas). The mire contains a range of *Sphagnum* mosses (*S. denticulatum* the most abundant) amongst soft rush and sharp-flowered rush, as well as abundant marsh St John's wort and marsh speedwell. The transition between clear open water and mire supports bog pondweed and floating club-rush, alongside the moss *Calliergon cordifolium*. It is actively encroaching into the shallow lake, creating ever larger expanses of priority mire habitat which is probably referable to

Figure 1.3. Transition mire around the lake.

- **Woogreens Lake** - Overall, and considering the likely natural habitat mosaic that was lost by quarrying, the best course of action is likely to be to allow the mire to continue to encroach into the open water, creating more high-value mire at the expense of a large expanse of open water which currently has low conservation value. A more complete hydrosere would then develop, from drier willow scrub at the periphery through transition mire to open water. The fragmentation of the open water into smaller areas is likely to help reduce and restrict the carp population, and will create open water habitat that is more characteristic of the pre-quarrying landscape. Some larger open water areas could be kept open near the existing lake margin to maintain existing public enjoyment of the area.

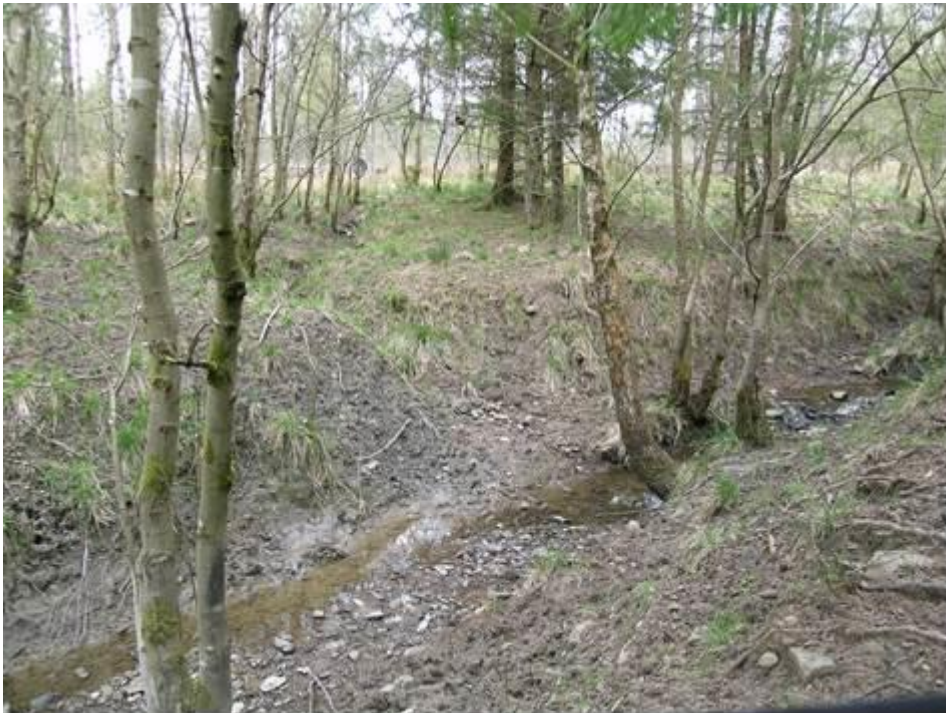
Figure 1.5. Deep ditch into which the troughs of the land-forming drain (an entry point can be seen in the centre of the photo). Note the heavy poaching, presumably by wild boar.

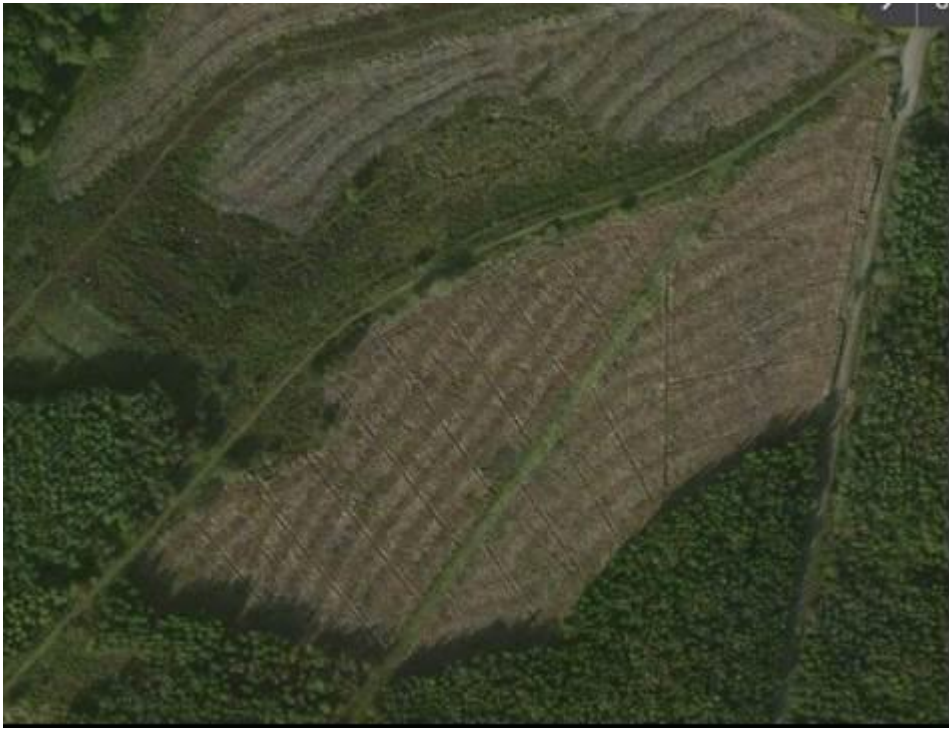
Figure 1.6 The northern (upper) part of Woorgreens Marsh showing drainage pattern (from Bing maps).

- **Woogreens Marsh south-facing slope** - As described above, the blocking and infilling of the entire drainage network would start to re-create the conditions necessary to restore the valley mire system including fringing wet and dry heath. The presence of the *Sphagna* and the clean catchment suggest that such an approach would bring rapid positive results, restoring a habitat type now almost lost from the county. As the mire/heath system develops it may be necessary to re-introduce components of the mire vegetation that have been lost from the area. The Flora of Gloucestershire lists many heath/mire species now apparently

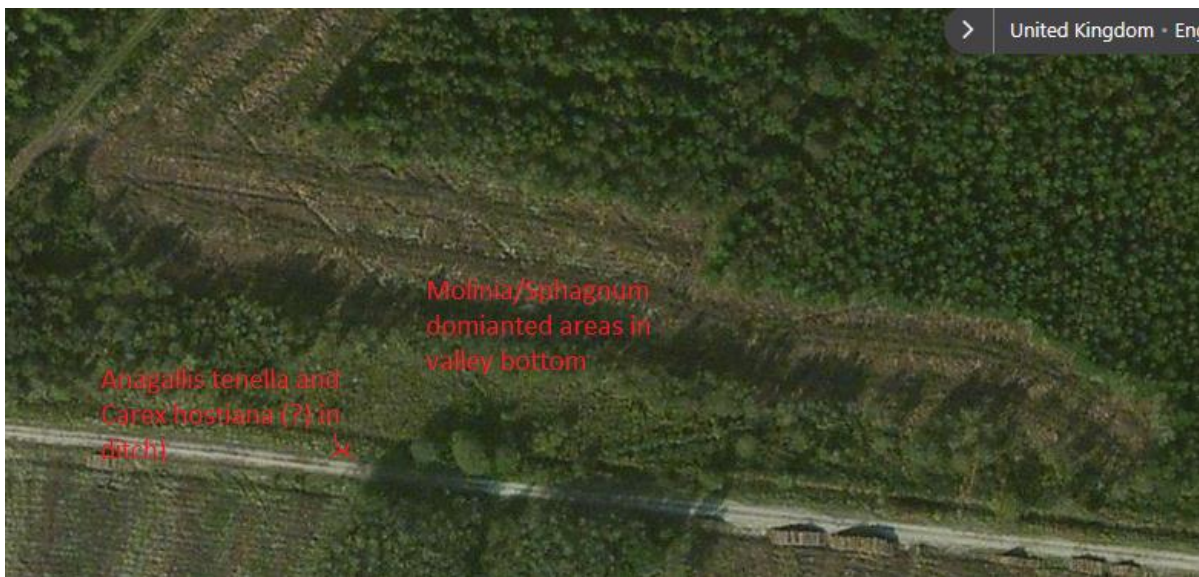
Figure 1.7. The southern (lower) part of Woorgreens Marsh (the valley bottom), showing drainage pattern (Bing maps).

The ditch shown in Figure 1.7, which runs alongside the road adjacent to Woorsgreen Lake, reflects the influence of base-richness by the presence of bog pimpernel and tawny sedge (tentative id), both species now very uncommon in Gloucestershire. This again indicates both diversity in water chemistry and geology and the low nutrient status of this area, which would appear to lend itself to the restoration of a high quality wetland system.

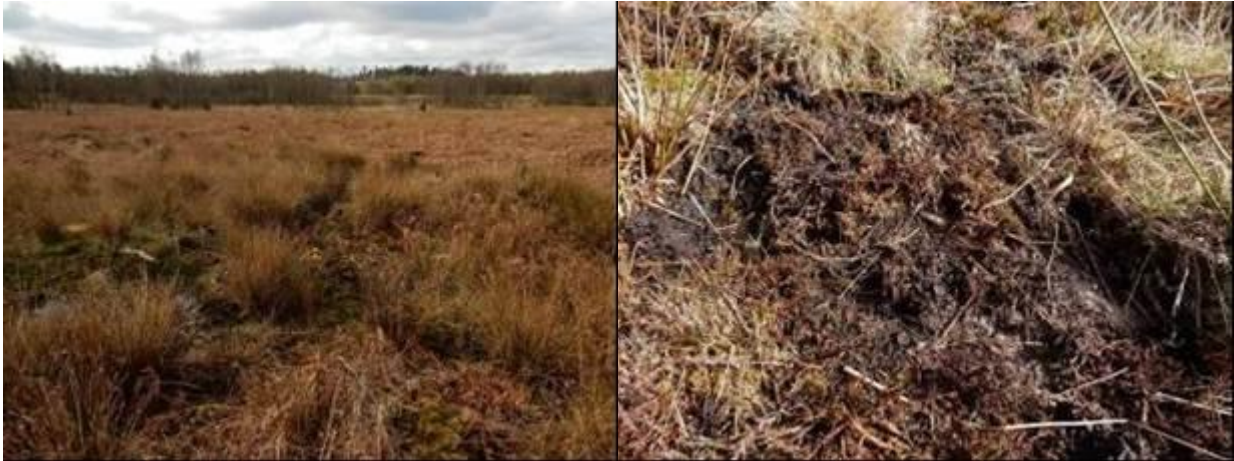
Figure 1.8 Woorgreens, southern slope, showing dense purple moor grass (left) and pioneer heather on bare ground (right).

The lower parts of the slope are dominated by dense Purple moor-grass *Molinia caerulea*, *Polytrichum commune* (Figure 1.8) and several *Sphagnum* species, including *S. denticulatum*, which is the commonest and most abundant species, *S. inundatum*, *S. papillosum*, *S. capillifolium*, *S. cuspidatum*, *S. fallax*, *S. palustre* and *S. fimbriatum*. In addition a small patch of *Sphagnum russowii* was found, a new record for Gloucestershire (conf. T. Blockeel). Although degraded and, in terms of vascular plants, species-poor (few mire plants remain, with the exception of *Carex demissa*, *C. echinata*, *C. panicea* and maybe others given more time on site), in a Gloucestershire context this is a very important remnant of habitat. Pioneer heather appears in the few bare ground spots (Figure 1.8), so there seems to be some seed bank.

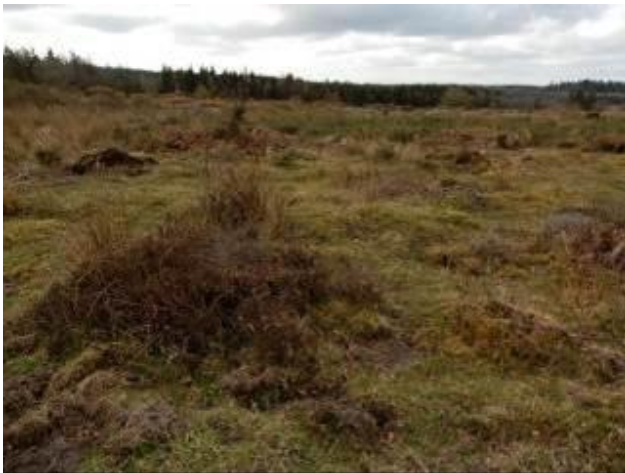
Figure 1.9 Dry heath on the upper slopes of Woorsgreen.

There is some dry heath in the drier substrates (Figure 1.9), most of it in mature/degenerate stage. There have been heather beetle outbreaks recently which may have killed some of the mature heather plants (Figure 1.10). Gorse *Ulex europaeus* and *U. gallii* are both present on site, as well as bilberry *Vaccinium myrtillus*. There are areas with dense bracken *Pteridium aquilinum* litter with high frond cover in summer (Figure 1.10), but the GWT is controlling it by spraying and flailing. There are also areas of arisings left after tree-felling (evident in Figure 1.9) which may complicate future management interventions, particularly mechanically. Gorse is regenerating in many areas and may pose future management problems.

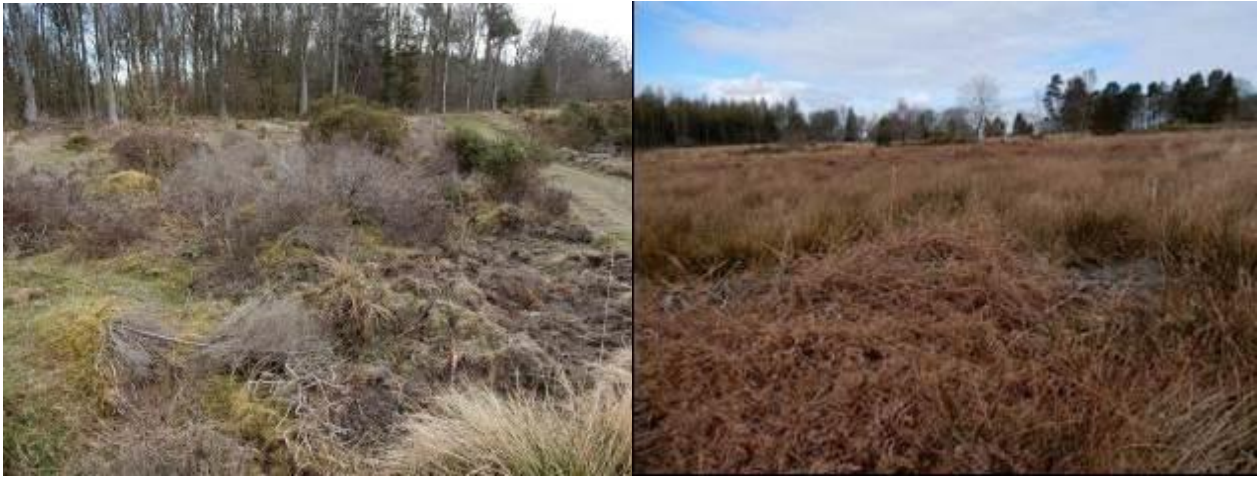
Figure 1 10 Woorgreens - outbreak of heather beetle (left) and a patch dense bracken (left).

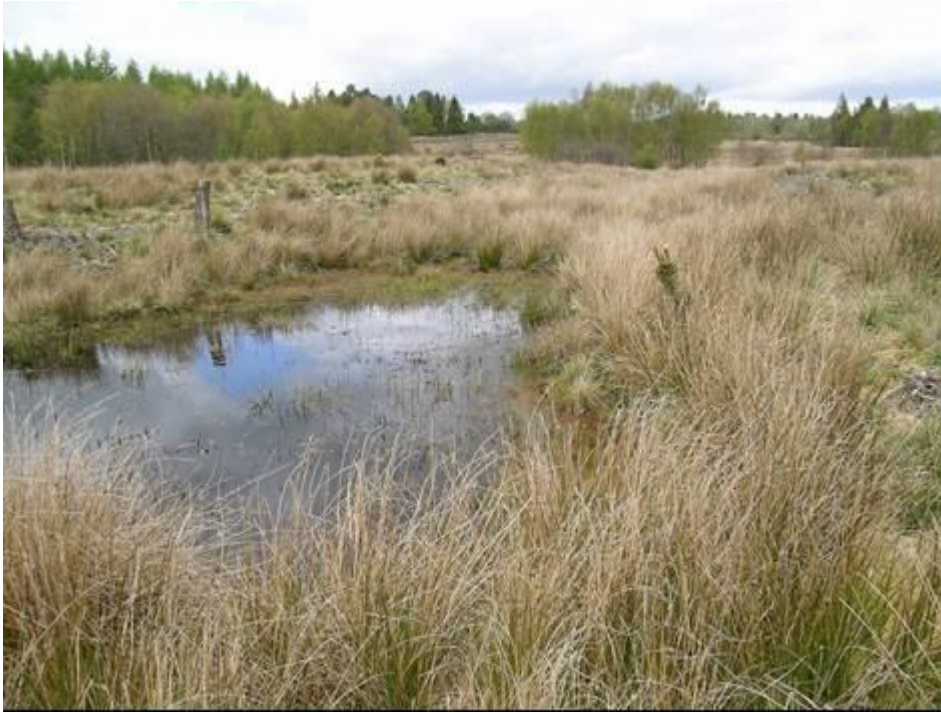
At the top of the slope in Crabtree, some restoration work has already been undertaken to push soil from parts of the ridges into the troughs to create linear ponds (Figure 1.11), which host species such as the scarce blue-tailed damselfly *Ischnura pumilio*. Although these ponds are being used by *I. pumilio*, it is a species characteristic of natural wetland habitat mosaics where pools and runnels are interspersed in mire and other wetland habitats. These ponds also supported a charophyte (unidentified) as well as *Potamogeton natans* and *Potamogeton polygonifolius*.

Figure 1.11 One of the linear series of ponds created by partial restoration of the Crabtree area.

- **Crabtree Hill** - Further soil movement from the ridges in the same manner as suggested for Woorgreens would provide a closer approximation to the habitat conditions naturally supported by the area, generating excellent conditions for characteristic species of both wet and dry heathland and mire habitats (such as *I. pumilio*). AS has highlighted that a Countryside Stewardship application focused around Crabtree Hill has been submitted to Natural England in 2016, based on re-introduction of grazing for the restoration of heathland. The applicant has funding to carry out an Implementation Plan which will determine the best options and capital work they need to deliver heathland and other habitats. They will need to look at the likely impact of grazing on mire restoration. The start of the CS agreement may need to be delayed for a few years to allow hydrological monitoring to take place.

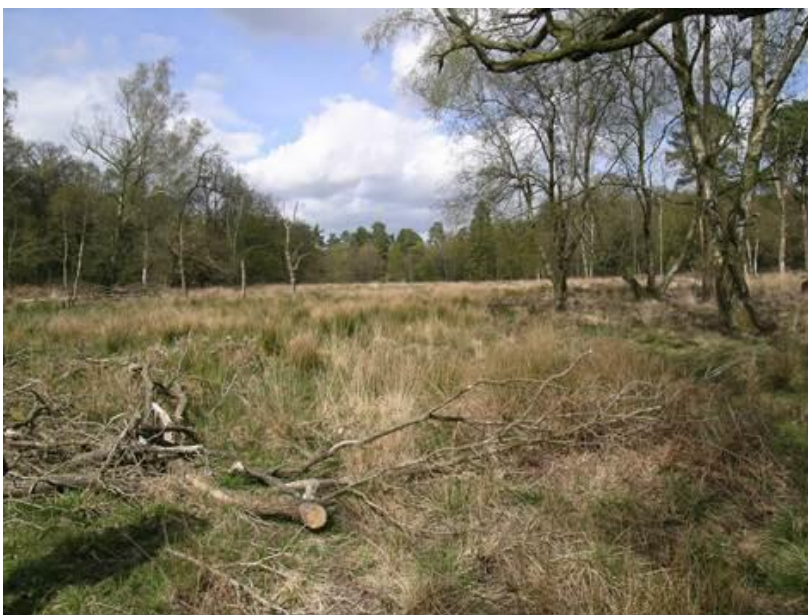
Figure 1.12 The valley mire at Foxes Bridge Bog.

Although this area contains what appears to be a stream running into it, originating from the Woorgreens area and culverted under the B4226, this is unlikely to be a natural stream at this point given the landscape in which it sits. This area is a relatively intact valley mire (Figure 1.12), although it has been affected by some drainage activity. The 'stream' channel at the upstream end of the mire is likely to have been formed by the road culverting, and is possibly maintained by the hydraulic energy generated by the upstream drainage and culvert. The channel soon disappears into the body of the valley mire (Figure 1.13). Drainage features are evident at the bottom of each valley side, acting to dewater the valley slopes for forestry purposes (Figure 1.14).

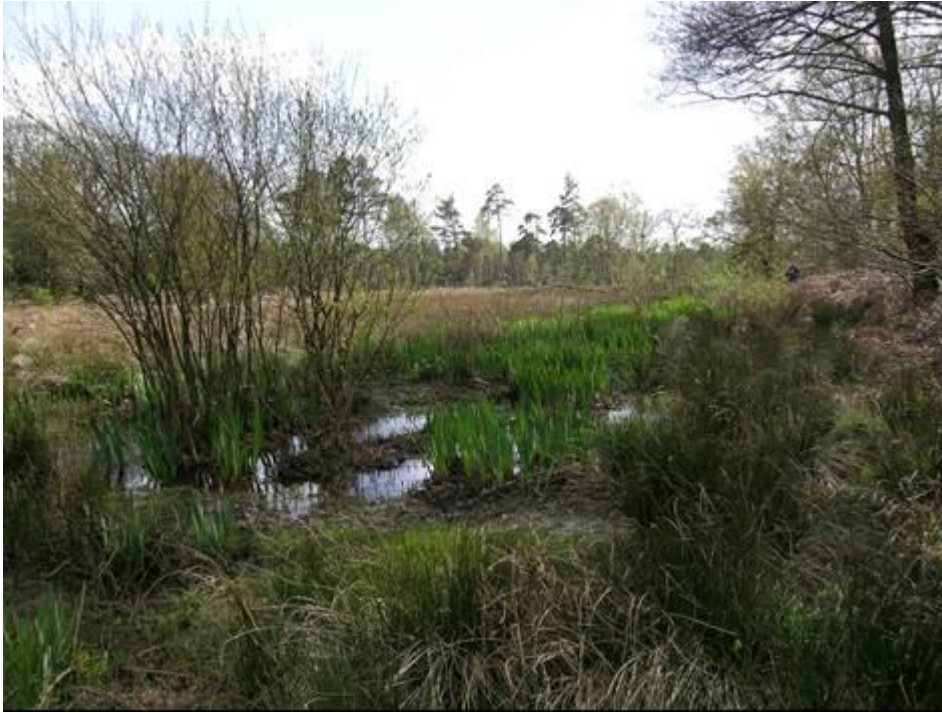
Figure 1.13 Channel petering out from left to right at the top of the valley mire.

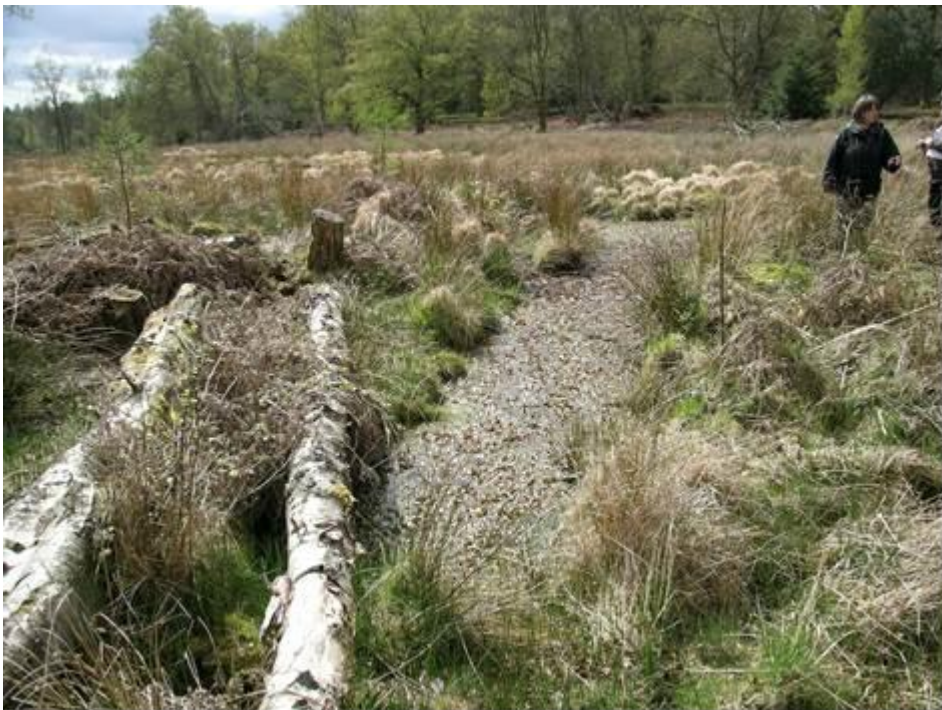
Figure 1.14 Ditch draining the left hand valley side.

In the light of this, the best course of action for restoration would be to block the central and lateral drains upstream and downstream of the inclosure wall to restore the integrity of the mire. This would involve blocking the culvert through the inclosure wall, but would not necessarily require the removal of the wall itself if this is considered to be a heritage feature. Holes could be created in the wall to allow a more natural seepage of water through the mire system. Restoration works should not aim to create a flat surface across the mire, but rather should provide a varied microtopography that would develop naturally in such systems. This allows for the creation of natural pools for standing water interest within the mire without having to dig out

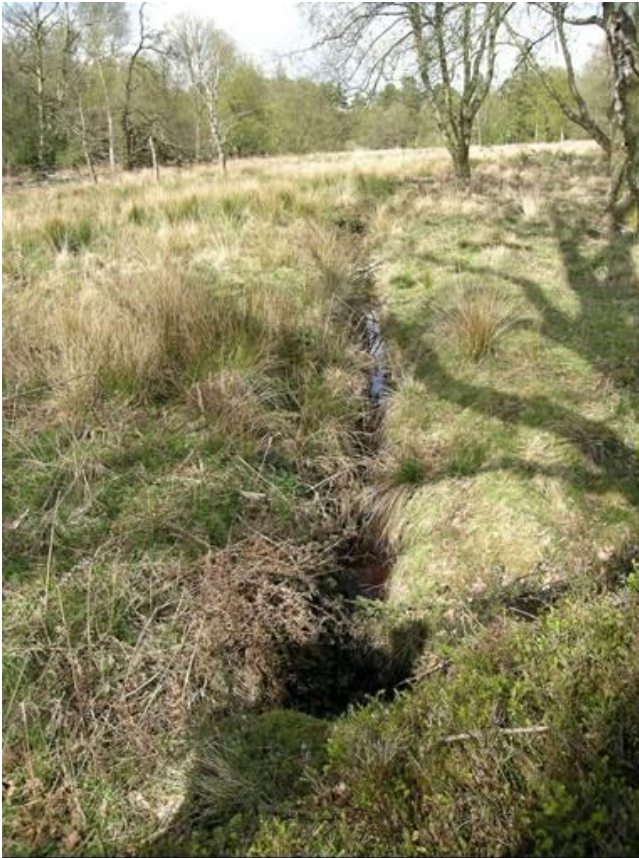
Further down the mire, drains have been formed (Figure 1.15) to channel water into a culvert passing through an inclosure wall, both of which appear to be historic features. Immediately upstream of the inclosure wall a 'stream' channel becomes distinct once more (Figure 1.16), running out of the mire and through the culvert, picking up significant energy from the gradient downstream – sufficient to start to exhibit some stream behaviour (erosion features, coarse gravel and cobble substrates etc. – Figure 1.17). As a result of this energy the channel appears to have incised into the bed. However, as is the case at the upstream end of the mire, a stream is unlikely to have existed here naturally in this landscape – the channel is a result of the

Figure 1.15 Ditch draining the central part of the mire, looking up the valley from the inclosure wall.

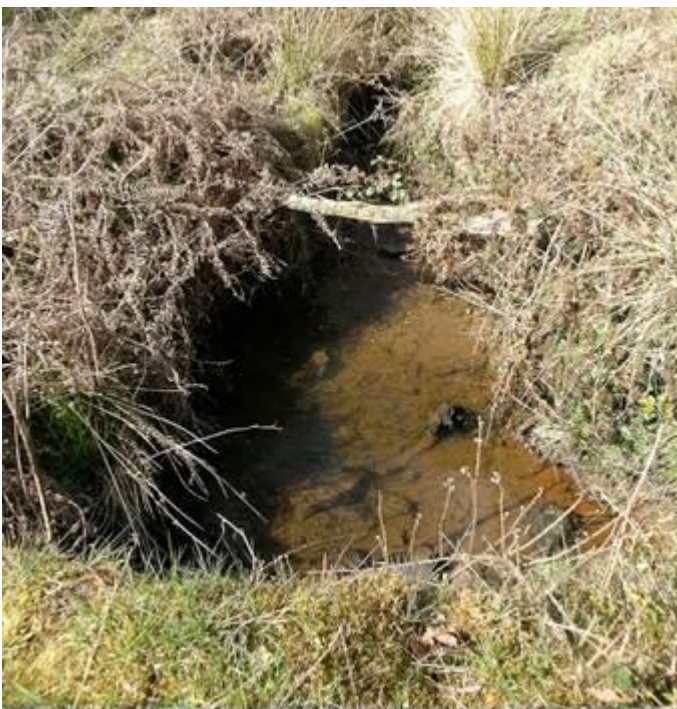
Figure 1.16 The main channel as it enters the culvert in the inclosure wall.

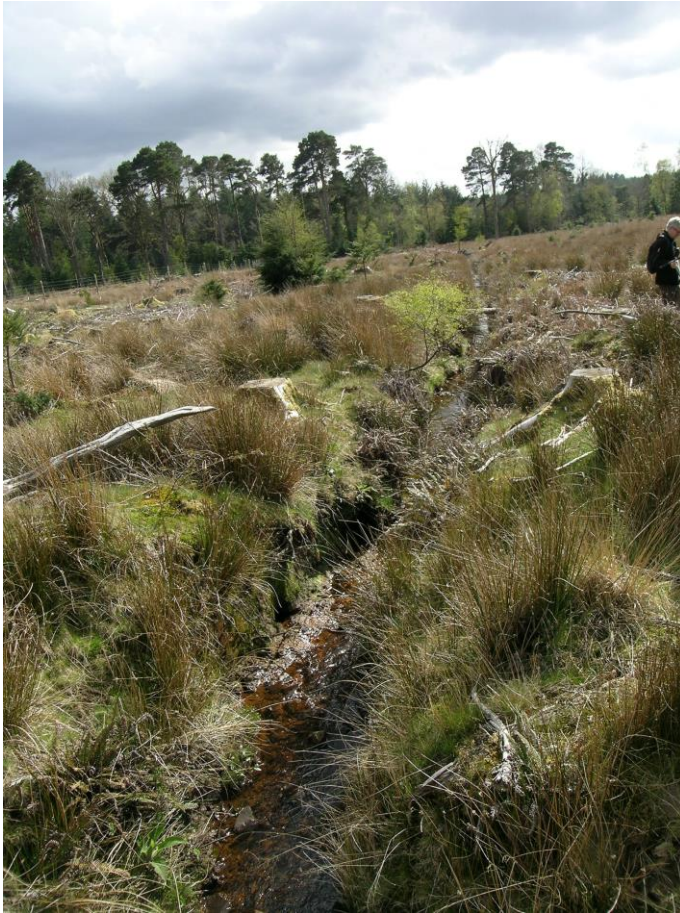
Figure 1.17 The main channel after exiting the culvert in the inclosure wall, running into the mire downstream.

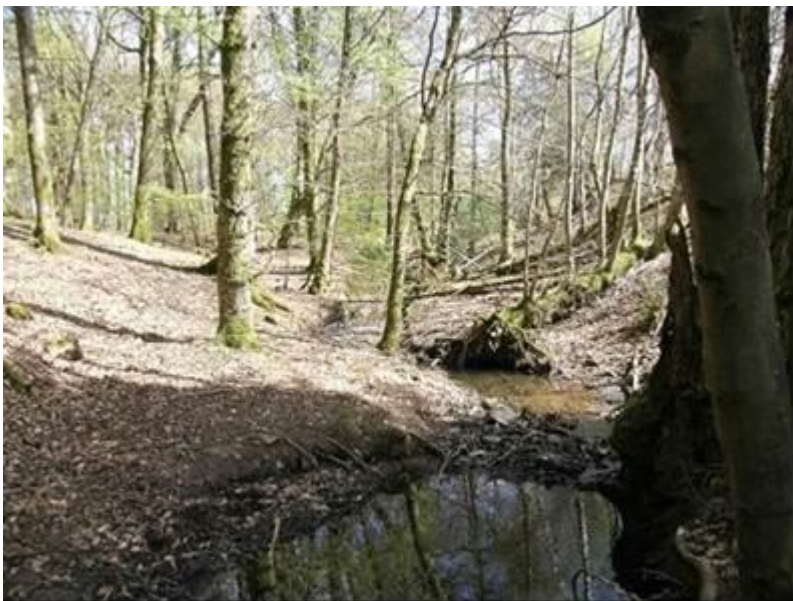
Perryhay ditch exhibits varied natural morphology within an incised 'ghyll' (Figure 2.1) formed by the hydraulic energy of the brook itself. This is similar in appearance to the ghyll streams running off the High Weald in Kent, but the ghyll sides and atmosphere generated are far less humid than the Wealden streams. This may be partly due to differences in solid and drift geologies and the specific aspect and canopy cover of the ghyll visited, but it is likely to be strongly influenced by the intensive drainage of the land above the ghyll, which is diverting water that would have seeped through the ghyll sides and helped to create a moist microclimate for ferns, bryophytes and flush vegetation. Much of the land above the 'ghyll' has been planted with oak, which in general appears to be in very poor condition with many trees dead and dying, largely as a result of squirrel and deer damage. The character of this higher ground is heavily influenced by drainage, but retains elements of heathland and mire and other semi-natural vegetation (various *Sphagna* present in drains), and would probably respond rapidly to restoration action, particularly drain blocking.

Figure 2.1 Channel habitat mosaic created by riparian trees. A fallen tree has created a pool, whilst the rootplate of a standing riparian tree has held up the stream bed level, creating a small cascade and scour pool below.

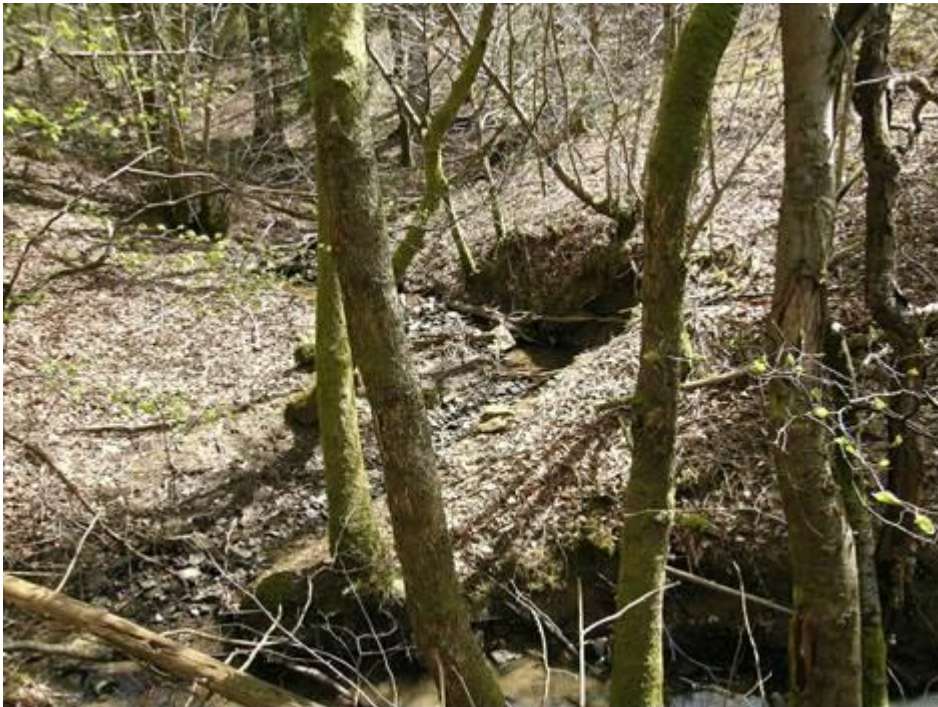
Figure 2.2 Sequencing of habitats formed by natural riverine processes.

Within the channel, the importance of riparian trees to the creation of the natural habitat mosaic is immediately apparent. Tree root systems generate points of resistance to streamflow, creating a characteristic sequence of debris dam, scour pool, riffle and exposed sediment bar downstream (Figure 2.2). They also generate lateral movement as the stream cuts through areas of least resistance, creating meander bends with characteristic patterns of erosion and deposition across the channel. All of this activity creates the habitat mosaic of shallow and deepwater, high and low current velocities, fine and coarse substrates, and retained woody material and leaf litter which the characteristic flora and fauna are adapted to exploit. Each species and life stage uses different parts of the mosaic under different flow conditions, and loss of any one part of the mosaic has ecological consequences.

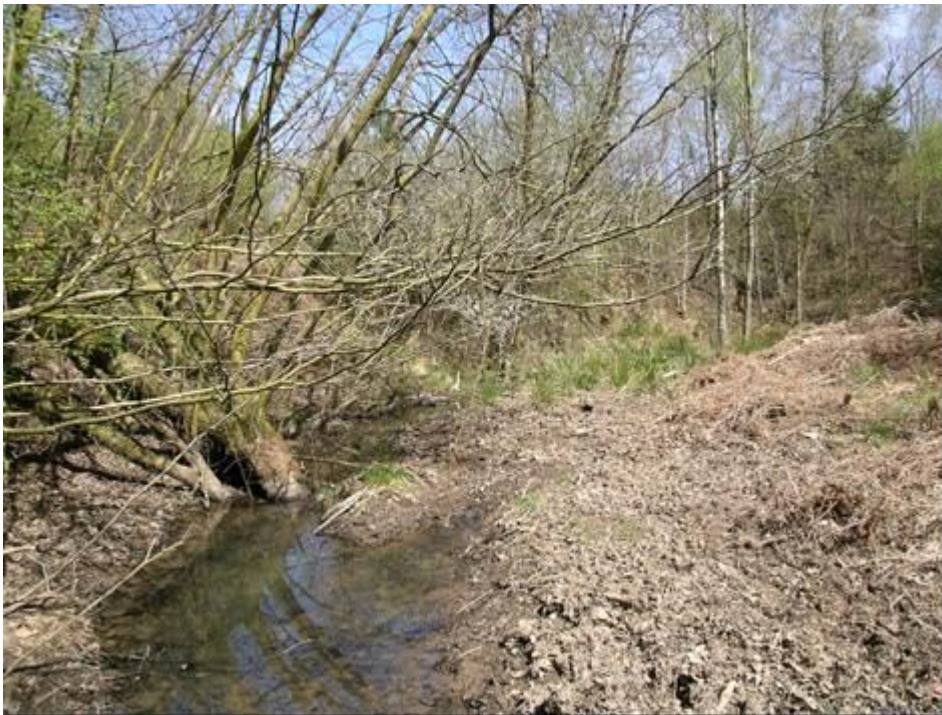
Figure 2.3 A tree in the channel near the top of the ghyll, encouraging sediment retention and invasion of the channel by mire vegetation. Note heavy poaching, presumably by wild boar.

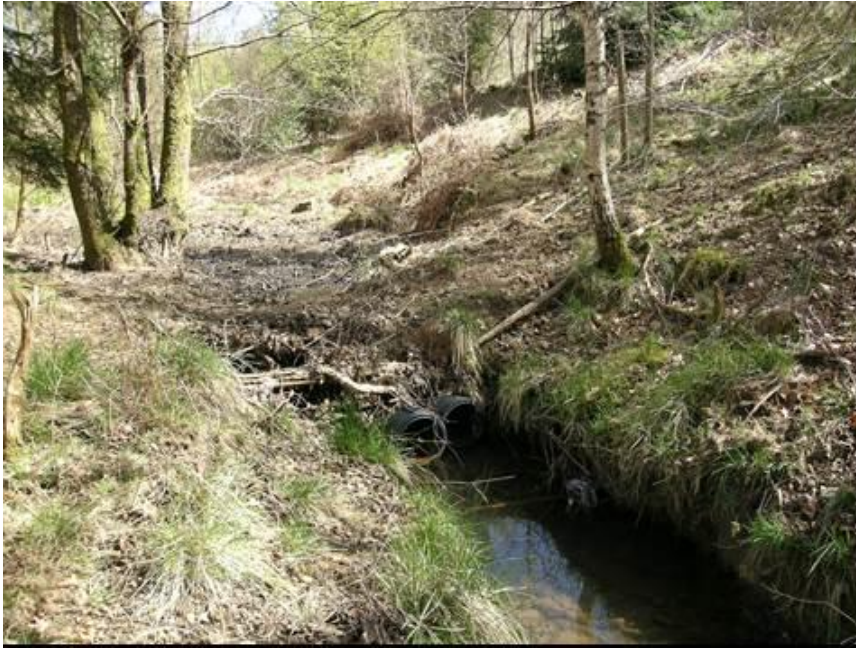
We came across a culvert near the top of the ghyll (Figure 2.4). This seems to have no significant use and generates an unnecessary impact on natural stream function, eliminating stream habitat for some metres.

Figure 2.4 A culvert near the top of the ghyll.

In restoration terms, there is little wrong with the stream channel – it is generally left to behave naturally although any temptation to remove fallen trees from the channel should be resisted. The biggest issue to address is the drainage at the top and to the sides of the ghyll. It would be best to block drains in at least the immediate vicinity of the ghyll top and sides, to help restore natural stream flows (which are likely to be diminished in the summer months due to poor water retention in the catchment) and hopefully restore more humid conditions to the ghyll for the benefit of the lower plant flora, flush vegetation and associated fauna (e.g. Scirtid beetles, Taeniopterygid stoneflies). Selective felling of plantation trees and planting of more characteristic riparian trees (alder, willow) to generate patchy shade and stronger interactions with channel form would also be beneficial. The culvert could be removed and if necessary replaced with a fording point using local coarse substrates.

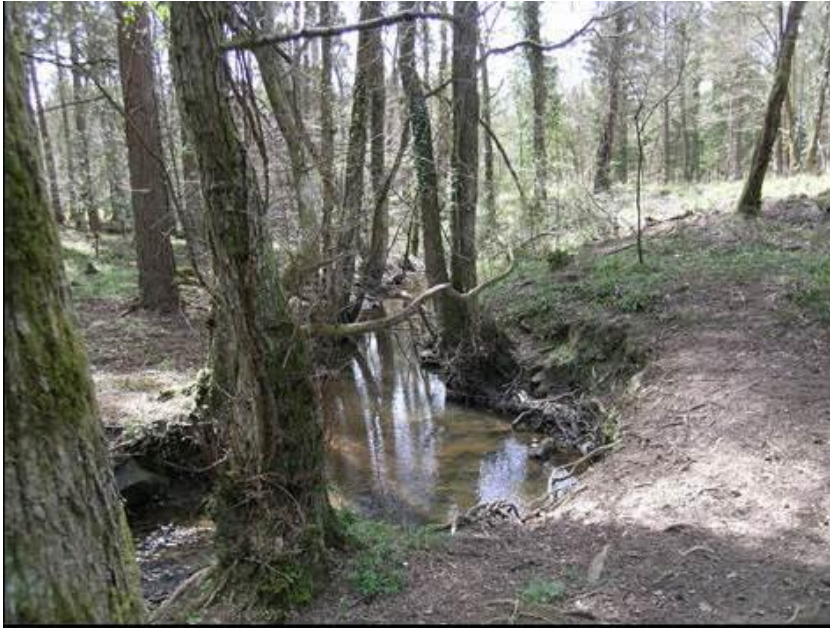
Figure 2.5 The Blackpool Brook below the confluence with Perryhay Ditch.

Below the confluence with Perryhay Ditch, Blackpool brook becomes a significant size and continues to exhibit a good range of natural morphological behaviour (Figure 2.5). The habitat mosaic provided by the stream along this section is very good, although there is a distinct absence of large woody material (fallen large boughs or trunks) lying across the channel. This material is highly important to the creation of partial blockages to flow, and the kind of habitat patterns described above. There are some suggestions that large material may be being relocated outside of the channel for some reason, although there is no known formal management practice of that kind operating within Forest Enterprise.

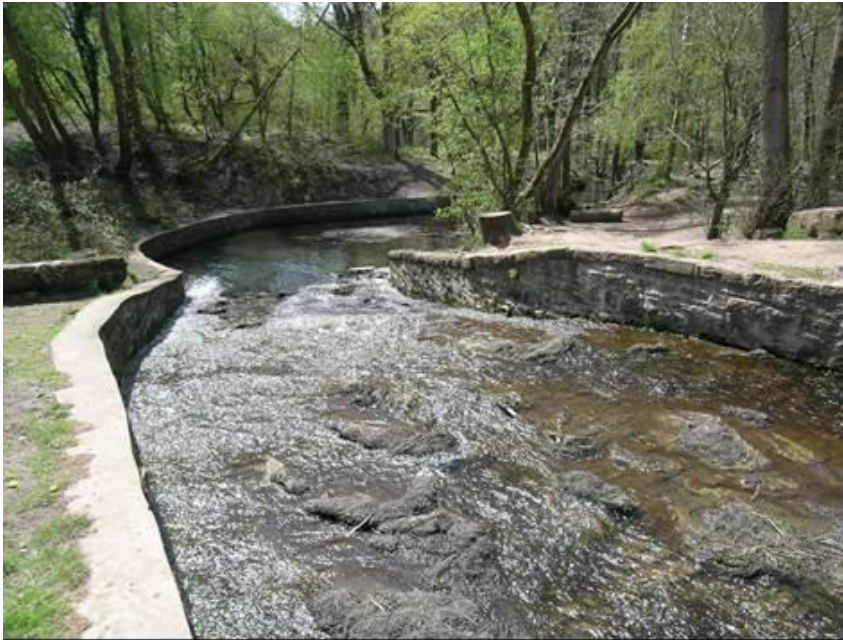
The impoundment creating the middle pond is a substantial rock structure extending across the narrow incised valley. The overflow is a rock spillway that would appear to be passable by eels (Figure 2.6). From a brief inspection by grapnel the submerged plant assemblage of the middle pond (Figure 2.7) is dominated by non-native *Elodea*. This appears to grow in a relatively large bed in the centre of the pond, suggesting it is not very deep. No other aquatic plants were found by brief grapnel sampling from the shore. There also appears to be a reasonable flushing rate through the pond, with *Elodea* fragments accumulating towards the outflow. There was limited emergent vegetation around the lake possibly due to shading and recreational pressures as well as unsuitable substrates where artificial structures/shorelines are present.

Figure 2.6 Rock spillway at the impoundment for the middle pond.

In terms of habitat restoration, ideally the impoundments would be removed to restore natural stream and riparian habitat and reinstate the natural connectivity of the stream system for stream biota. However, the ponds are a key recreational amenity for the local community and are an important tourist attraction. In some cases in the river SSSI system the effect of on-line artificial impoundments has been circumvented by 'dragging the river' out of the lake/pond, i.e. creating a new channel beside the lake/pond and taking the standing water habitat off-line. The scope for doing this varies from site to site and it would not be easy at Cannop Ponds given the incised nature of the valley and road/car park infrastructure adjacent to the ponds.

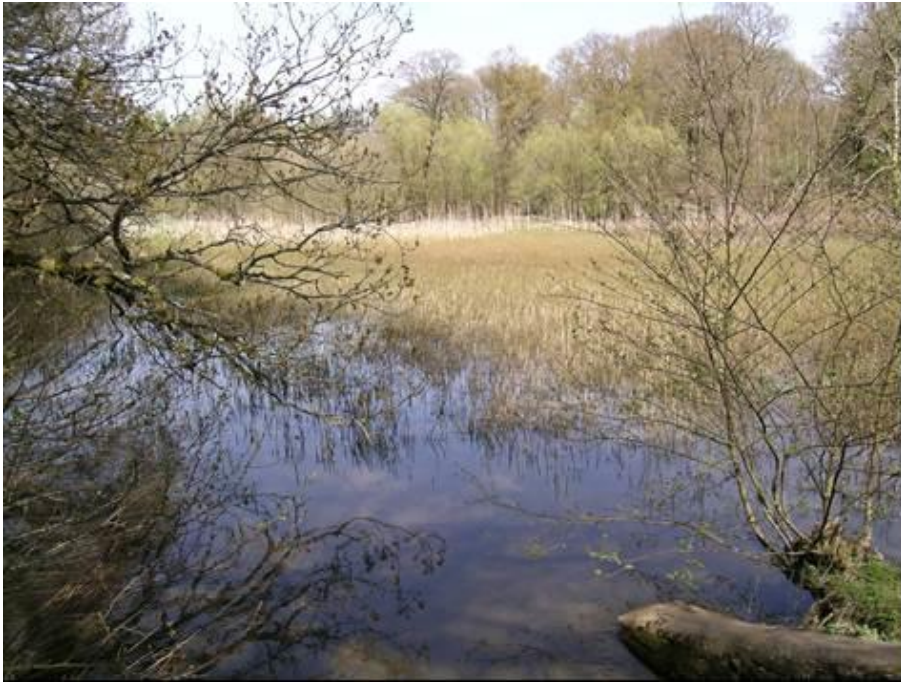
Figure 2.8 The hydrosere that has developed in the upper Cannop pond, viewed from the overflow to the middle pond. Water horsetail swamp (in the foreground), through reedswamp to willow carr (alder carr is beyond the willow).

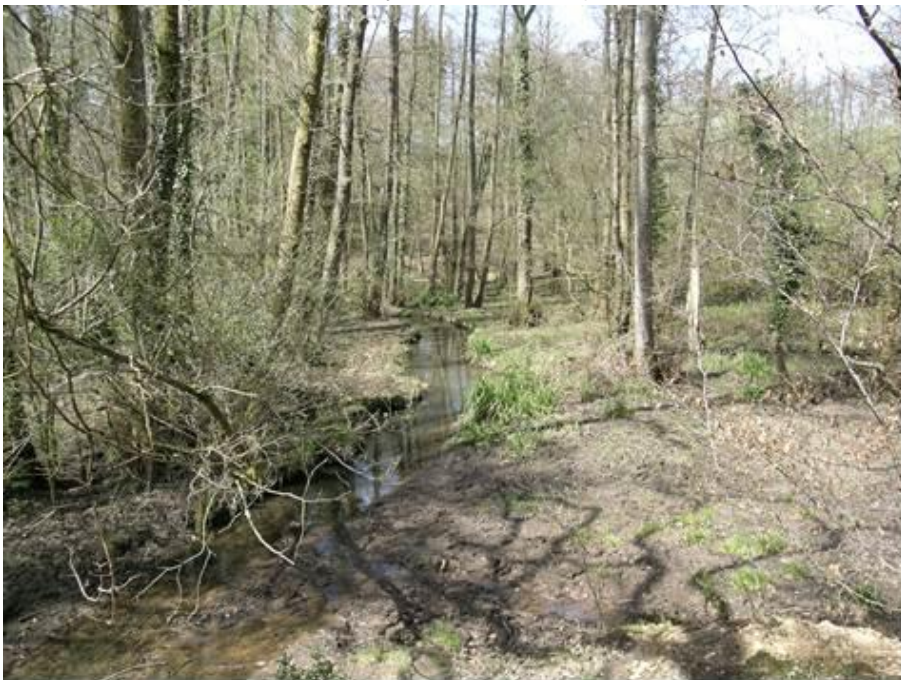
Figure 2.9 Alder woodland at the upstream end of the hydrosere in the upper pond. Note heavy poaching in the foreground.

Walking up into the alder carr, specimens of the invasive non-native skunk cabbage were found scattered within the carr vegetation. Given the dispersed nature of the plants this does not appear to be *ad hoc* dumping by an individual who has cleaned out their pond. AS believes the plants are likely to originate from a small nursery immediately upstream of the site. Urgent action is needed to remove plants from the carr and to address the invasion pathway from the nursery.

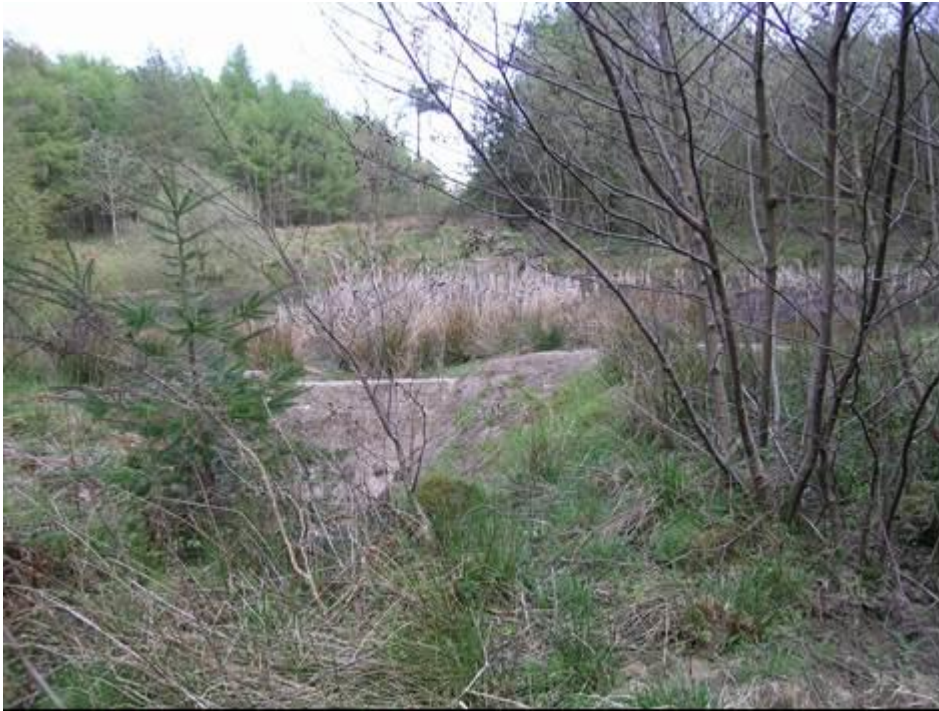
Figure 2.10 Artificial pond to the west of Woorgreens Lake, showing overflow.

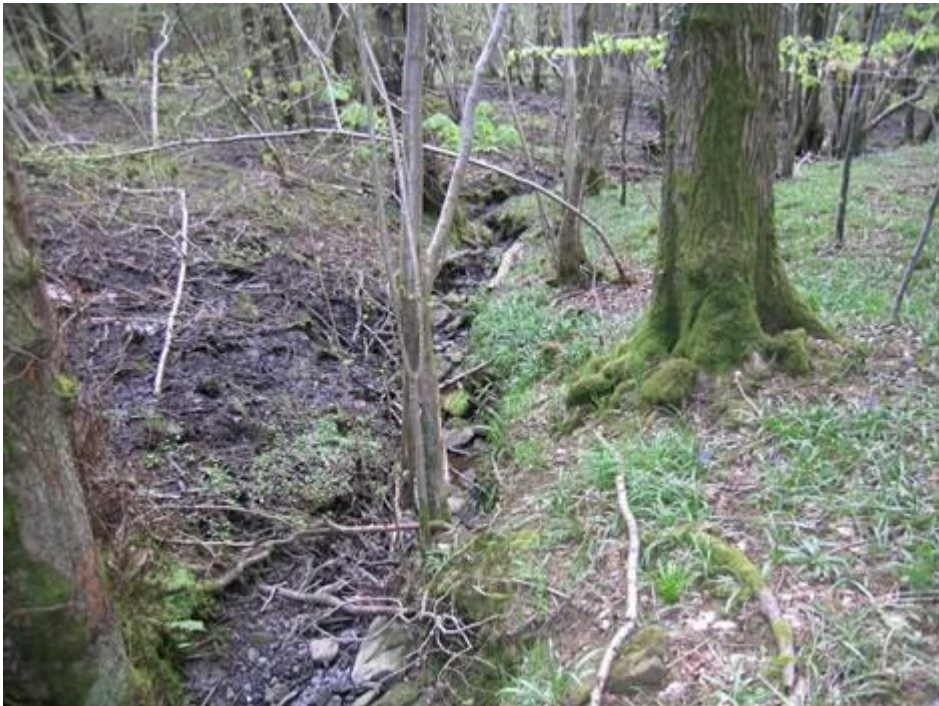
Figure 2.11 The channel downstream of the artificial pond.

A pond (Figure 2.10) has been created to the west of Woorgreens Lake which seems to receive an overflow from the lake through a drainage ditch before discharging into the headwaters of the Cannop Brook. It has a concrete overspill and has the appearance of a settlement pond. Like many created ponds of this type it has filled with a monoculture of reedmace. Downstream of the pond there is a distinct channel which has sufficient energy on a relatively steep gradient to

influence its own morphology (Figure 2.11). However, it is unclear if it was a stream channel prior to the upstream drainage works, and may have originally been flush habitat.

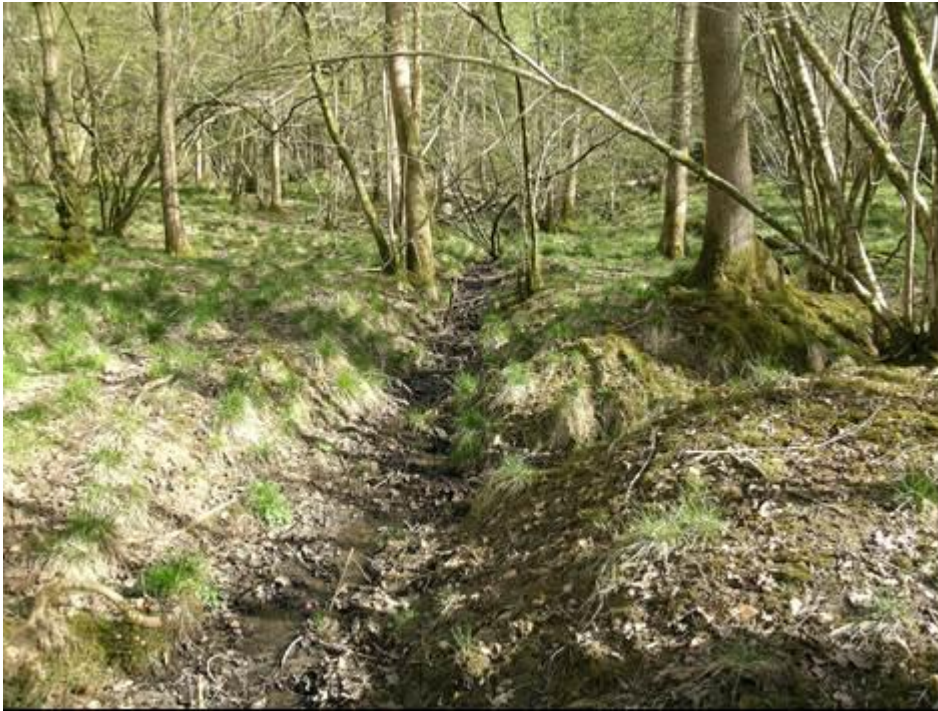
The main track leading down the slope had a side drain with a healthy flow of water being channelled away from the upper slopes. It indicates there could be sufficient water to resupply the largely defunct flushes and springs across the western slope draining into the Cannop brook.

Figure 2.12 Forest drains cut through the broadleaf plantation area.

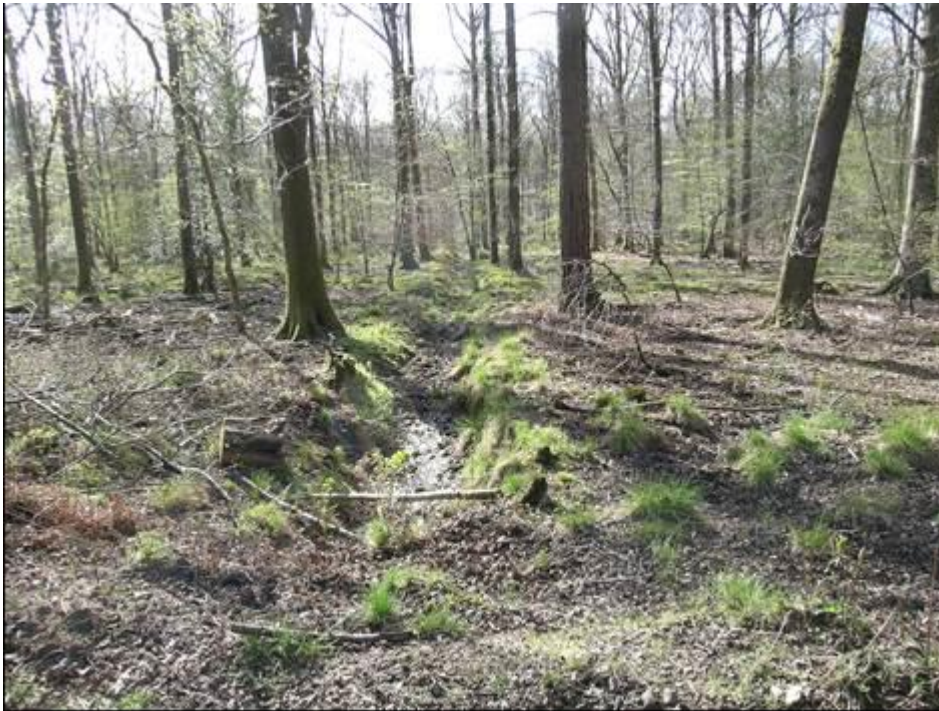
Figure 2.13 Another drain through the broadleaf plantation.
