Specialist site visit – Forest of Dean, Tuesday 3 – Thursday 5 May 2016

Chris Mainstone, Ruth Hall, Iain Diack and Isabel Alonso

April 2017

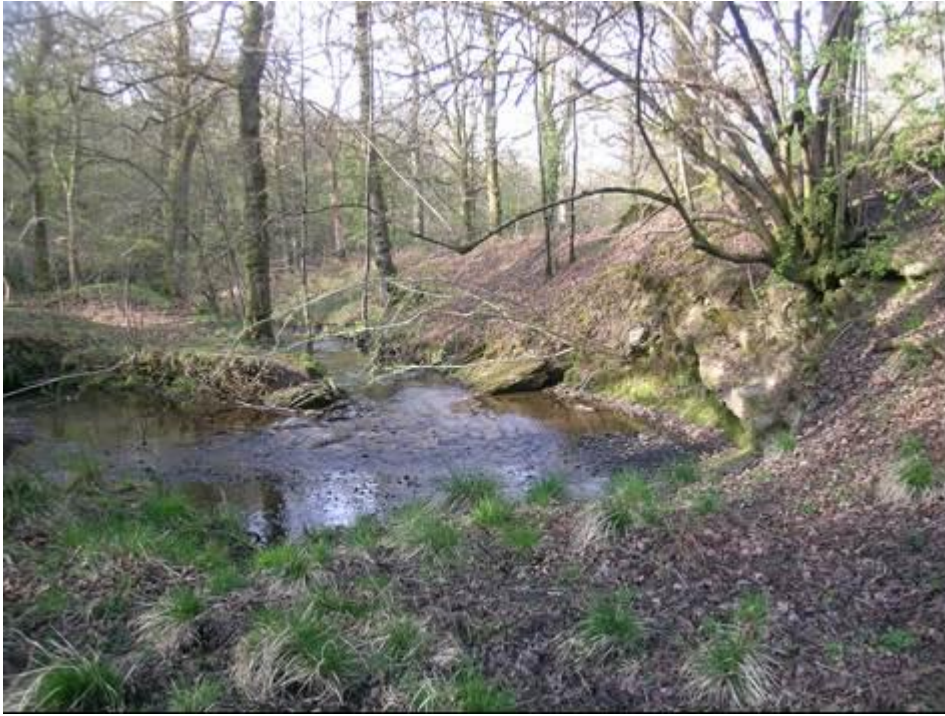
Figure 3.1 The Cannop Brook above Cannop Ponds.

Brief inspections were made (by Chris Mainstone only) of the middle and lower reaches of the Cannop Stream, above and below Cannop Ponds. Above Cannop Ponds at NGR SO 611 127, the stream channel functions very naturally, meandering through a narrow valley floor (Figure 3.1). A brief kick-sample was taken of the benthic macroinvertebrate assemblage of the stream at this point. A good range of stoneflies was again recorded: the predators *Isoperla grammatica* and *Chloroperla torrentium*, the shredder/detritivore *Amphinemura sulcicollis*, and the Taeniopterygid species *Brachyptera risi*. An abundant mayfly assemblage was evident, dominated by riffle-dwelling species *Rithrogena semi-colorata* and *Ecdyonurus* sp. and *Ephemera danica* in areas with somewhat finer substrates. Other riffle dwellers recorded are the caseless caddis-fly *Rhyacophila* sp. and riffle beetles (Elmidae). Freshwater shrimps (Gammaridae) were abundant as in other Forest streams.

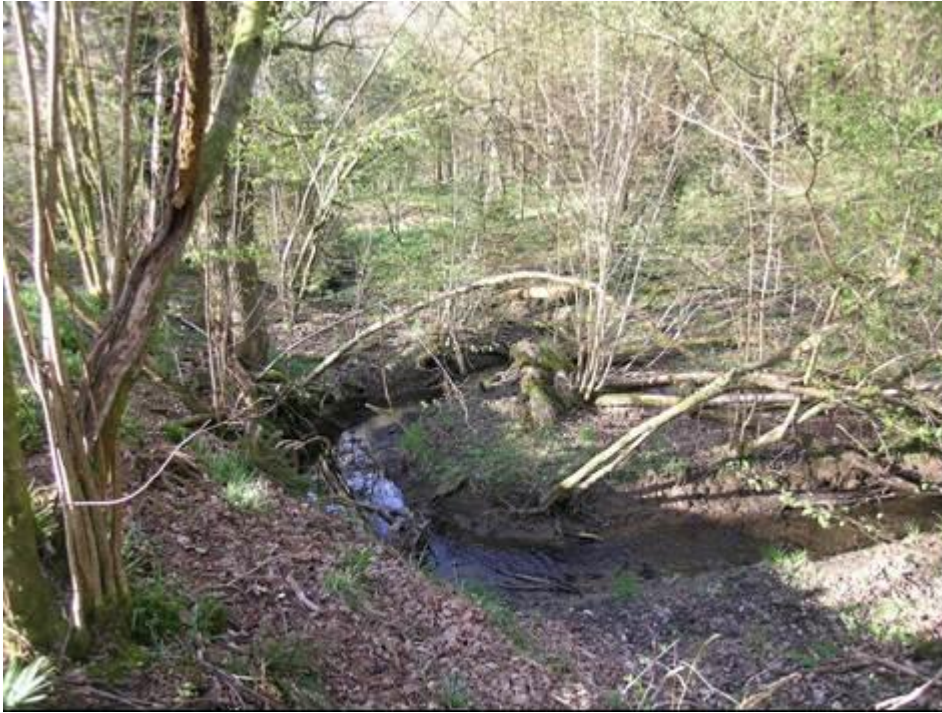
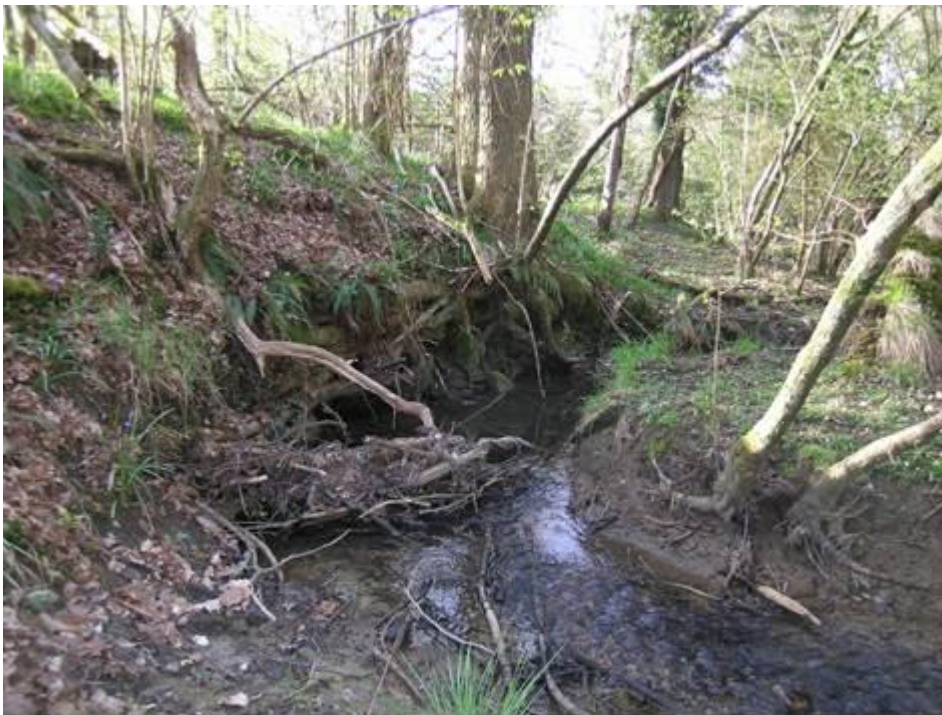
Ropehouse Ditch was inspected at NGR SO 611 134, immediately above its confluence with the Cannop Brook. Although given the epithet of 'ditch', the channel appears to be functioning very naturally, showing quite extreme meandering behaviour with good interaction with riparian trees (Figures 3.2 and 3.3). The resulting habitat mosaic is of reasonable quality, although coarser substrates are in short supply (possibly due to the stream gradient at this point, or historical ditching operations). The channel was presumably ditched at some point in the past (the stream bed is a considerable way below the bank top) but it seems likely that there was a pre-existing stream. A brief kick-sample was taken of the benthic macroinvertebrate assemblage of the stream at this point. The stoneflies *Isoperla grammatica* and *Brachyptera risi* (?), and Ecdyonurid and Rithrogenid (*R. semi-colorata*) mayflies, indicate swift-flowing gravelly biotopes within the habitat mosaic. The presence of Scirtid beetles and alder-fly larvae (Sialidae) reflect more quiescent zones and vegetated margins. Freshwater shrimps (*Gammarus* sp.) were again abundant. Overall invertebrate diversity was lower than in other streams visited, presumably in part due to the predominance of relatively fine substrates.

Figure 3.2 Ropehouse Ditch above the confluence with Cannop Brook.

Figure 3.3 Ropehouse Ditch above the confluence with Cannop Brook.

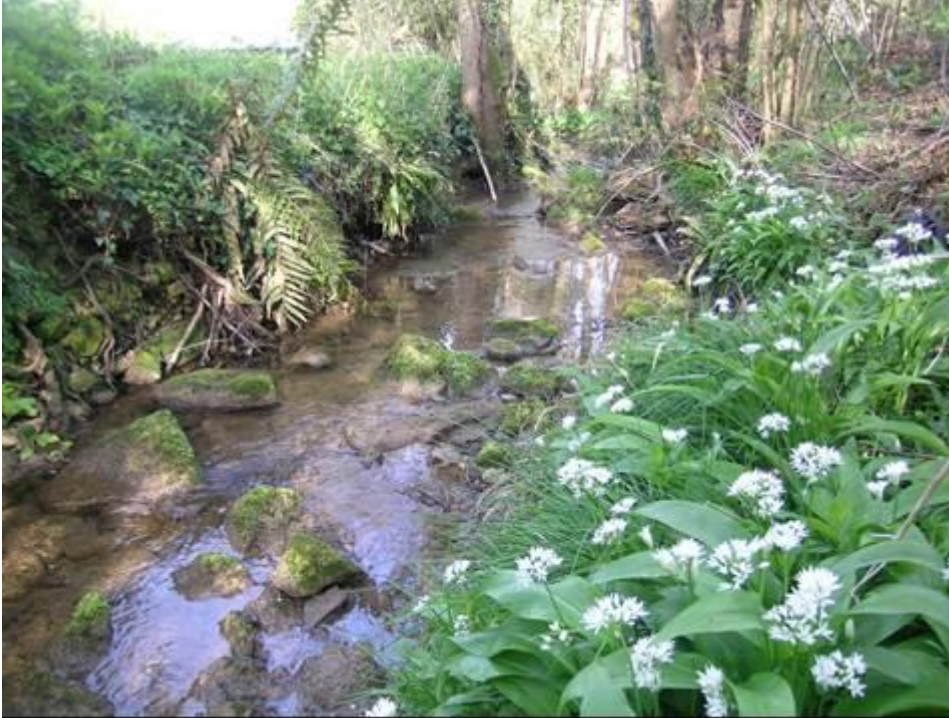
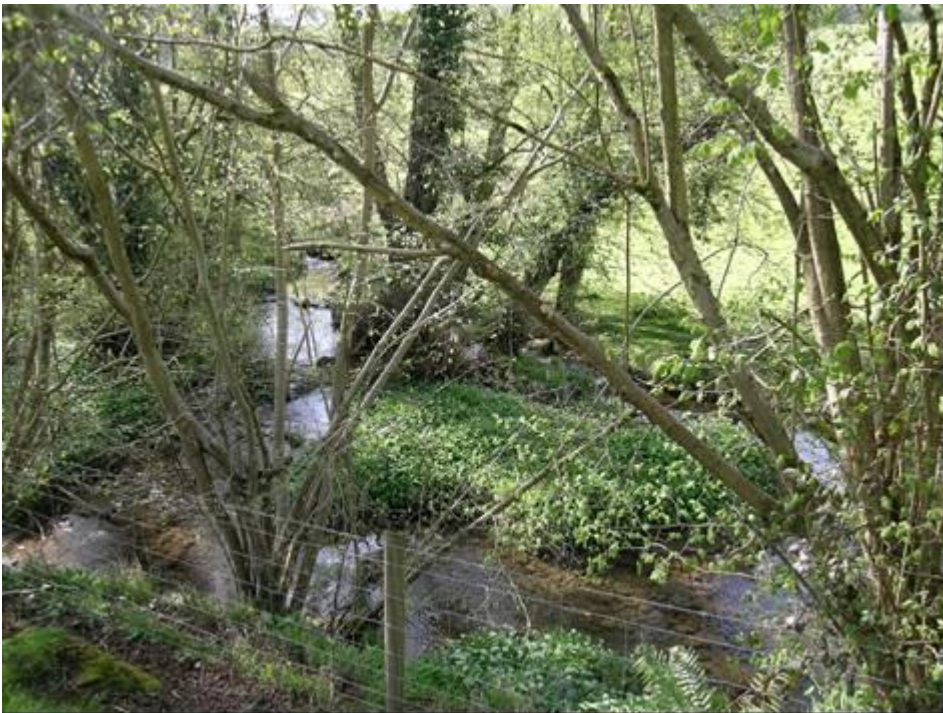
A brief inspection (by Chris Mainstone only) was made walking upstream from Mork. The brook is extremely natural with excellent in-channel habitat mosaics and woodland riparian zone (Figures 3.4 and 3.5). It is heavily tufa-forming, creating characteristic tufa steps (Figure 3.6). A brief kick-sample was taken of the benthic macroinvertebrate assemblage of the stream. This revealed a wide range of caseless (*Psychomyiidae*, *Hydropsyche* sp. and *Rhyacophila* spp.) and cased caddis-fly larvae (*Odontoceridae* and *Limnephilidae*), a diverse mayfly assemblage (*Seratella ignita*, *Rithrogena semi-colorata*, *Ephemera danica*, and baetids), abundant freshwater shrimps (*Gammarus* sp.) and Scirtid and Elmidae beetles. No stoneflies were found but

Figure 3.4 Slade Brook immediately upstream of Mork.

Figure 3.5 Slade Brook immediately upstream of Mork.

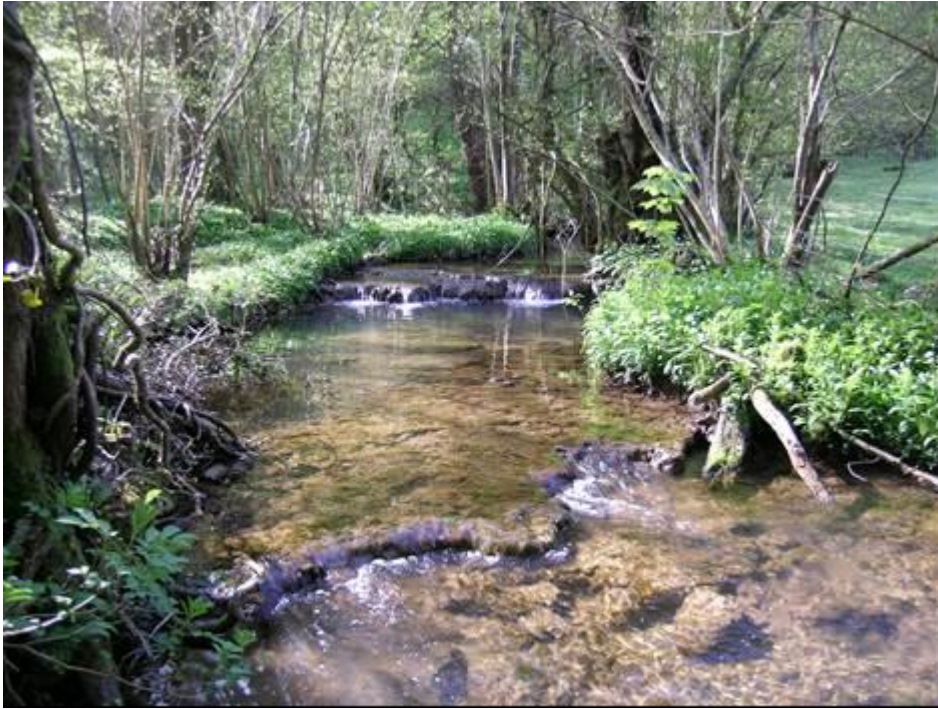
Figure 3.6 Tufa steps in Slade Brook.

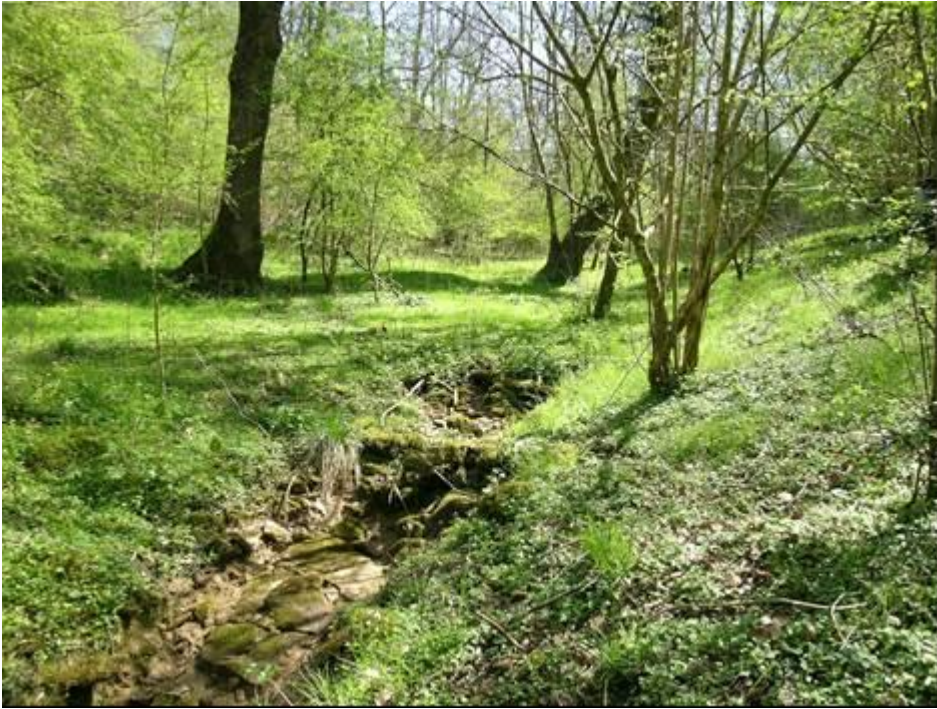
Later in the day a larger group walked downstream from the top end of the southern headwater of the brook. Although the top end of the headwater catchment has been drained and developed (scattered housing and gardens), there is a small field at the top of the stream channel where there is still a natural transition between flushes and the stream proper (Figure 3.7). This field is fenced off and covered by golden saxifrage. The top end of the stream channel is defined by bedrock controls (Figure 3.8), which support the large area of flush vegetation above it. There was no flow at the stream head at the time of inspection (probably naturally ephemeral). At the confluence of the northern and southern arms, it was clear that the northern arm (Figure 3.9) contributes much greater flow than the southern arm.

Figure 3.7 Head of the stream channel on the southern headwater of Slade Brook.

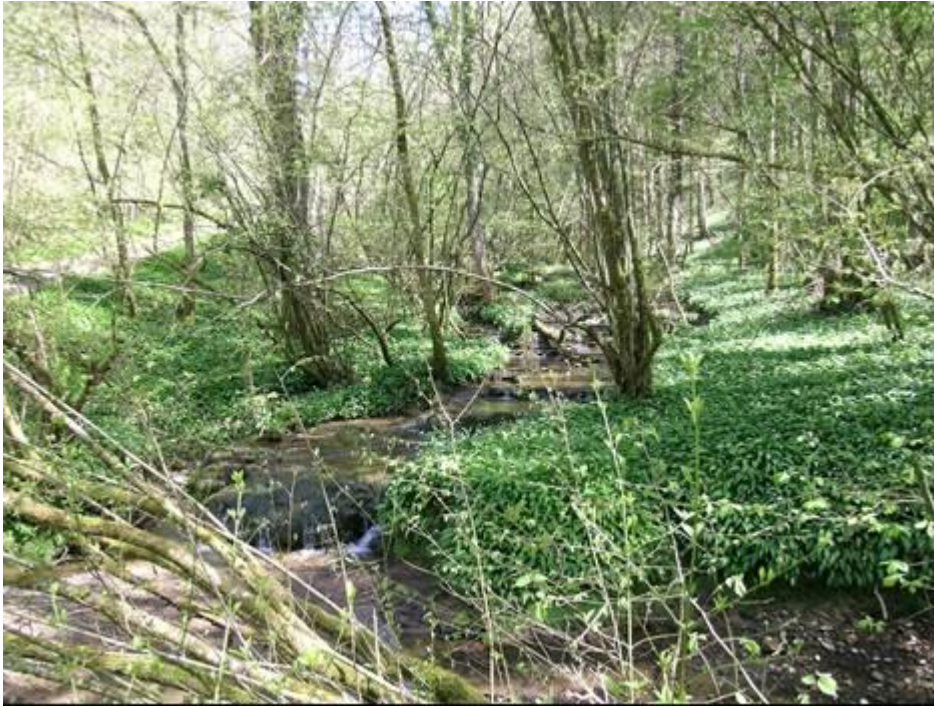
Figure 3.9 The northern headwater of Slade Brook immediately upstream of the confluence with the southern headwater.

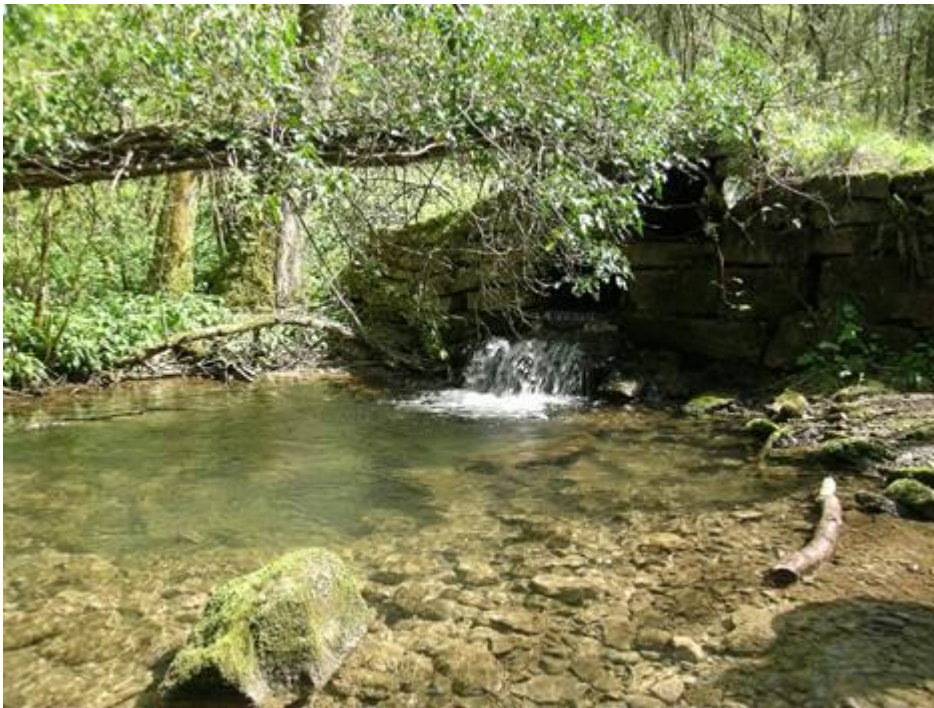
Immediately below the confluence of the headwater arms the stream runs through a culvert underneath a farm track. This has created an artificial tufa mound and a scour pool underneath the discharge point of the culvert (Figure 3.10).

Figure 3.10 The culvert, tufa mound and scour pool on Slade Brook.

The culvert is creating a loss of naturalness, causing complete loss of stream habitat for a short distance, interfering with natural morphological processes that create the natural habitat mosaic, and interrupting biological movements. It is recommended that the culvert be replaced by a wide span bridge. There was also a section of the brook which overlapped with the footpath and could be looked at whether a separate footpath route can be devised slightly upslope of the brook.

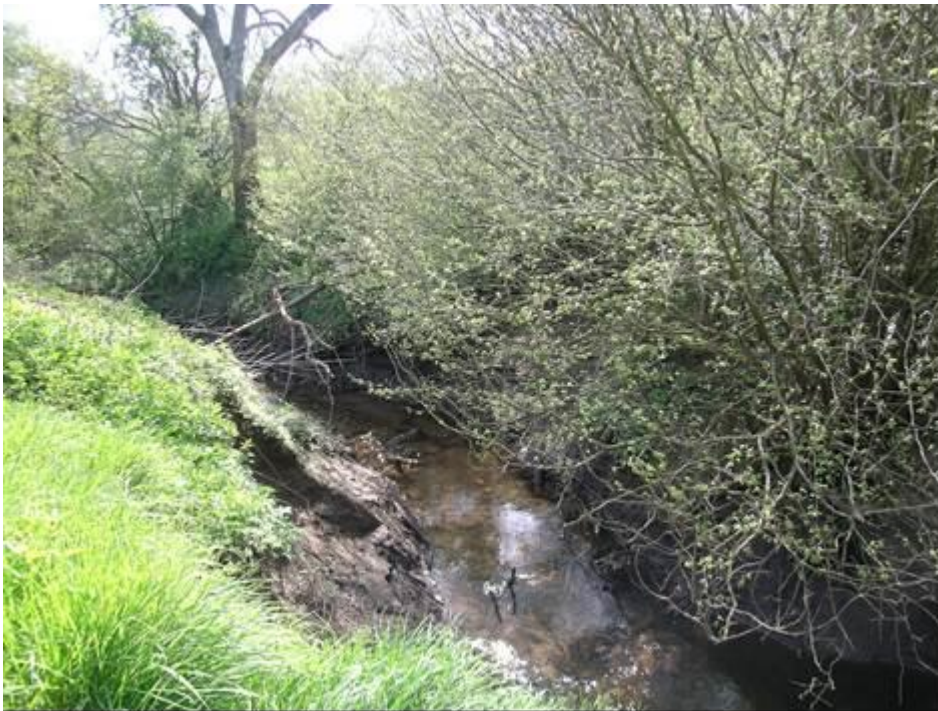
This is located downstream of Slade Brook, discharging directly into the main River Wye at Bigweir Bridge. The downstream end of the brook is heavily incised to meet the bed level of the main Wye (Figure 3.11), and shows considerable tidal influence from the main river. However, the bed level shallows considerably only a short distance upstream, due to the stabilising influence of tree root systems (Figure 3.12).

Figure 3.11 The heavily incised Mork Brook at the confluence with the tidal River Wye,

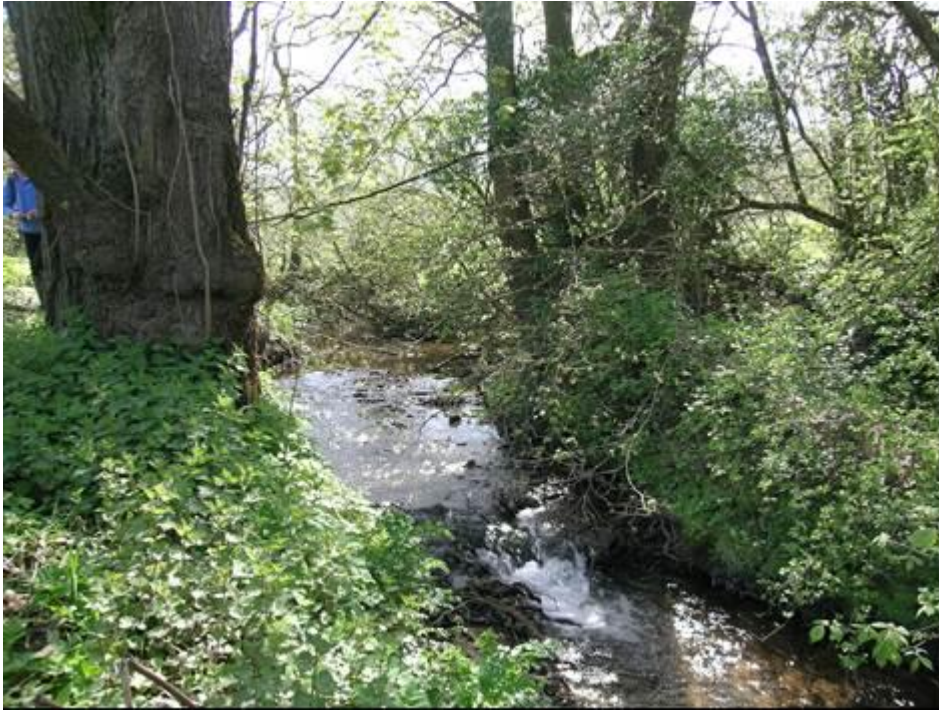
Figure 3.12 The bed level of Mork Brook being protected from incision by extensive riparian tree root systems.

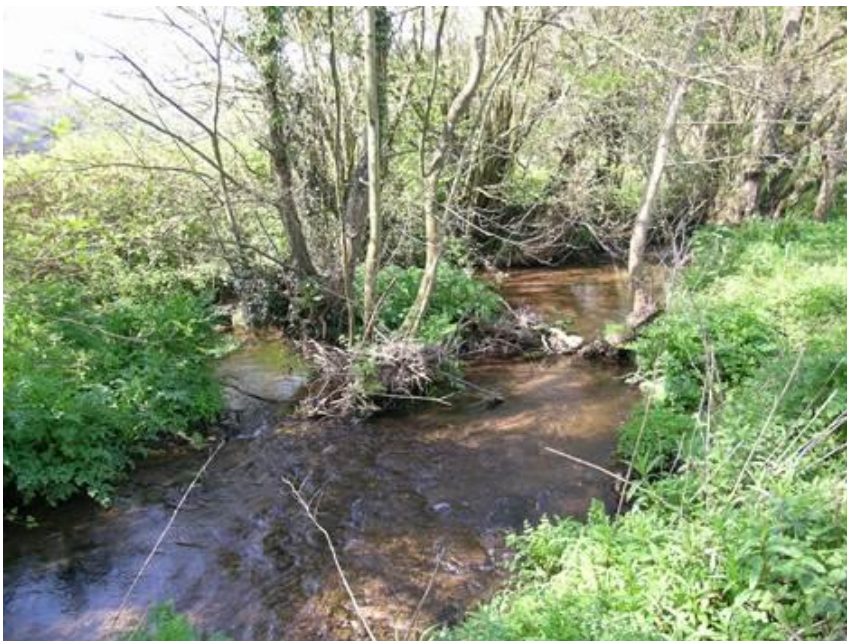
Walking upstream, the brook exhibits a reasonable habitat mosaic (Figure 3.13). A brief macroinvertebrate sample as taken at this point. This revealed a relatively diverse assemblage including stoneflies (*Isoperla grammatica* and *Brachyptera risi*), caseless (*Rhyacophila* sp.) and cased caddis-flies (*Sericostoma personatum*, Odontoceridae, Limnephilidae), mayflies (*Rithrogena semi-colorata*, *Seratella ignita*, *Baetis* sp.), Elmids and Gyrinid beetle larvae, and Simuliid and Chironomid dipteran larvae,

Figure 3.13 The habitat mosaic in Mork Brook.

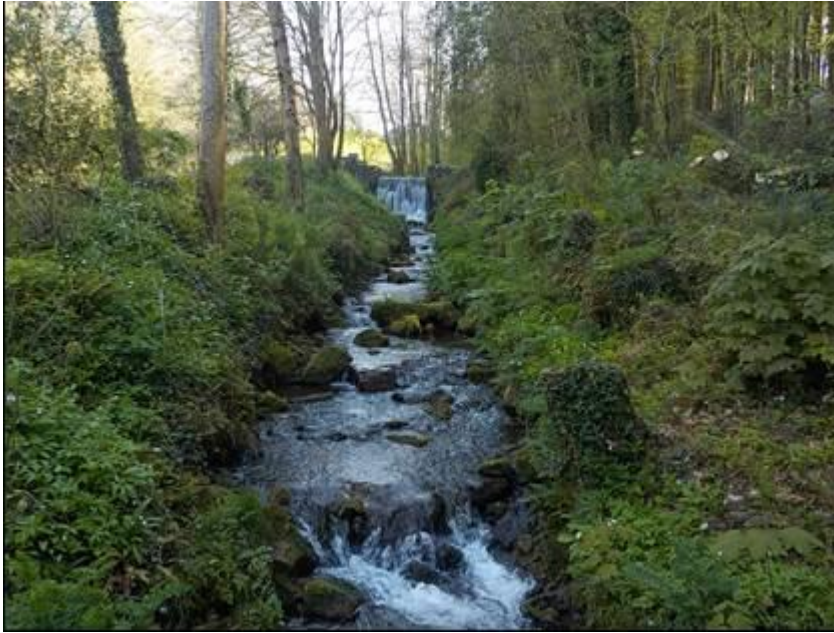
Further upstream, and prior to the confluence with Slade Brook, the channel is heavily affected by landscape engineering associated with an old country house (Figures 3.14 and 3.15).

Figure 3.14 Weir below Mork Farm and confluence with Slade Brook.

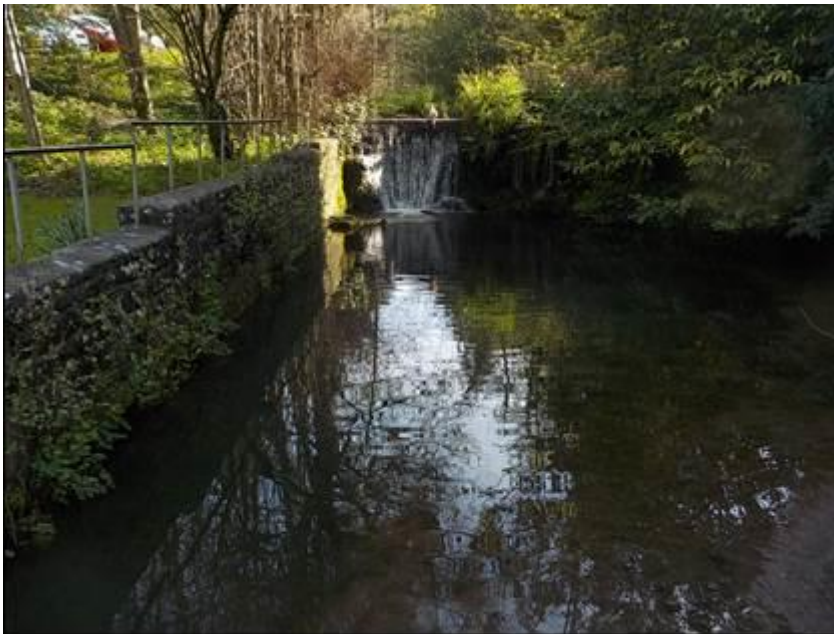
Figure 3.15 Weir on Mork Brook in the grounds of an old Country House.

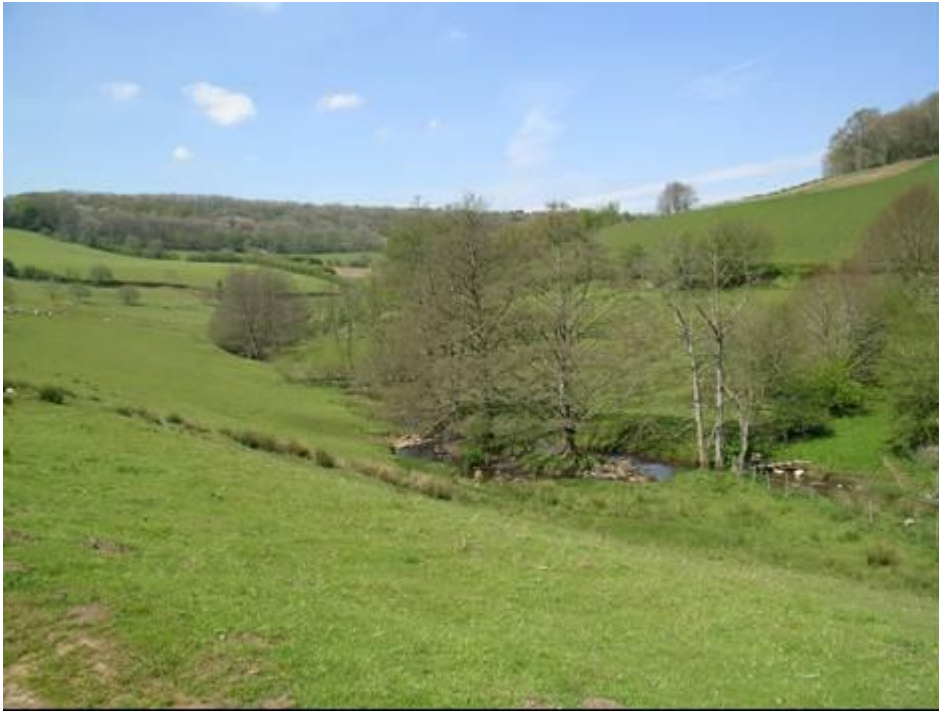
Figure 3.16 Middle reaches of the Valley Brook.

This brook discharges into the Wye upstream of Mork Brook. It is more affected by development than the Mork Brook system, but has some stretches with reasonable remaining physical habitat. We walked along a short section of the middle reaches. The section was heavily impacted by an impounding structure which seems to serve no on-going function – the resulting pond is heavily silted and devoid of submerged plants. Downstream the brook runs through sheep pasture (Figure 3.16), with some impressive riparian alders (Figure 3.17). The channel behaves naturally through this stretch, creating a good in-channel habitat mosaic (Figure 3.18). However, the heavy bankside grazing provides no opportunity for a diverse riparian zone – the effect of

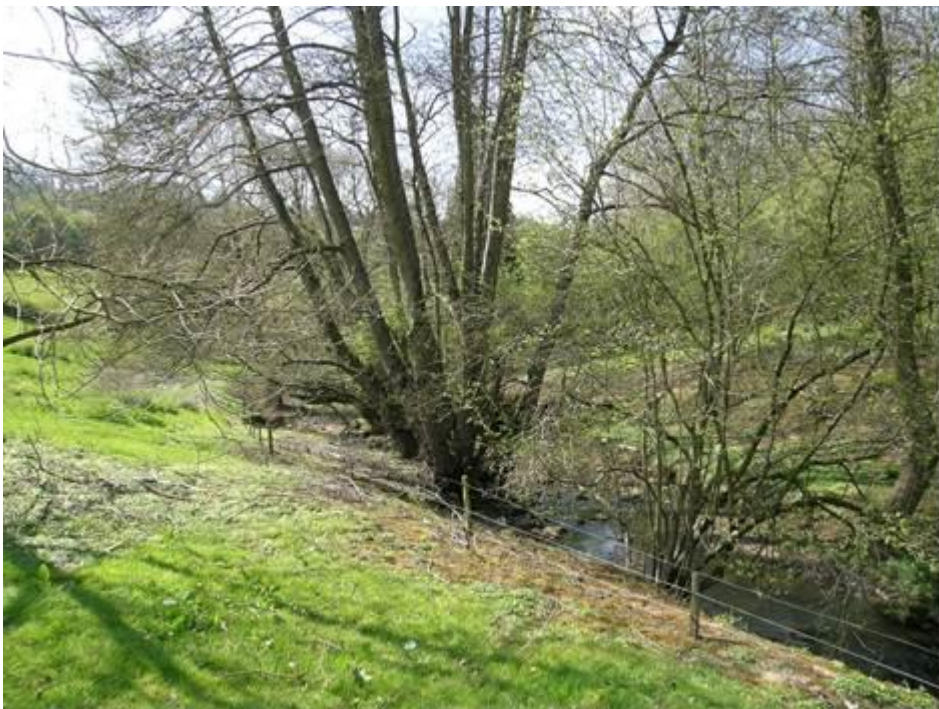
Figure 3.17 Old riparian alders on Valley Brook.

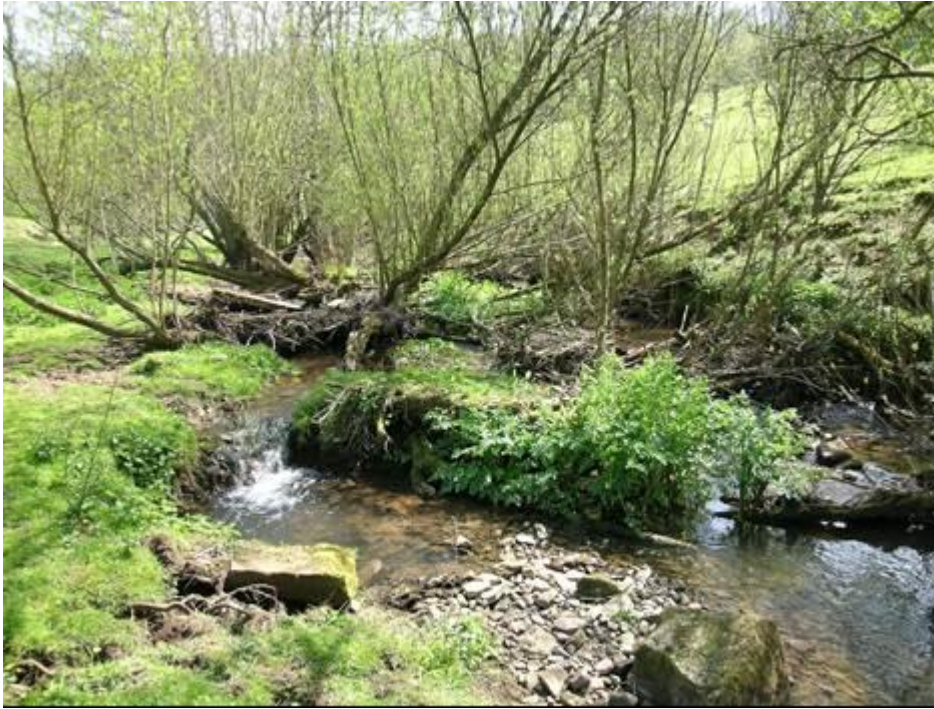
Figure 3.18 Strong dynamic habitat mosaic in Valley Brook.

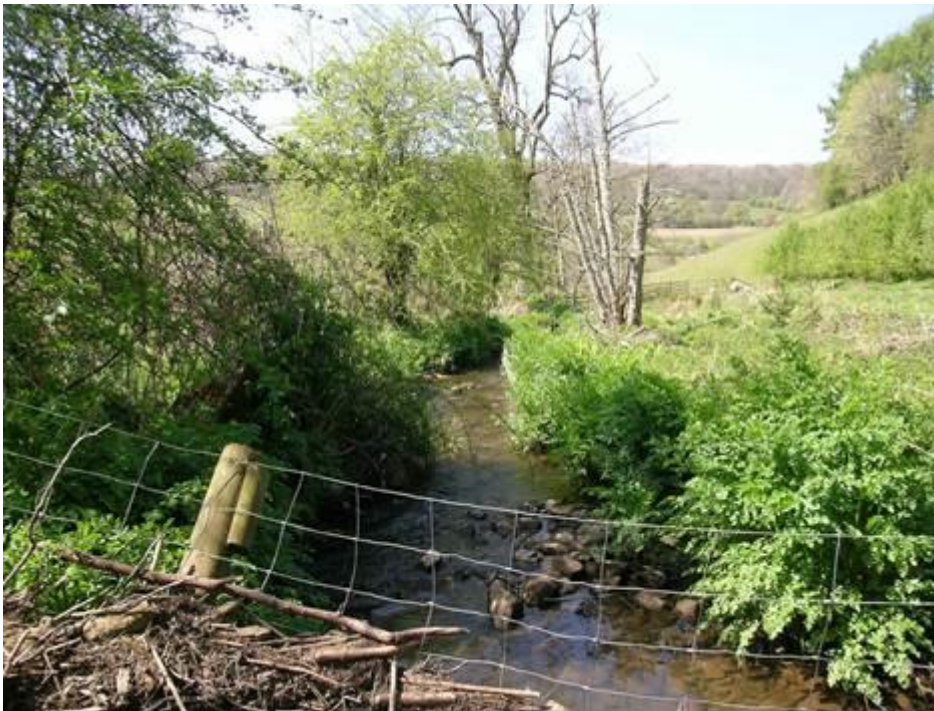
eliminating grazing pressure can be seen further downstream, (Figure 3.19), where the vegetation (albeit mainly hemlock water dropwort) has sprung up behind riparian fencing.

Figure 3.19 The effect of fencing on Valley Brook.

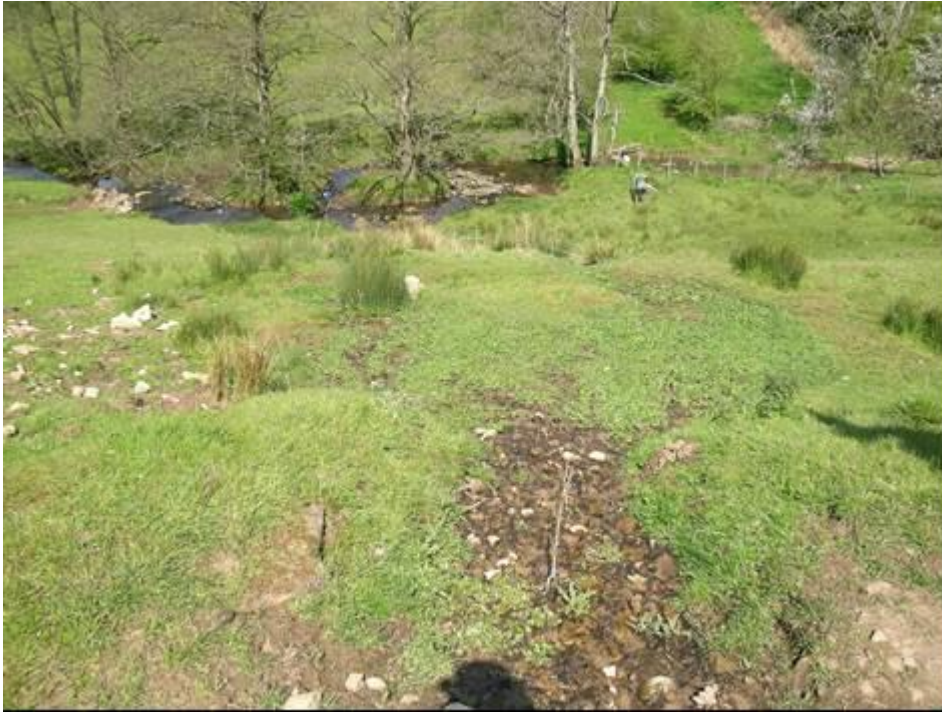
The incised valley does show evidence of flushes that would have come off the valley sides before land drainage activity (Figure 3.20).

Figure 3.20 A flush running into the middle reaches of Valley Brook.

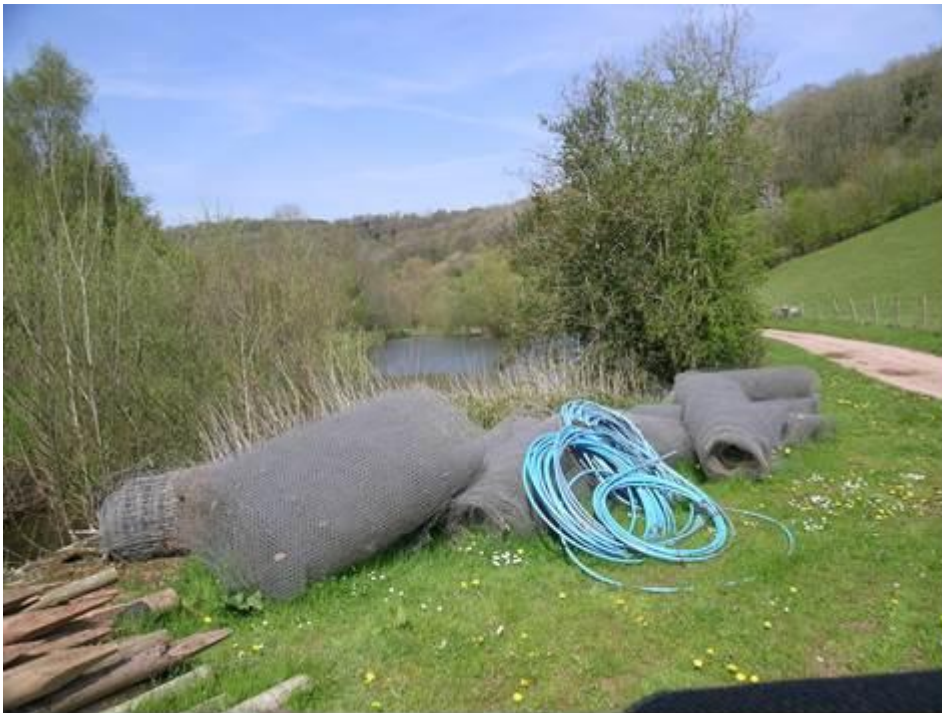
We briefly visited a stretch further downstream above Redbrook, which turned out to be heavily impacted by an impoundment (Figure 3.21), seemingly for fishery purposes.

Figure 3.21 Impoundment on Valley Brook.

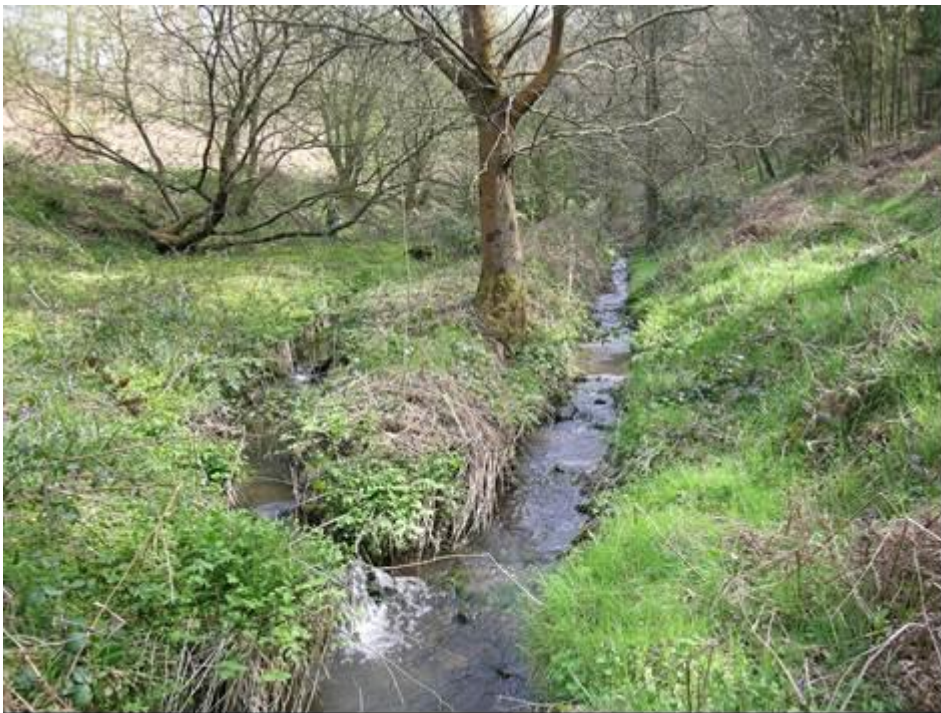
Figure 3.22 Greathaugh Brook.

This is the proposed site of a beaver enclosure, in the northern part of the forest draining the northern slopes of Woorgreens/Crabtree Hill. We walked downstream from the forest track at NGR SO 622 154. The channel has been ditched historically but is beginning to show signs of natural recovery (Figure 3.22). There are still strong flushes entering the channel from the right hand bank (e.g. Figure 3.23), from seepages along the steep valley side – these are probably the strongest flushes we have seen during this visit to the forest, supporting abundant golden-leaved saxifrage and valerian.

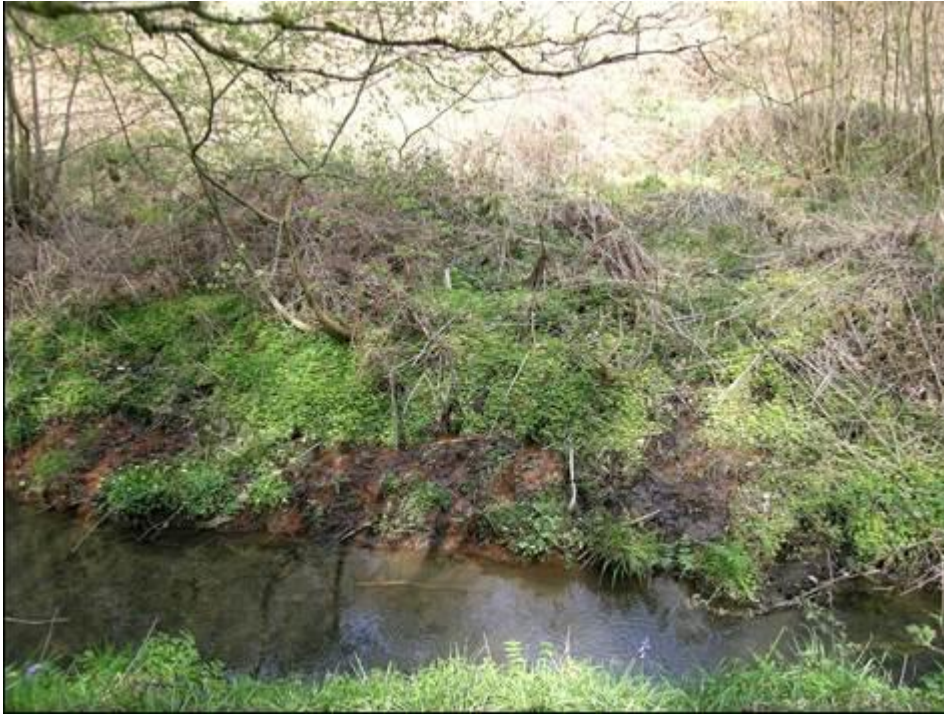
Figure 3.23 Chalybeate (ferruginous) spring entering Greathaugh Brook.

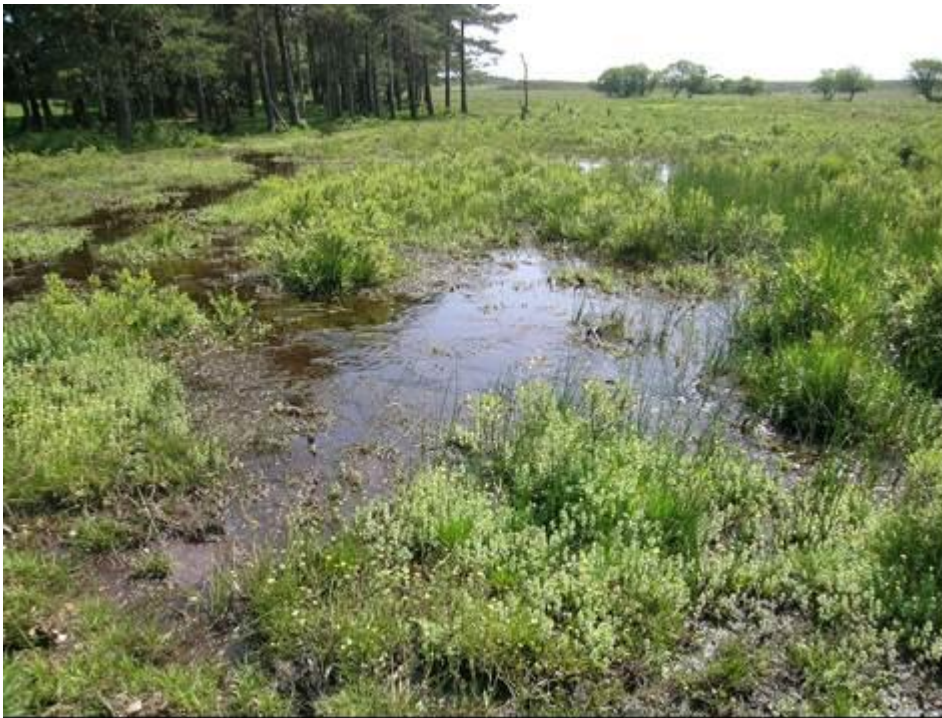
Figure 4.1 Seepages and runnels running into Oberwater at Aldridgehill Inclosure, New Forest.

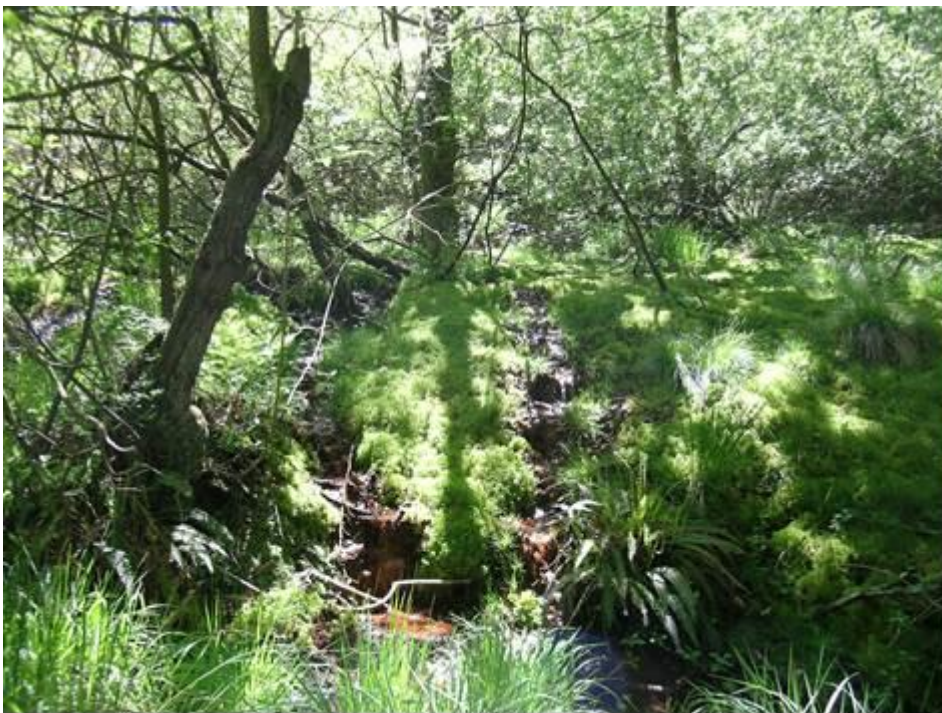
Figure 4.3 Chalybeate springs draining out of the Sphagnum beds to form the stream channel, Broadstone Warren in Ashdown Forest.

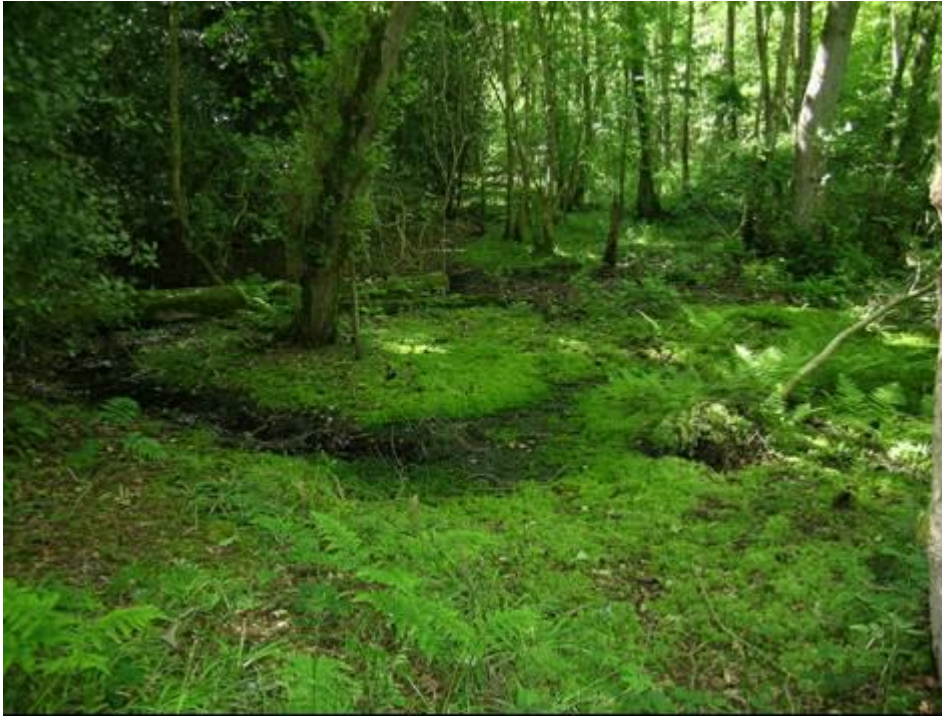
Figure 4.4 The mire/stream transition at the top of Nap Wood, High Weald, showing extensive *Sphagnum* cover and natural stream formation.
