## Specialist site visit to Kent Downs streams 5 June 2015

### 1. Seabrook Stream

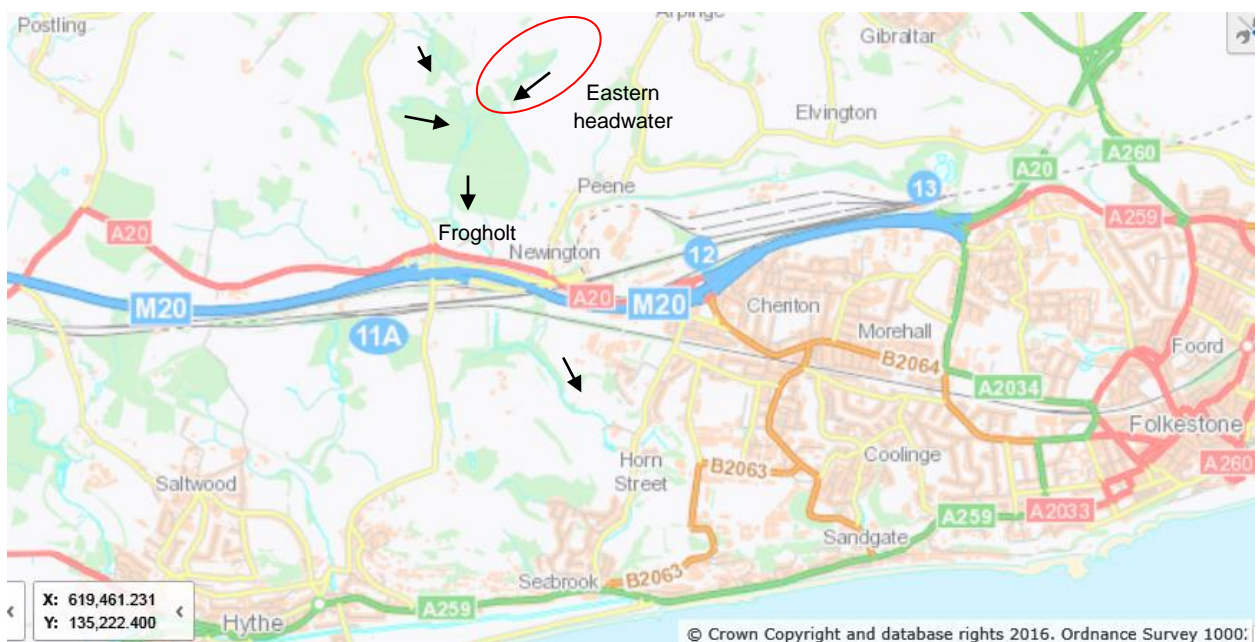
The headwaters of the Seabrook Stream run southwards off the scarp slope of the Downs, converging into the Seabrook Stream proper which runs down to the south coast at Seabrook (see map below). We walked up the eastern headwater, up the eastern arm to its source at TQ 183 389, then over to the western arm from its source at TQ 180 390 downstream to the railway embankment. We then drove to the main Seabrook Stream at Frogholt to look for native crayfish.

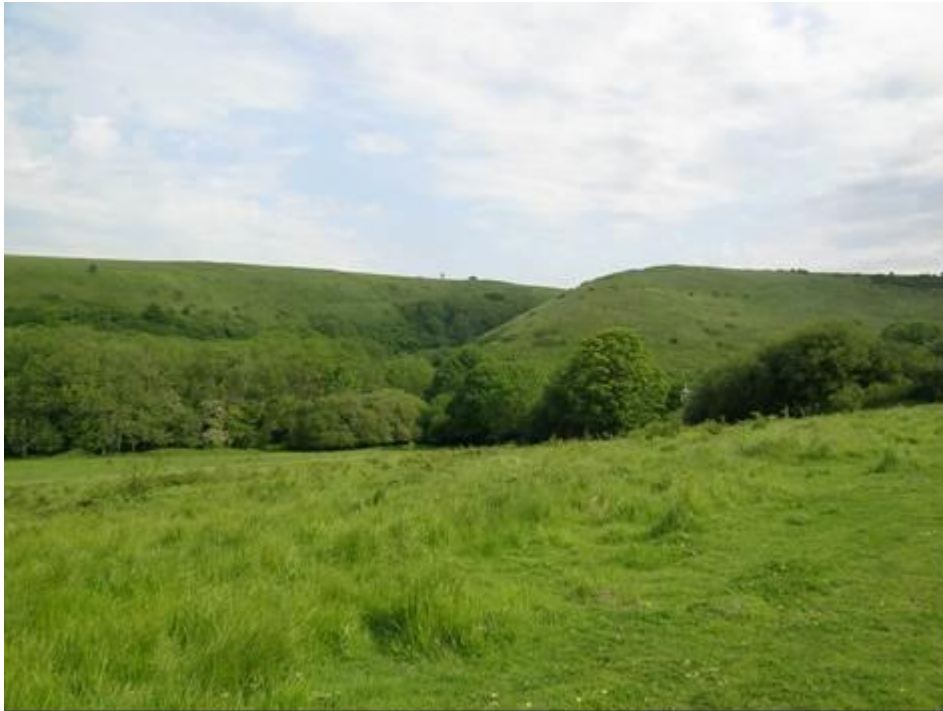
The topographical catchment of the headwaters may be unique in the North Downs in consisting of semi-natural vegetation: low-intensity grassland and woodland. The groundwater catchment will be more extensive and subject to wider pressures from arable farming and rural development. Further downstream, the Seabrook Stream is impacted by development associated with the Channel Tunnel, M20 and urban development.

**Figure 1. The topographical catchment of the headwaters of the Seabrook Stream.**

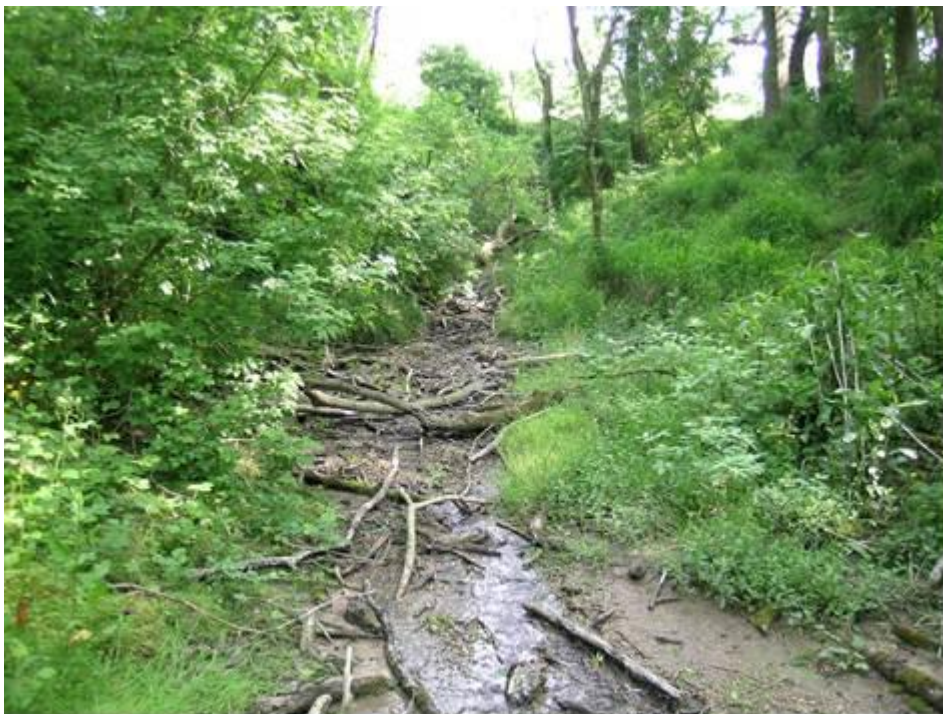
The eastern arm showed particularly high levels of physical naturalness. Good patchy cover from riparian woodland (mainly ash), generating high levels of woody debris in the channel but with sufficient light to support abundant riparian vegetation (Figure 2)

**Figure 2. The eastern arm of the eastern headwater.**

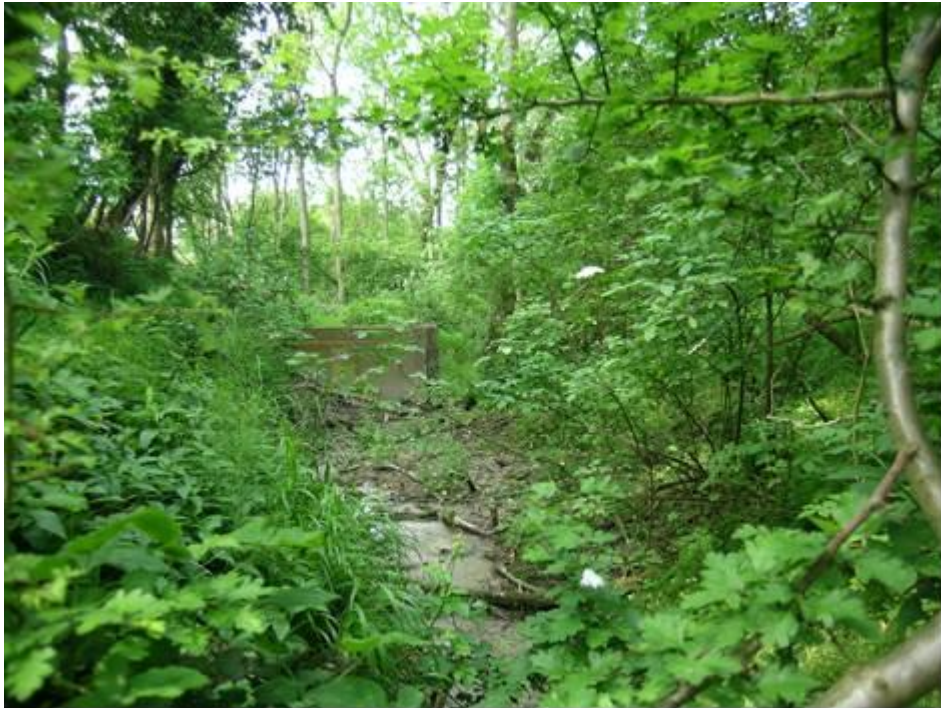
The only evidence of significant physical modification was a concrete impounding structure (Figure 3), apparently associated with a historical domestic abstraction. This has been

abandoned and is not now greatly affecting channel morphology because the centre of the structure is open down to the current bed level – it presumably had wooden slats to control water levels, which have rotted away.

**Figure 3. Concrete impounding structure on the eastern arm.**

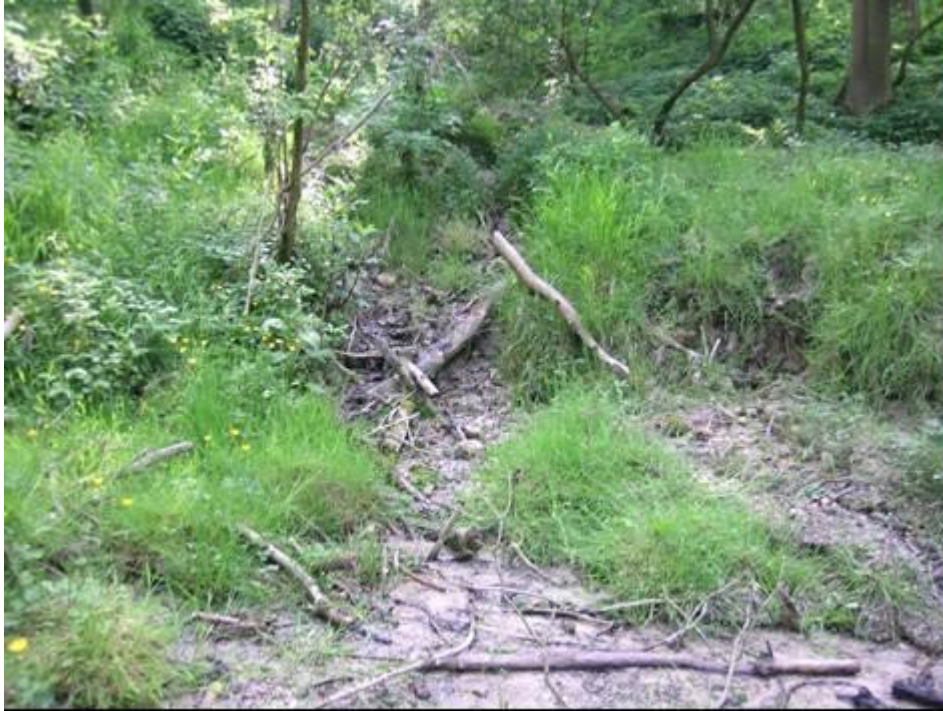
The channel cross-section is very shallow, providing good hydrological continuity with the riparian zone and allowing wetland vegetation to develop (*Apium nodiflorum*, *Rorippa nasturtium-aquaticum*, *Veronica beccabunga*), interspersed with bare substrates. Woody debris rarely forms into significant debris dams, which limits the plan form variation and hence development of meso-scale habitat variation. This seems to be a natural result of the low stream power typical of chalk stream headwaters when running over chalk – hydraulic energy is insufficient to shift woody debris in ways that generate localised accumulation into jams.

**Figure 4. A rare example of a debris dam on the eastern arm, generating natural bed-raising upstream.**

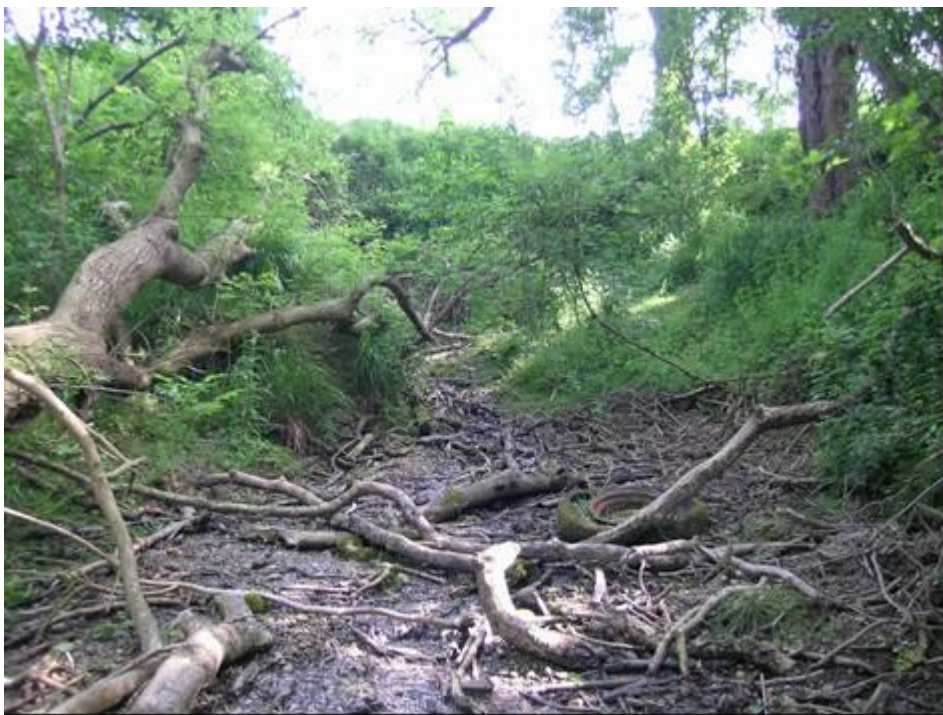
The eastern arm rises in a spring set in a steep chalk bank (Figures 5 and 6), surrounded by liverwort (*Pellia* sp). The spring and upper section of the stream were dry at the time of the visit.

**Figure 5. The upstream end of the eastern arm, with the spring head in the background.**

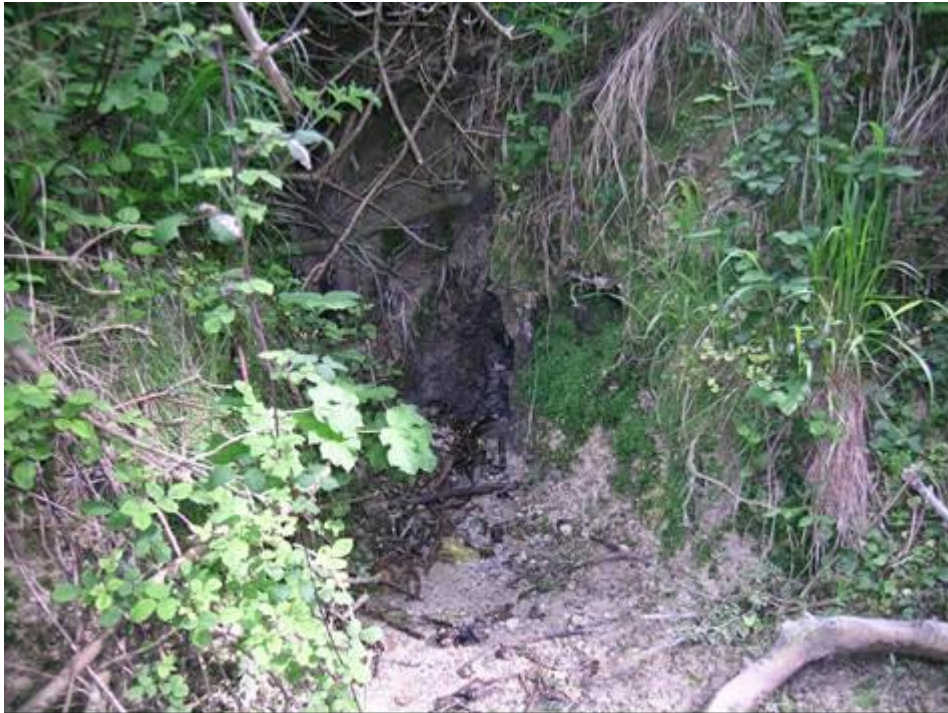
**Figure 6. The spring head of the eastern arm.**

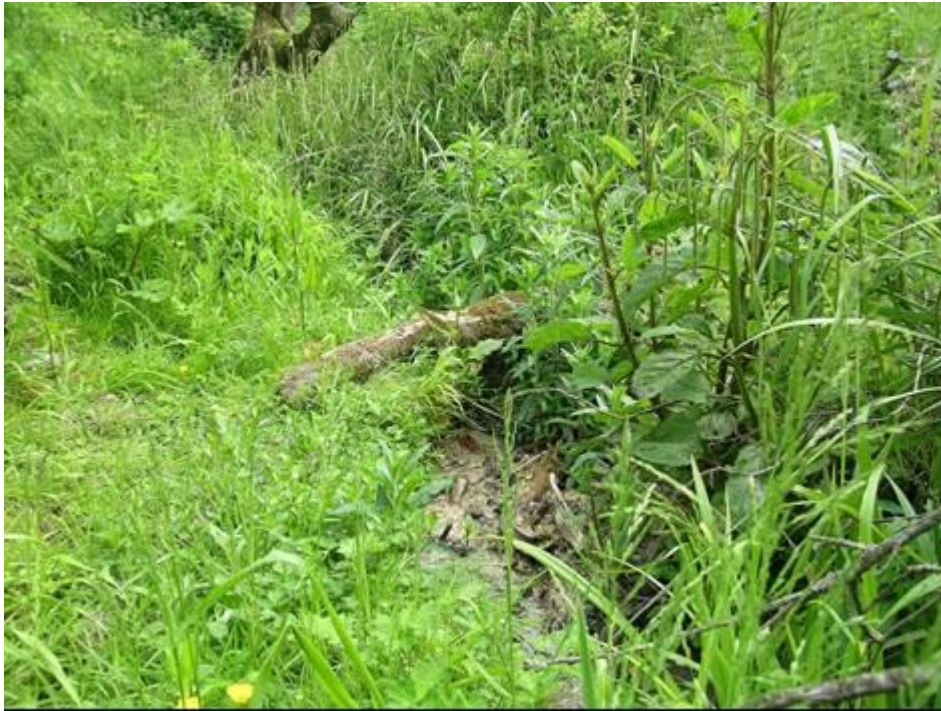
The upstream end of the western arm was more open in parts, with greater abundance of riparian vegetation including *Scrophularia* (Figure 7). Leaf litter seemed to be more prevalent (possibly more riparian hazel than on the eastern arm?).

**Figure 7. Upstream end of the western arm.**

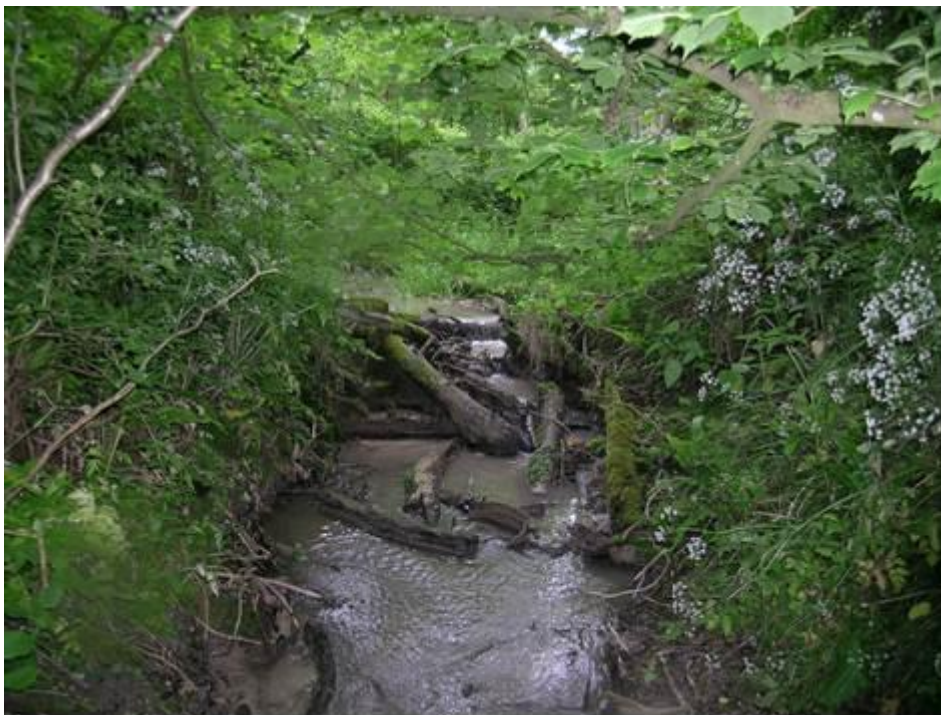
Further downstream, the channel widens and jams of large woody debris are evident (Figure 8), helping to create greater morphological diversity than in the eastern arm.

**Figure 8. Woody debris dam on the western arm.**

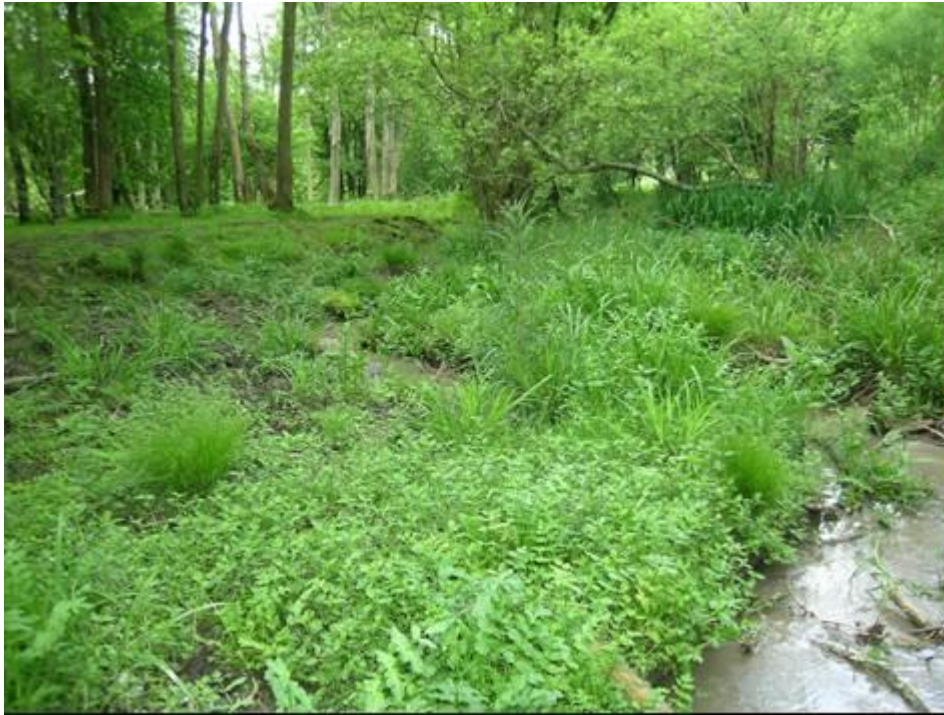
Further downstream still, the western and eastern arms meet and stream gradient shallows as the stream flows out of the steep scarp slope. The riparian zone becomes considerably wetter, with a consequent increase in the extent of wetland vegetation (Figure 9). Abundant

**Figure 9. Extensive wet margins below the confluence of the two arms.**

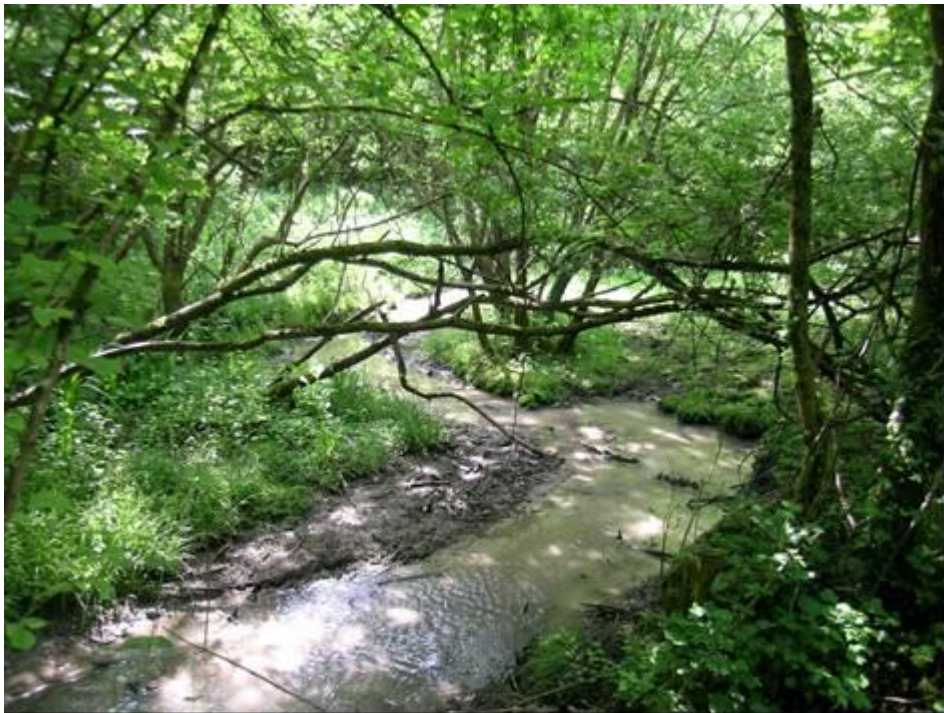
*Apium nodiflorum*, along with *Veronica beccabunga*, *Myosotis* (presumably *scorpiodes*), and opposite-leave golden saxifrage (*Saxifraga oppositifolia*). The softer margins have created greater scope for planform movement, with the greater meso-scale habitat diversity that brings to the channel (Figure 10). However, it also brings greater vulnerability to livestock trampling. Although livestock densities are very low, herding around the water margins has generated heavy localised pressure (Figure 11).

**Figure 10. Planform movement brought about by shallower gradient and finer and softer riparian substrates. Note exposed sediments accumulated as point bars.**

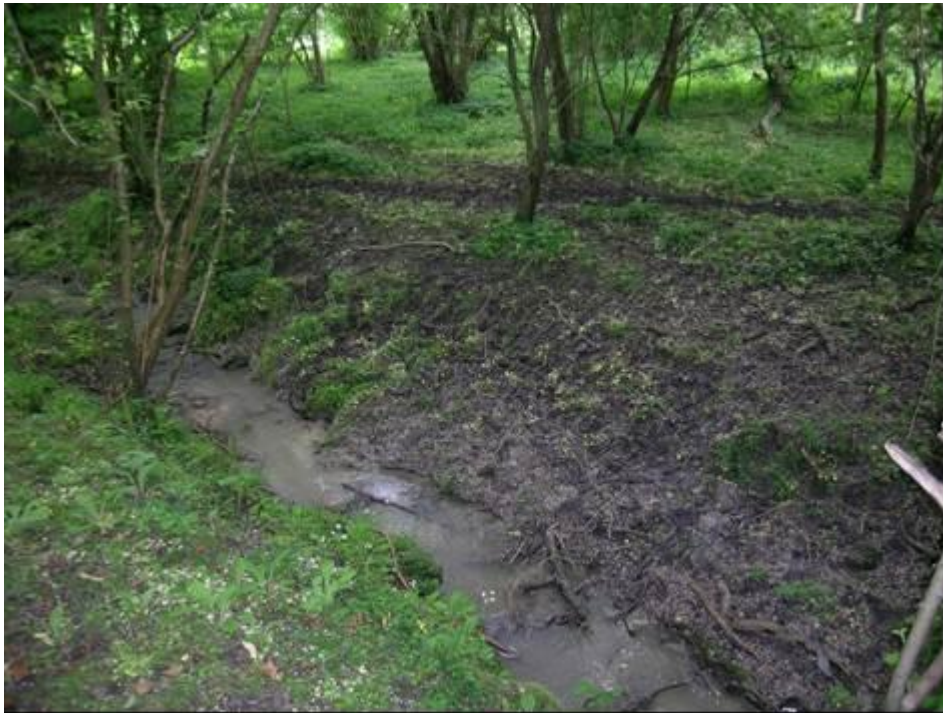
**Figure 11. Heavy localised livestock trampling.**

7. Consider options for controlling the heavy localised livestock trampling on the western arm. Although riparian fencing is undesirable and hinders any management of the riparian zone, some targeted set-back fencing and provision of troughs may alleviate the problem. There still needs to be allowance for livestock access through any fencing where needed to maintain a mosaic of sward height and some bare ground.
8. If not already known, commission a crayfish survey to ascertain distribution and meso-scale habitat utilisation within the Seabrook stream system. To include consideration of the impact of artificial structures on distribution and the extent to which natural habitat provision could be restored.

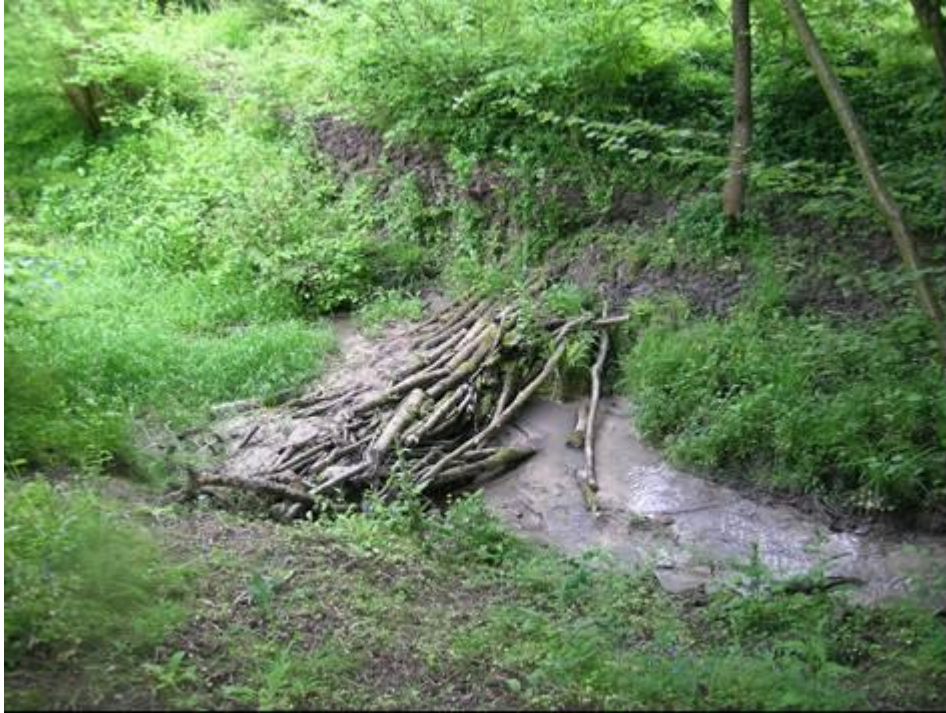
Physical impacts on the western arm include artificial crossings, one made from woody debris (Figure 12) and another built from stone (Figure 13). The woody debris crossing is essentially mimicking a natural woody debris dam, including undershot flow, and does not appear to be a major issue although undesirable. It is not clear whether the crossing is still used. The stone built structure is of more concern, generating a significant artificial barrier and morphological impact. The small-diameter pipe through the wall is heavily silted and must generate an impounding effect under high flows. The structure appears to have no on-going use.

**Figure 12. Artificial crossing created by fallen and cut wood.**

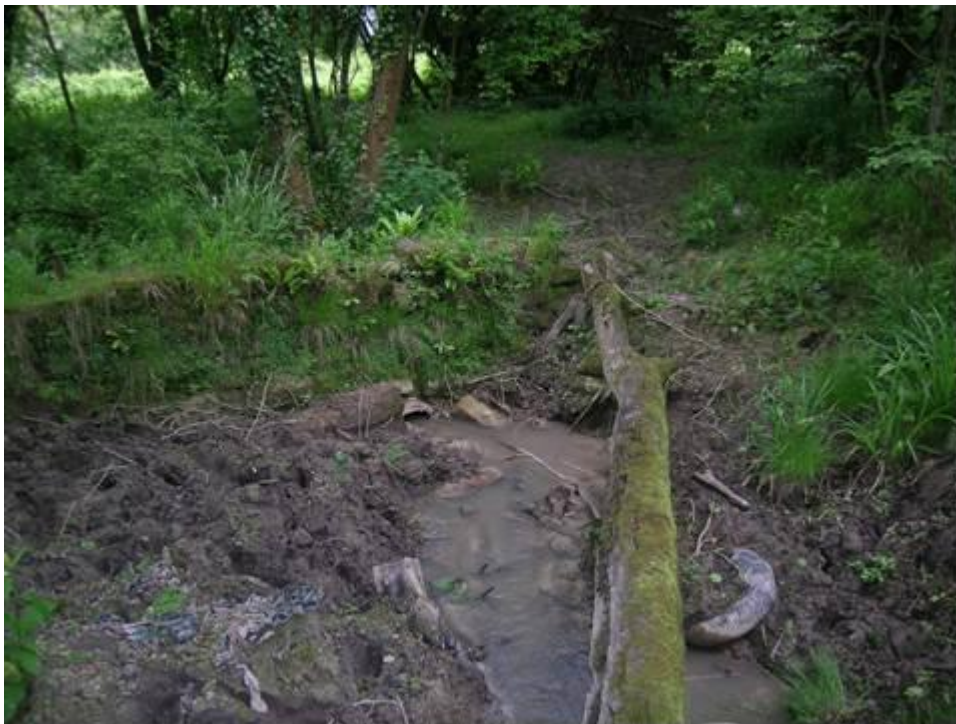
**Figure 13. Stone wall built across the stream, and the small diameter pipe intended to take the streamflow.**

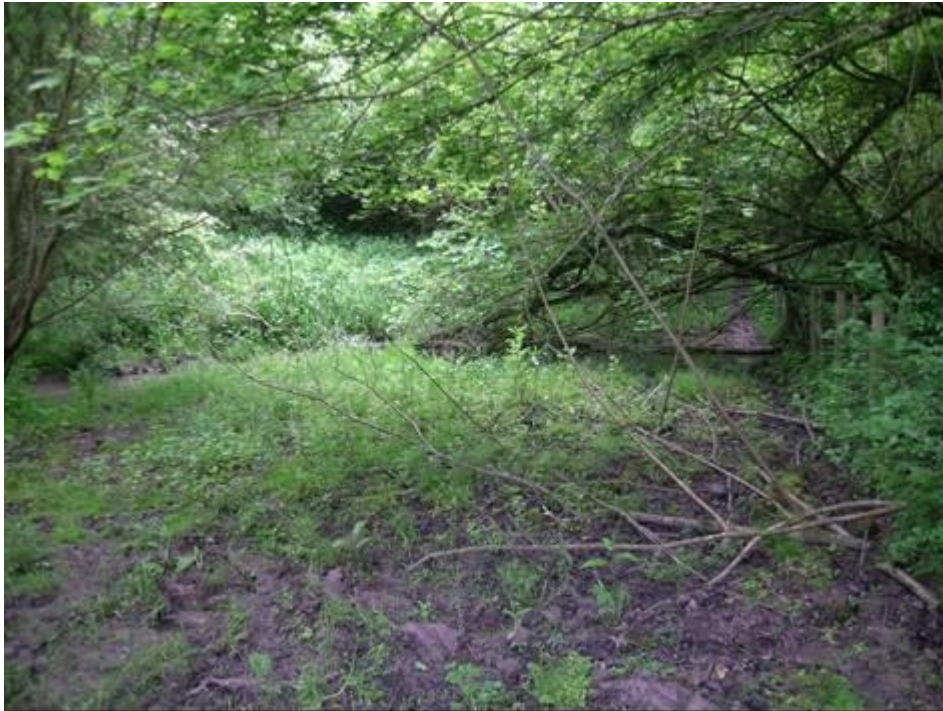
At the railway embankment, the stream runs into a further artificial impoundment that drops the stream into a scour hole immediately before the culvert under the railway (Figures 14 and 15). It is not clear to what extent this impoundment is responsible for the extensive wet and soft riparian margins that were evident at the time of the visit.

**Figure 14.** Riparian zone immediately upstream of the railway impoundment and culvert (impoundment is located at the fence line on the left).

1. Include the Seabrook Stream above the railway line in local refinements to the national priority river habitat map.
2. Through the NE notification strategy, include river habitat as a formal notified feature of the Seabrook Stream SSSI.
3. Plan for loss of ash trees in the riparian zone – consider replacement species that are most characteristic of the landscape. Alder or willow would be suitable ecologically.
4. Completely remove the abandoned impounding structure on the eastern arm of the eastern headwater to maximise naturalness.
5. If there is no on-going use, remove the stone and woody debris crossings on the western arm to restore natural stream function.
6. Consider modifications to the impoundment and culvert associated with the railway embankment. It may be possible to remove the impoundment entirely and restore water and bed levels.

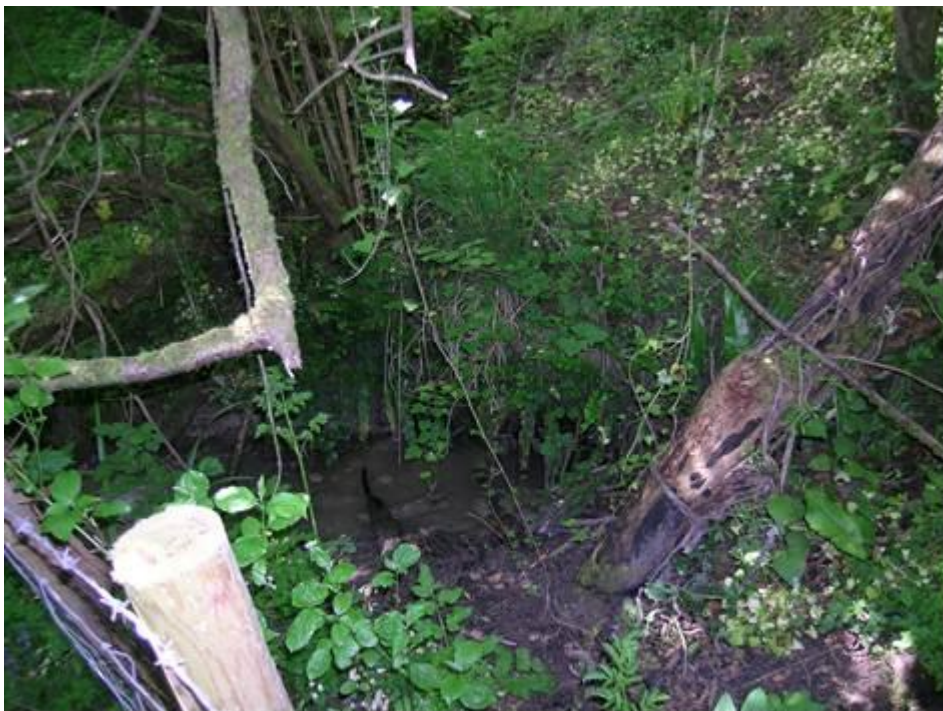
**Figure 15.** The fall from the impoundment into the culvert under the railway.

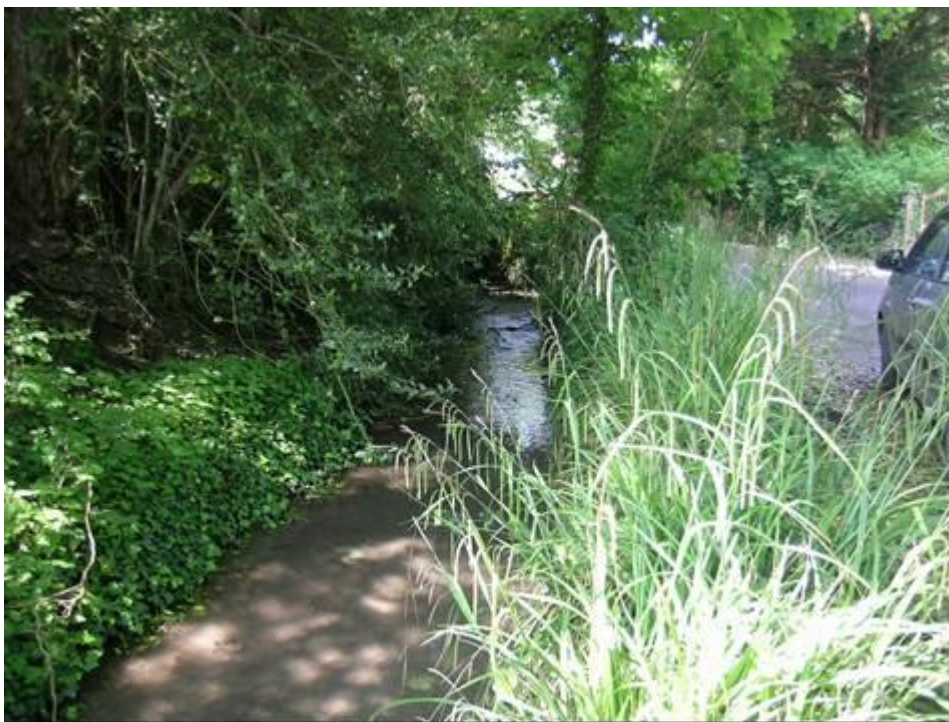
Downstream of the railway embankment, the stream flows through woodland. There was insufficient time to follow the stream through this section. Further downstream still, the stream runs through Frogholt (Figure 16). This section supports a healthy population of white-clawed crayfish, protected from signal crayfish and plague to a considerable degree by the isolation of the Seabrook Stream as a coastal stream with a hydrologically isolated catchment (although vulnerable to accidental or deliberate release of signals). Two adult crayfish were caught in a 15 minute handsearch (Figure 17). Natural habitat was somewhat lacking in this stretch, with few large cobbles, concretion of the substrate by tufa formation, and no large woody debris. The strength of the population here may be linked to the dry stone walling of the banksides, or else upstream habitat.

**Figure 16. The Seabrook Stream at Frogholt.**

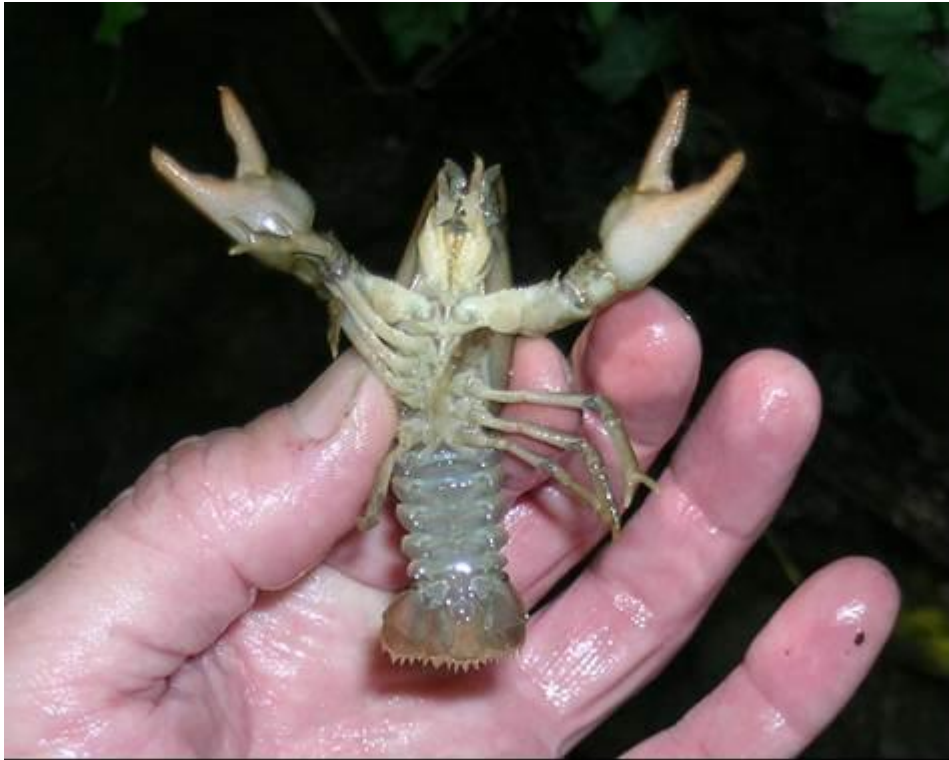
**Figure 17. White-clawed crayfish at Frogholt.**

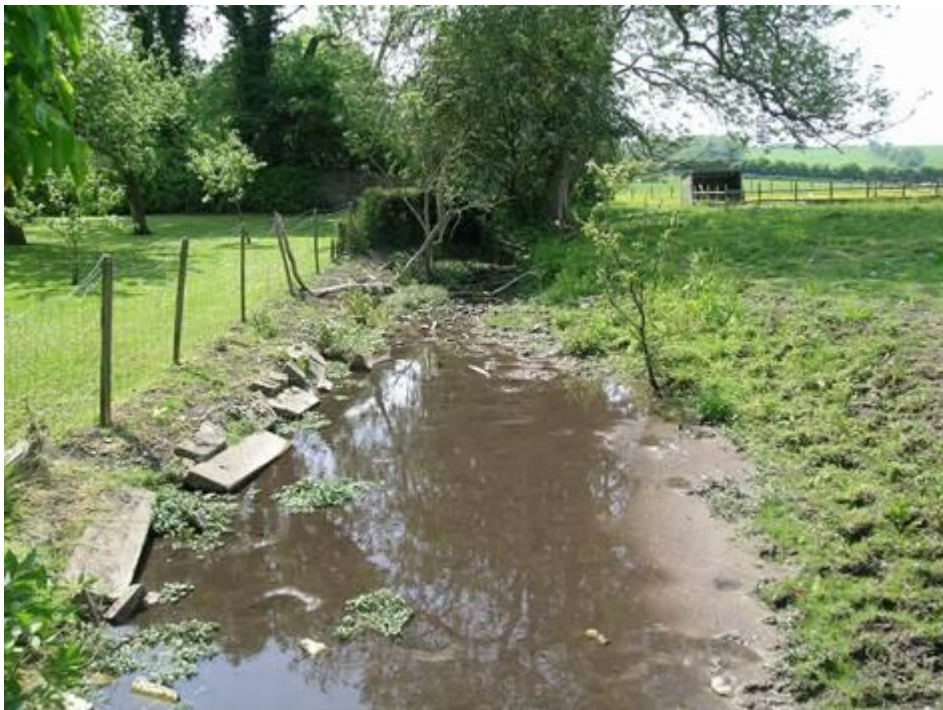
We inspected the stream near its source, within the village of Lyminge around TQ 161 400. The stream was highly artificial at this point (Figure 18) and not suitable for inclusion on the priority river habitat map or for consideration as SSSI. After inspection we decided not to drive downstream into the Elham Valley. The middle section of the Nail Bourne is known to be dry in most years, running on average 1 year in seven. This is too infrequent to be considered an ecologically important winterbourne.

**Figure 18. The upper Nail Bourne at Lyminge.**

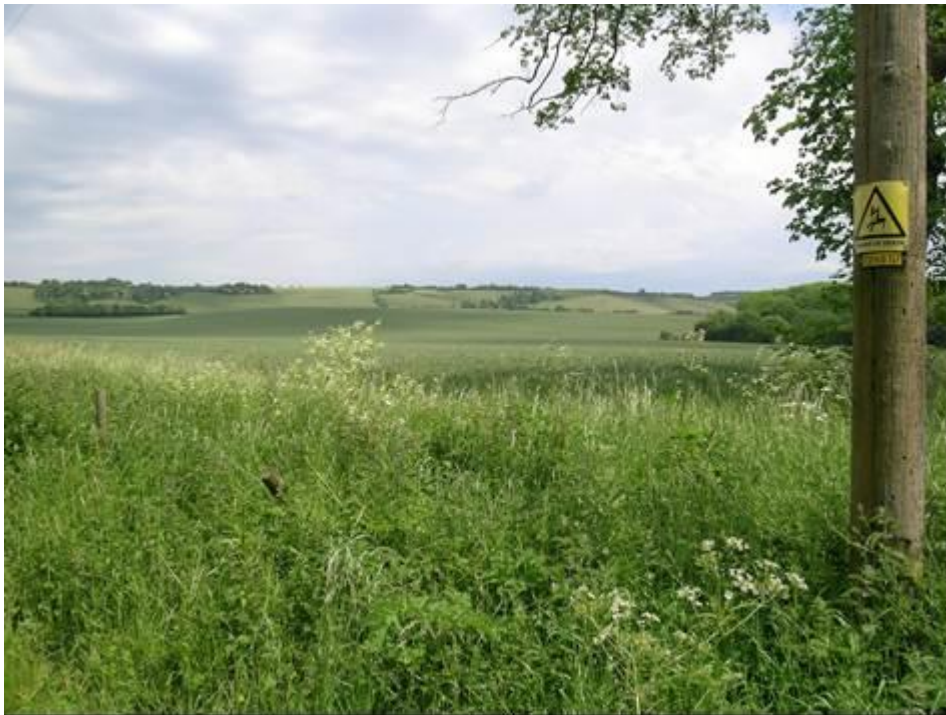
We walked to a headwater stream suggested by Tom Cook, south east of Maidstone and just outside of Broad Street at TQ 822 562. The immediate catchment is dominated by arable crops (Figure 19), although the upper section of stream runs through a block of dense woodland. There was insufficient time to venture into the woodland to examine the stream. Downstream of the woodland, the stream immediately runs into a ditch bordering an arable

**Figure 19. The catchment of the Len headwater.**

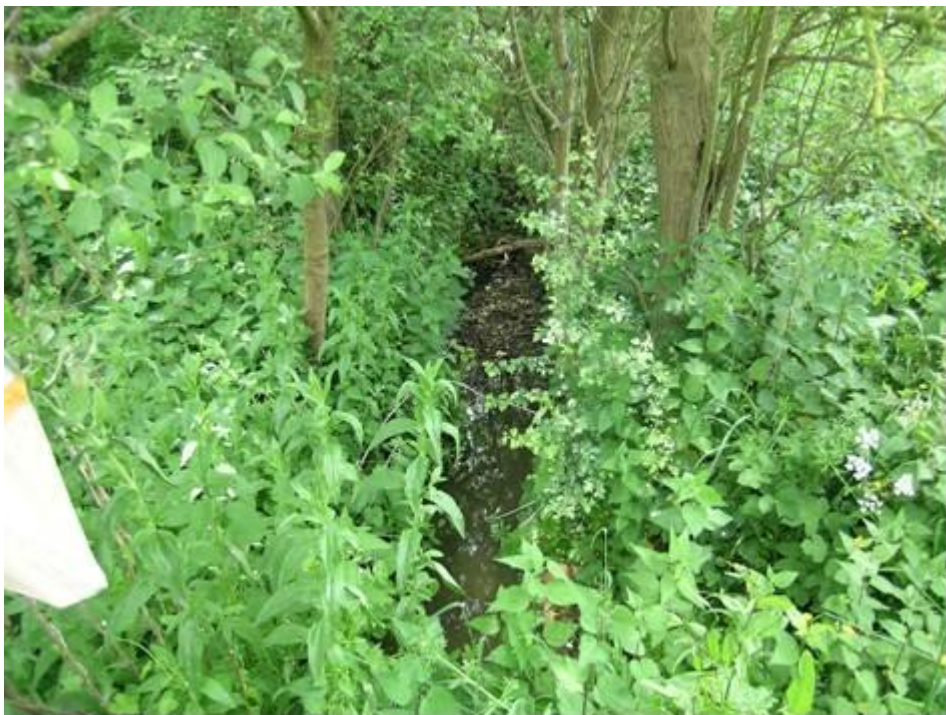
field and continues in this character downstream (Figure 20). It seems unlikely that the short section of stream running through the woodland block would warrant inclusion on the priority river habitat map.

**Figure 20. Ditched stream running between woodland and arable land, into which the stream running through the woodland discharges.**
