Gloucestershire headwater streams – site visits, May 2015

Kingscote Woods

Chris Mainstone (Senior Freshwater Habitat Specialist) Iain Diack (Senior Wetland Specialist) Natural England

April 2017

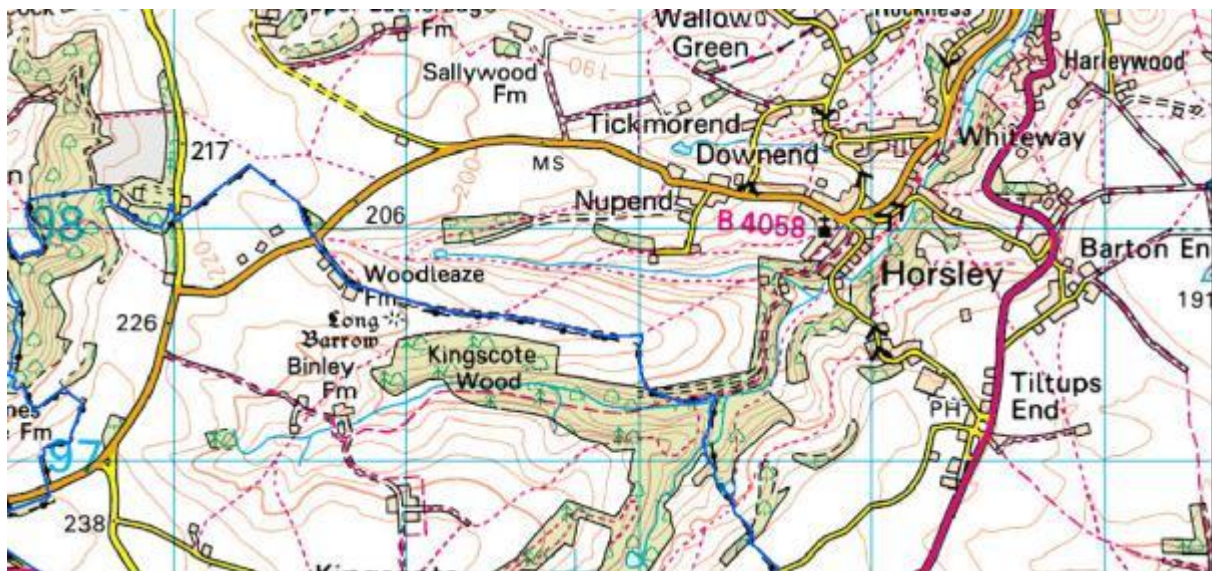
We walked up the stream from the bottom end of the wood at Horsley (ST 838 978) up to and through the top end of the wood at ST 822 973 (Figure 1), looking out onto the upper catchment. We had insufficient time to explore the springs at the top of the catchment, or the southern tributary and its springs.

Figure 1. The stream system in Kingscote Wood

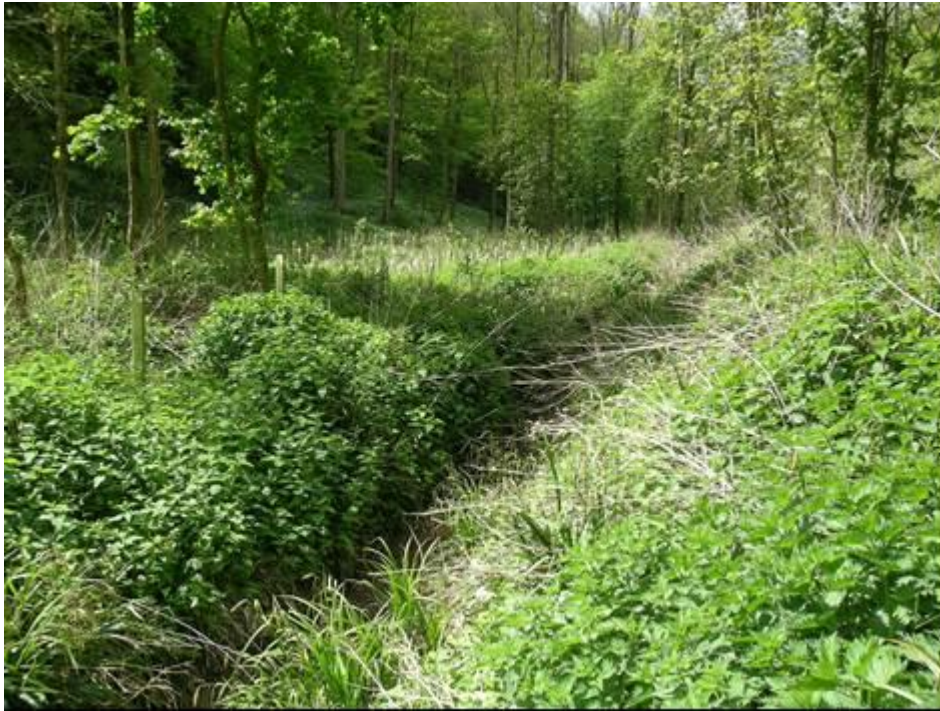
The downstream end of the stream is degraded through channelization associated with a poplar plantation (Figures 2 and 3). The stream habitat mosaic has been lost, as has hydrological connectivity with the steep banks. There are no bankside trees interacting with the channel, and no woody material in the channel to provide any habitat diversification. The disturbed banks, presumably covered in spoil from the stream, are dominated by nettles.

Figure 2. The deepened and straightened stream channel running through a poplar plantation.

Intervention is needed in the ditched channel running through the poplar plantation, to restore natural stream function. The additional of large woody debris dams at intervals along the channel should be sufficient to raise bed levels and initiate plan form movement, both necessary to restore the natural stream habitat mosaic. Observations at other sites in the locality demonstrate how efficient woody debris dams are at restoring bed levels, through the capture of coarse and tufaceous substrates delivered by the upstream catchment.

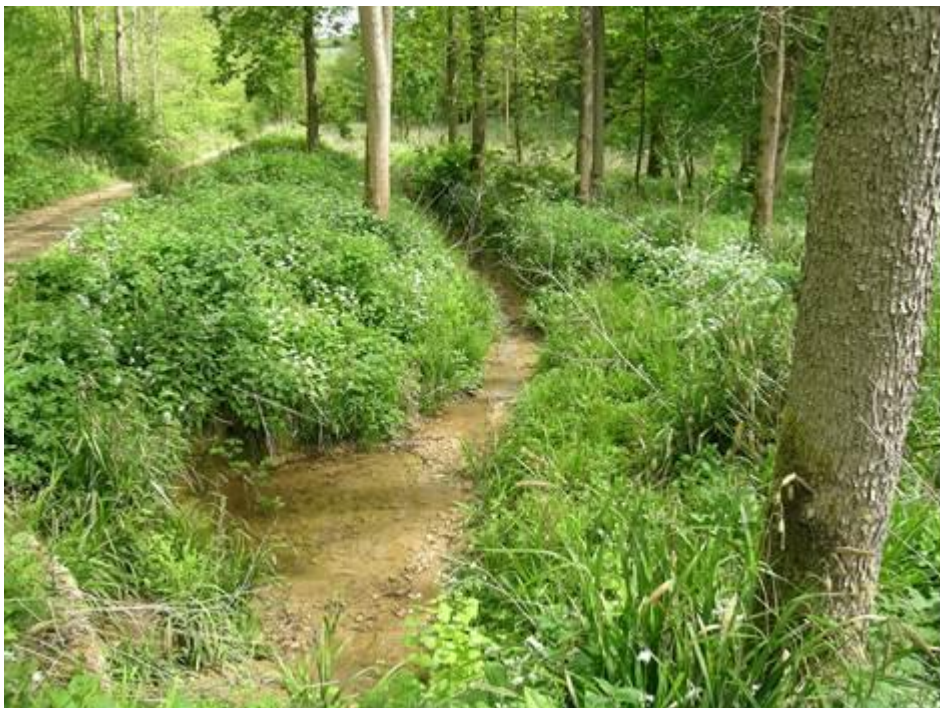
Figure 3. The top end of the poplar plantation looking downstream.

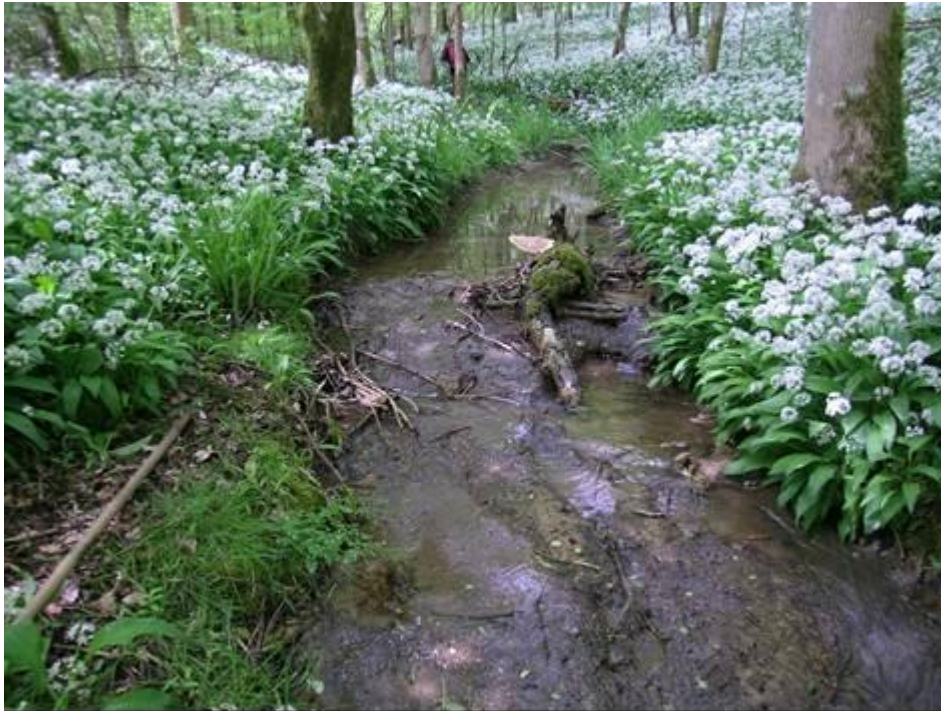
Upstream of the plantation, stream gradient increases and the woodland becomes semi-natural. The unmanaged channel contains reasonable amounts of woody material, creating variation in current velocities, bed substrates, and water depth. It is this variation that provides the habitat mosaic necessary to support the full range of characteristic biota.

Figure 4. The unmanaged channel upstream of the plantation.

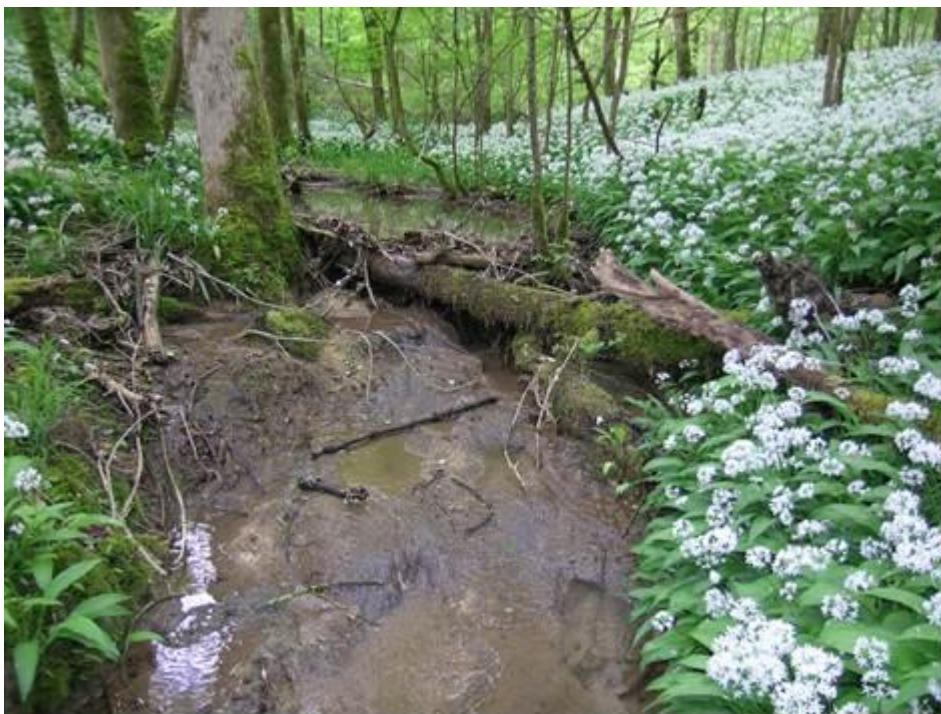
Further upstream, a fallen tree has created a partial dam, catching leaf litter and small woody debris and generating a scour-pool and riffle downstream. This combination of biotopes is characteristic of naturally functioning woodland streams. The leaf litter caught by the dam is fundamental to the trophic structure of the stream ecosystem, providing food for leaf-shredding invertebrates which in turn break the leaves down into assimilable nutrients for the rest of the food web.

Figure 4. Habitats created by a fallen tree.

Trees and woody debris - The importance of the interaction between standing and fallen wood and stream habitat is clear here as it is elsewhere in the headwater stream systems recently visited in Sussex and Kent. Fallen trees across mire and stream habitat should be left in place to generate characteristic habitat mosaics and provide dynamism in the stream/mire system. Debris dams should be allowed to develop and decay naturally.

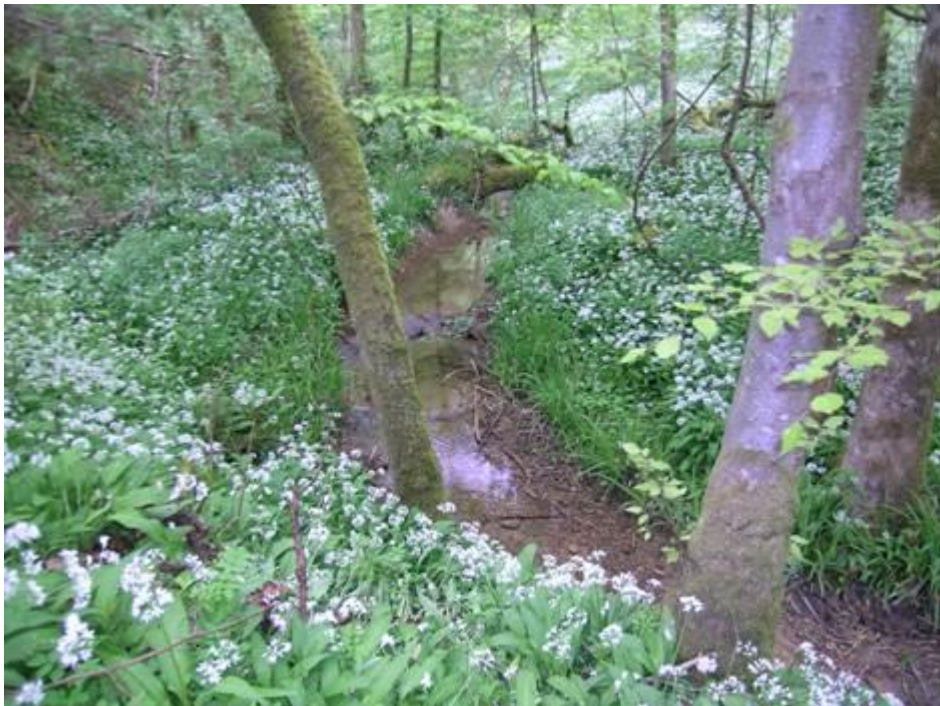
The shallow cross-section of the stream channel is very evident in the unmanaged stream section (Figure 5), providing a gradual change in hydrological conditions through the riparian zone that can be exploited by wetland flora and fauna (e.g. Scirtid beetles).

Figure 5. Shallow cross-section of the natural stream bed.

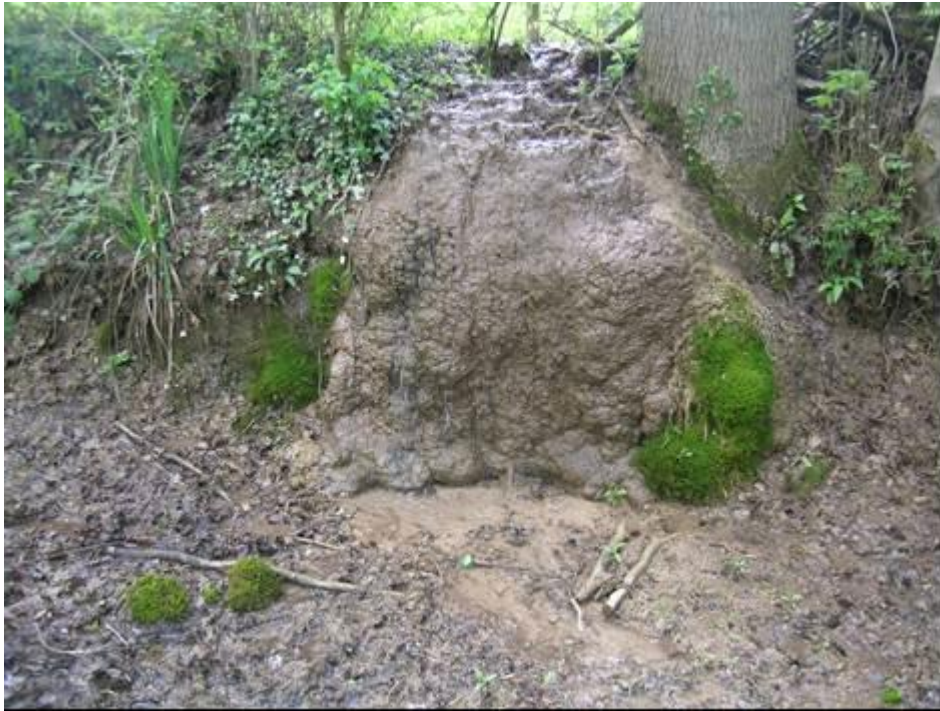
Tufa-forming springs feed into the main channel at intervals (Figures 6 and 7), associated with *Cratoneuron* moss which is indicative of the Habitats Directive Annex I habitat H7220 (petrifying springs with tufa formation).

Figure 6. Small tufa mound formed by a spring that drains into the main stream.

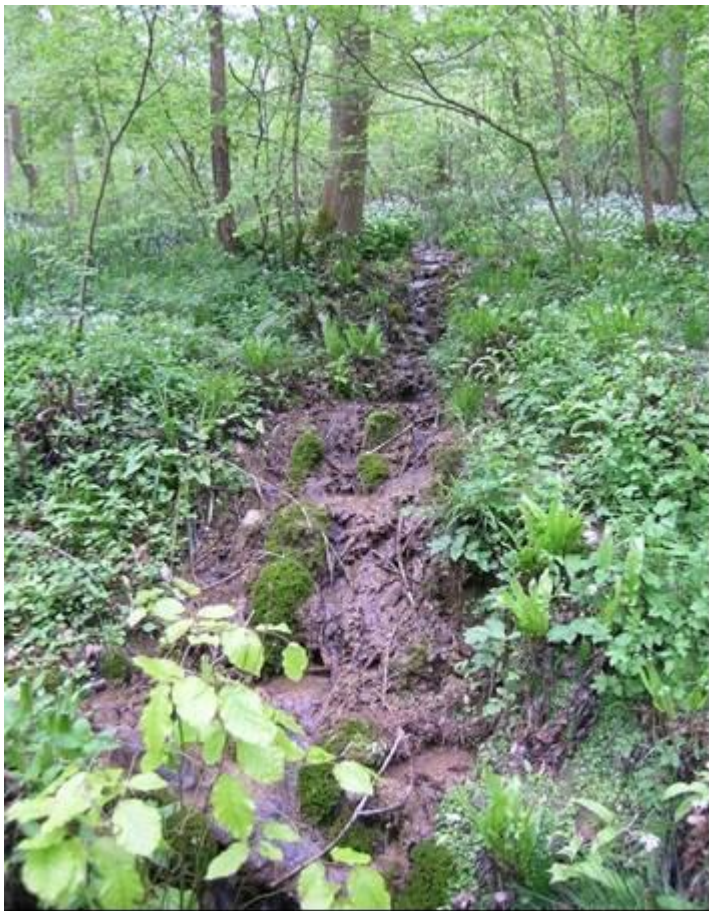
Figure 7. Tufa spring with Cratoneuron moss running down into the main stream.

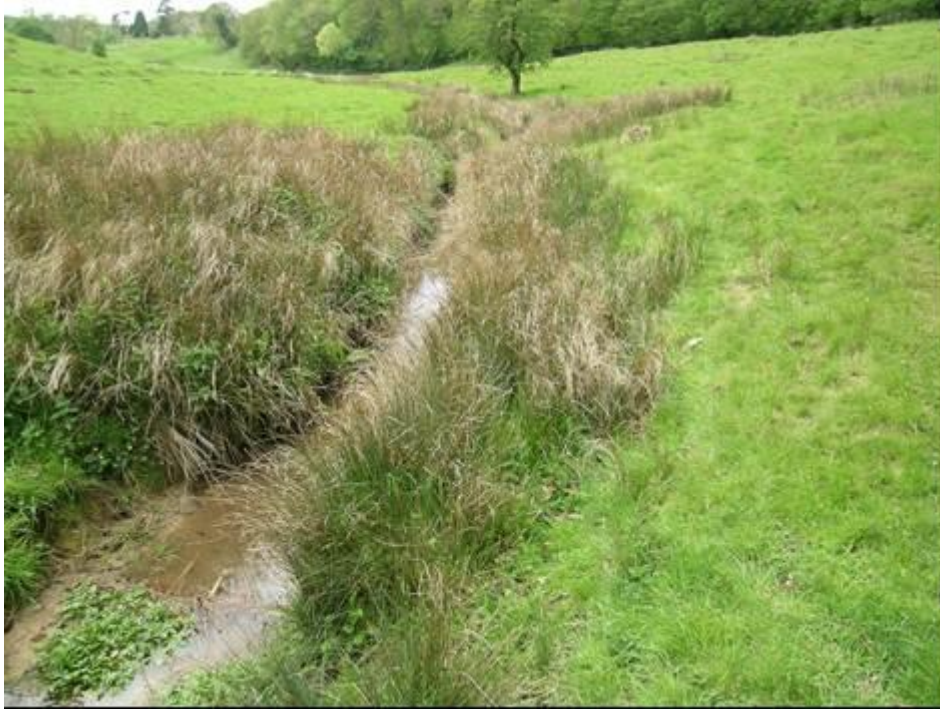
Coming out of the top end of the wood into open land, the stream still appears relatively unmodified, with shallow cross-section and well-vegetated shallow banks (Figure 8). The lighter conditions allow some submerged higher plants to grow, including less water-parsnip. The shallow banks provide a niche for marginal plants such as brooklime to establish, which characteristically encroach into the channel as flows recede through the summer months.

Figure 8. The stream running through the upper catchment.
