Gloucestershire headwater streams – site visits, May 2015

Strawberry Banks

Chris Mainstone (Senior Freshwater Habitat Specialist), Iain Diack (Senior Terrestrial Wetland Specialist), Natural England

April 2017

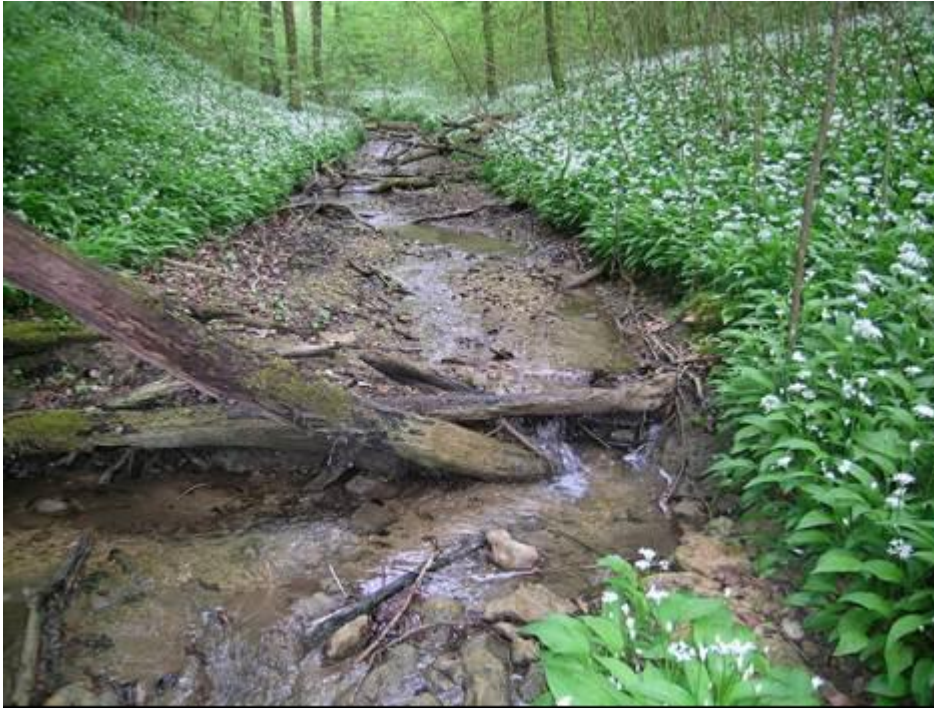
The stream is extremely strongly tufa-forming, set in a v-shaped valley cloaked in broad-leaved woodland with an understorey dominated by wild garlic (Figure 1). The stream is completely unmanaged, with an abundance of woody material in the channel. This material has a strong influence on stream morphology and hence habitat provision.

Figure 1. Tufa deposition and woody material in the channel (channel looking suspiciously straight at this point).

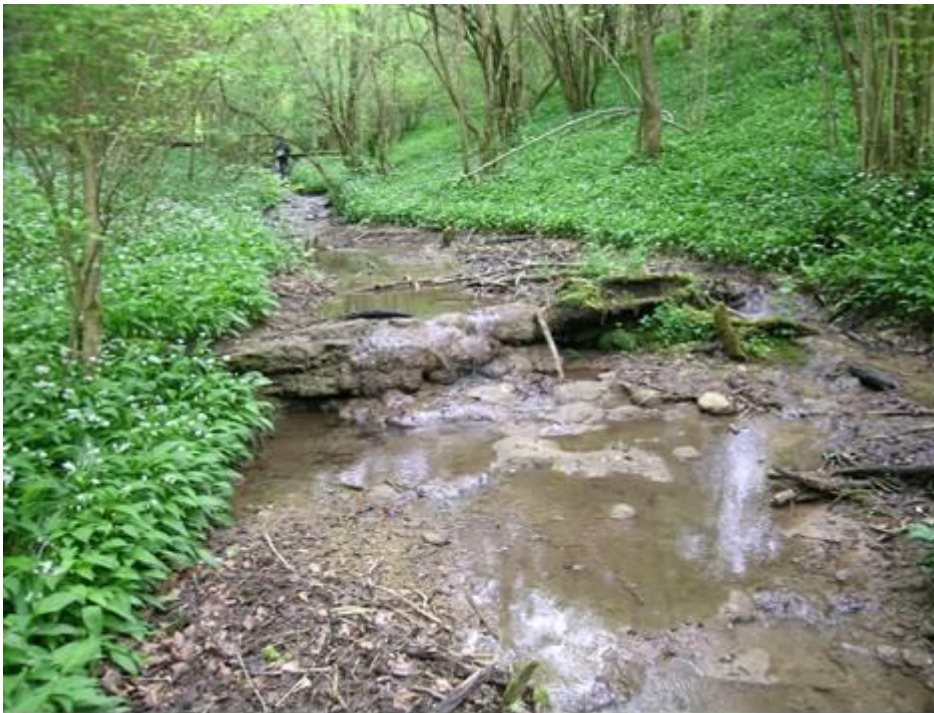
The intensity of tufa deposition is evident from the fallen tree in Figure 2, which has taken on the appearance of solid rock. The tufa has a heavy influence on bed substrates, which are concreted together to a large extent.

Figure 2. Tufa deposition on a fallen tree.

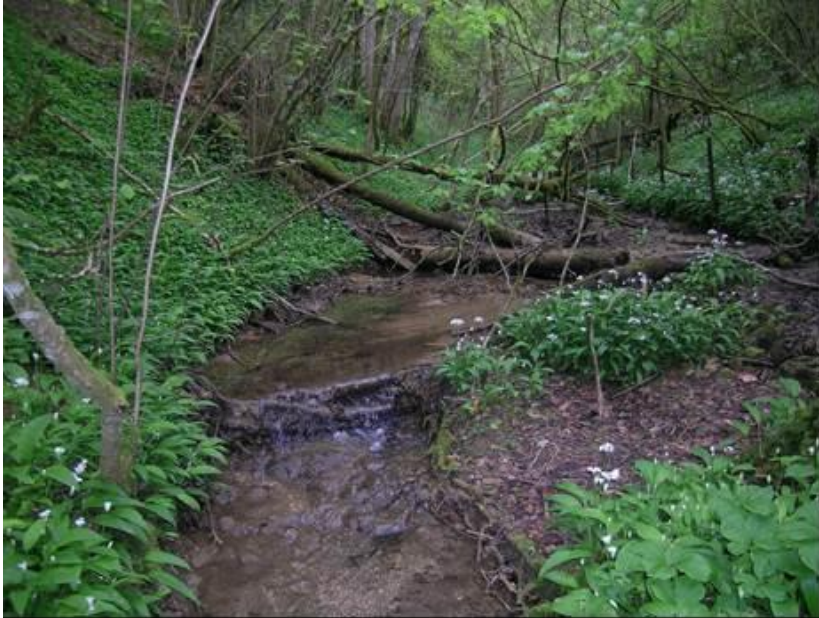
In addition to shaping habitat mosaics within the channel, woody debris dams are clearly important in maintaining and elevating stream bed levels (Figure 3). As dams

form, sediment from upstream infills behind and creates a step in bed levels. As this sediment is relatively coarse the elevated bed is typically firm and relatively well-aerated, and so suitable for a range of characteristic stream invertebrates. Below the dams, scour pools and associated downstream riffles are created, adding to habitat diversity.

Figure 3. The effect of a debris dam on stream morphology and hence habitat provision.

Trees and woody debris - The importance of the interaction between standing and fallen wood and stream habitat is clear here as it is elsewhere in the headwater stream systems recently visited in Sussex and Kent. Fallen trees across mire and stream habitat should be left in place to generate characteristic habitat mosaics and provide dynamism in the stream/mire system. Debris dams should be allowed to develop and decay naturally.

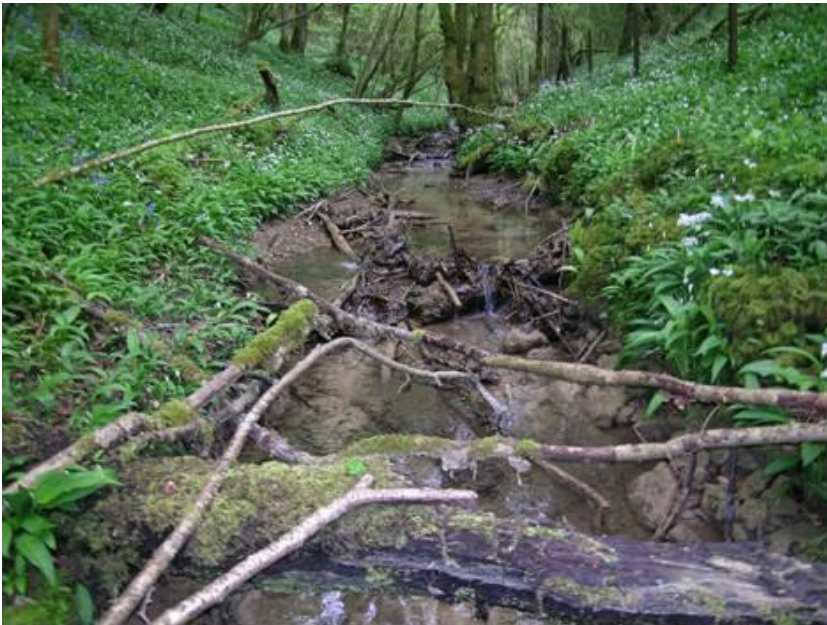
Figure 4. Further stepping in bed levels mediated by woody debris in the channel, with associated depth and hydraulic variation in habitat conditions.

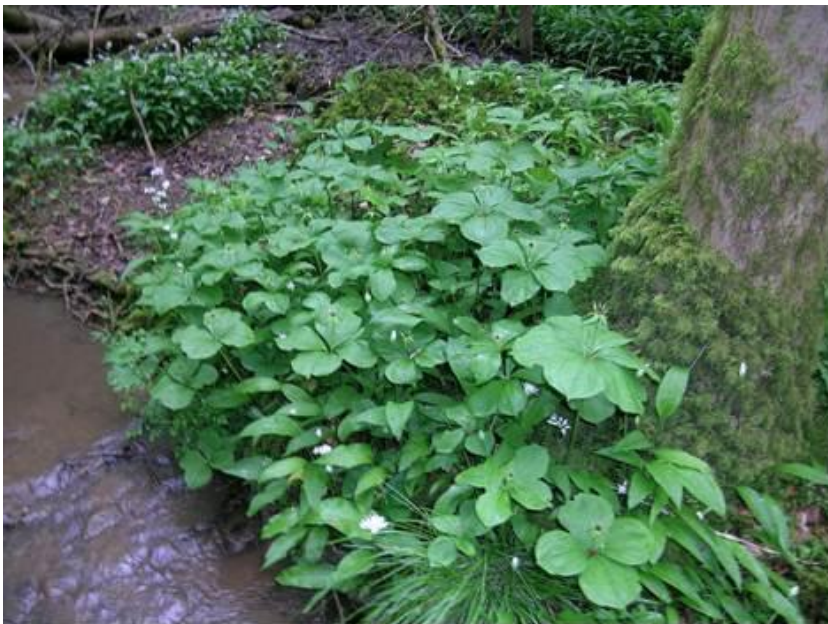
The riparian flora is extensive, including herb paris (Figure 5). Within the stream there is no developed aquatic higher plant vegetation, which is typical of wooded headwater streams with high levels of shading. The strong tufa-formation also appears to limit

Figure 5. Herb paris on the stream bank.

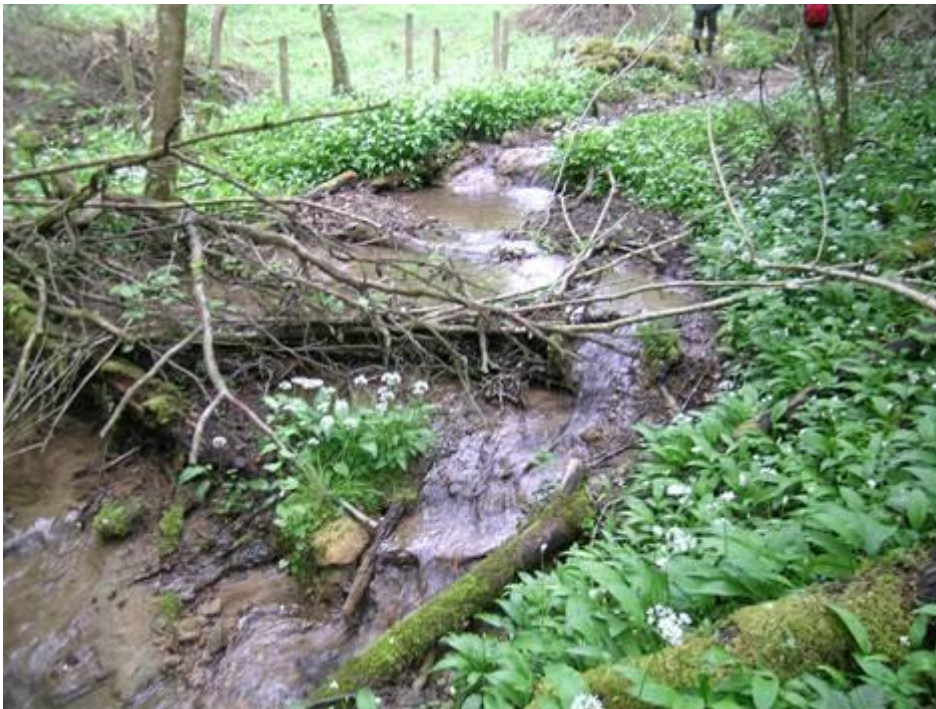
Figure 6 shows the effects of fallen wood on channel planform. This planform movement generates channel sinuosity that is critical to the full expression of stream habitat extent and characteristic habitat mosaics in headwater streams. The sinuosity creates variation in hydraulic energy across the channel, which creates differential hydraulic scour on the stream bed and banks, which in turn creates diversity in water depths, substrates and bank profiles. These processes provide the characteristic variety of habitat niches needed to support the full range of species characteristic of the stream.

Figure 6. Woody material initiating channel planform movement.

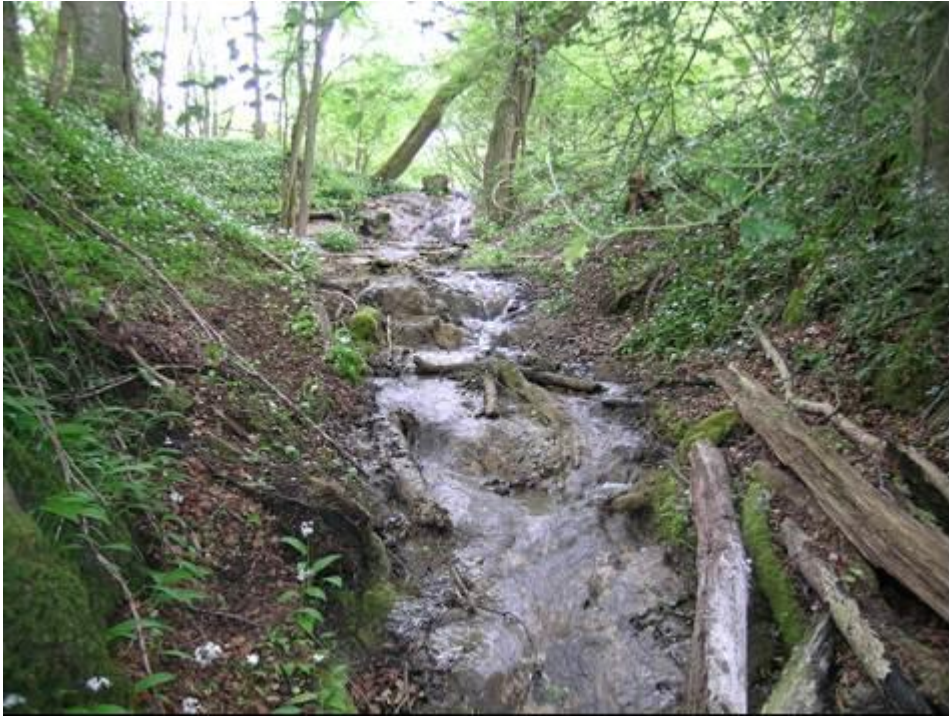
At the upstream end of the section we walked, stream gradient increases considerably and the channel forms into a tufa chute (Figure 7 and 8), which has no loose bed substrates but rather is composed of smooth tufa concretion. A remarkable natural geological and geomorphological feature, with an algal biofilm that creates interesting specialist habitat opportunities for invertebrates.

Figure 7. Tufa chute.

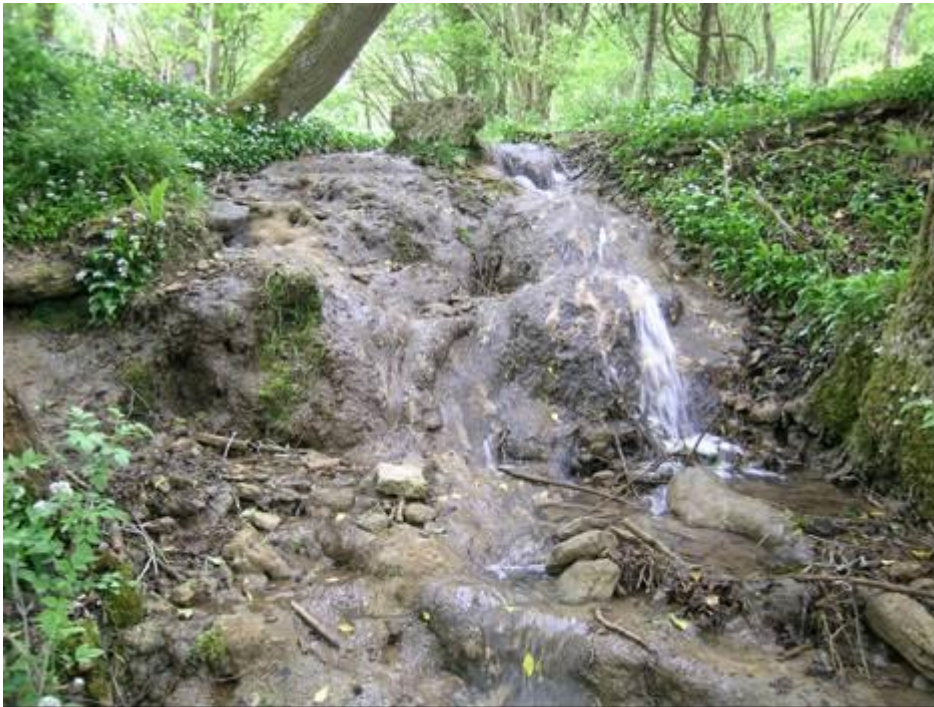
Figure 8. Top end of the tufa chute.

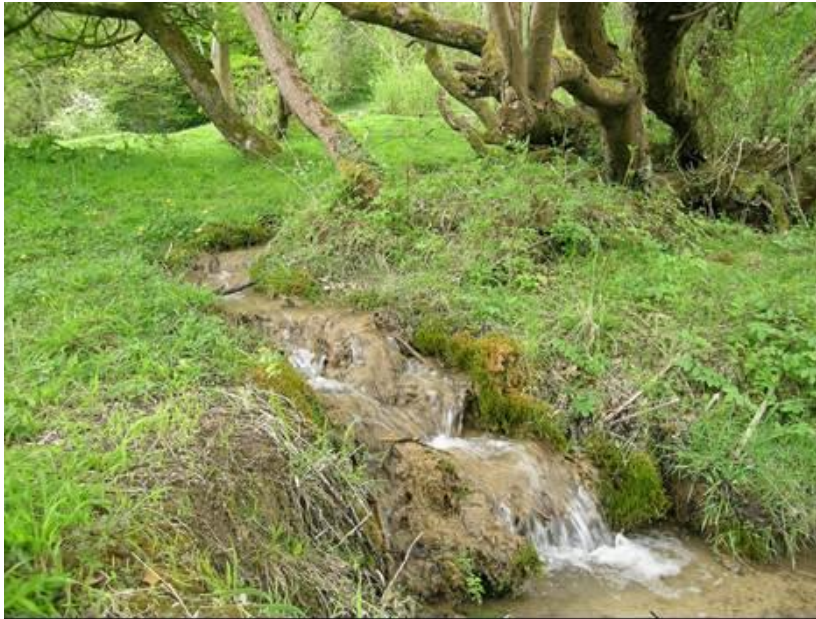
The side-stream runs through semi-natural grassland, with occasional riparian trees (Figure 9). The small channel is dominated by tufaceous deposits, associated with an abundance of the orangey green *Palustriella commutata* moss which is indicative of the

Habitats Directive Annex I habitat H7220 (petrifying springs with tufa formation)¹ and can be seen in Figure 9 on mounds at the edge of the channel.

Figure 9. The tufa-dominated side-stream.

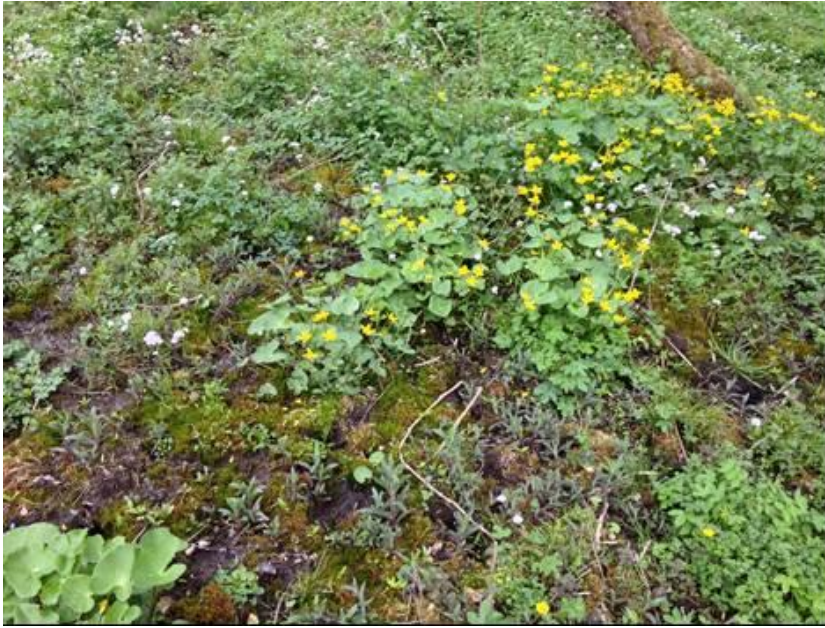
Patches of base-rich fen vegetation occur around springs and areas of impeded drainage, with much *P. commutata* alongside meadowsweet, water mint, lesser water-parsnip, marsh marigold, and an abundance of marsh valerian. The vegetation is weedier than would be expected, possibly as a result of regular heavy poaching (see hoof prints in Figure 10).

Figure 10. Base-rich fen on spring mound. Poaching evident with frequent willow-herb.

Grazing - While some grazing may be necessary to maintain open herbaceous fen, stock trampling can very quickly destroy small, bryophyte-dominated low-nutrient spring and seepage features. Even if not completely destroyed, poaching tends to allow weedy species into the vegetation which if nutrient levels allow can dominate. Stock numbers should be set at a level which avoids anything more than very minor trampling on these rare and easily damaged features.

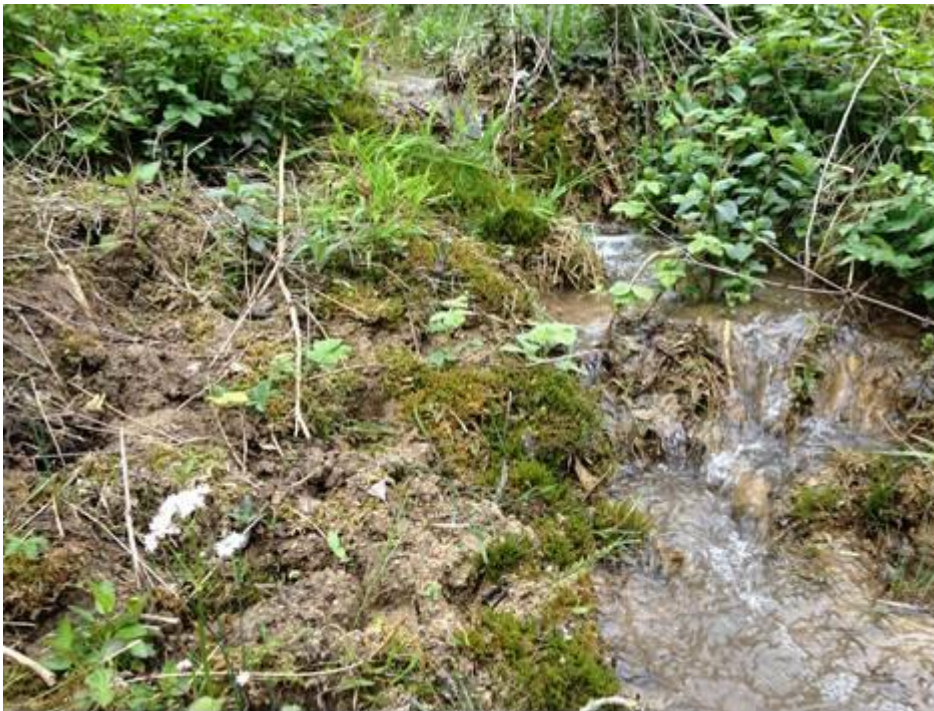
Figure 11. Some damage to tufa is also evident in the stream, again probably a result of stock trampling.

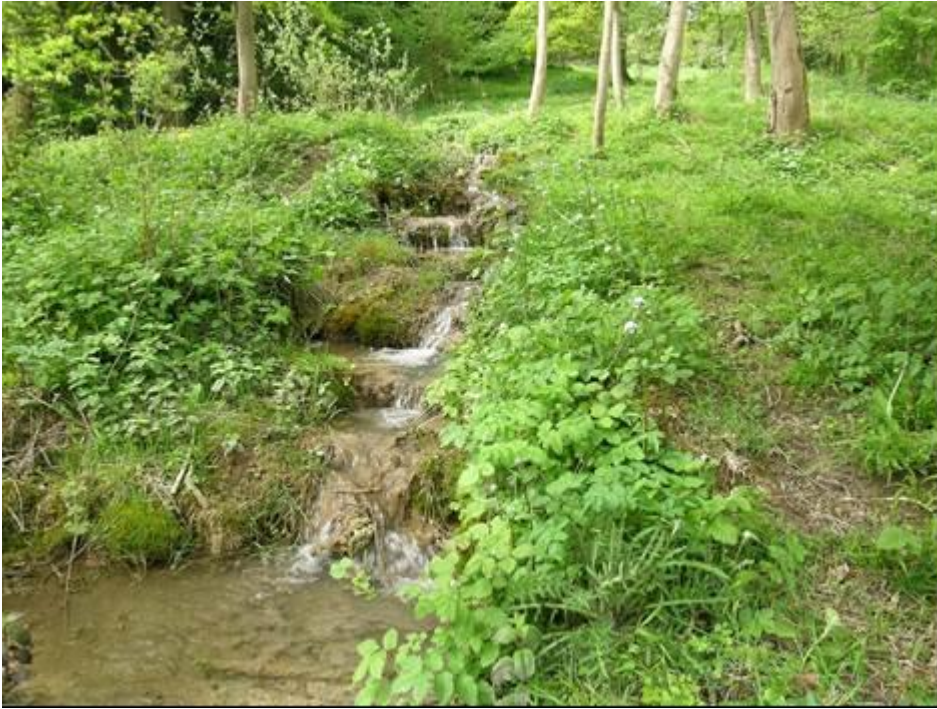
The stepped nature of the stream bed is again apparent (Figure 12), although the origin of this is not so evidently woody material on the stream bed (perhaps it has a bedrock origin here).

Figure 12. Streambed steps forming a cascade.

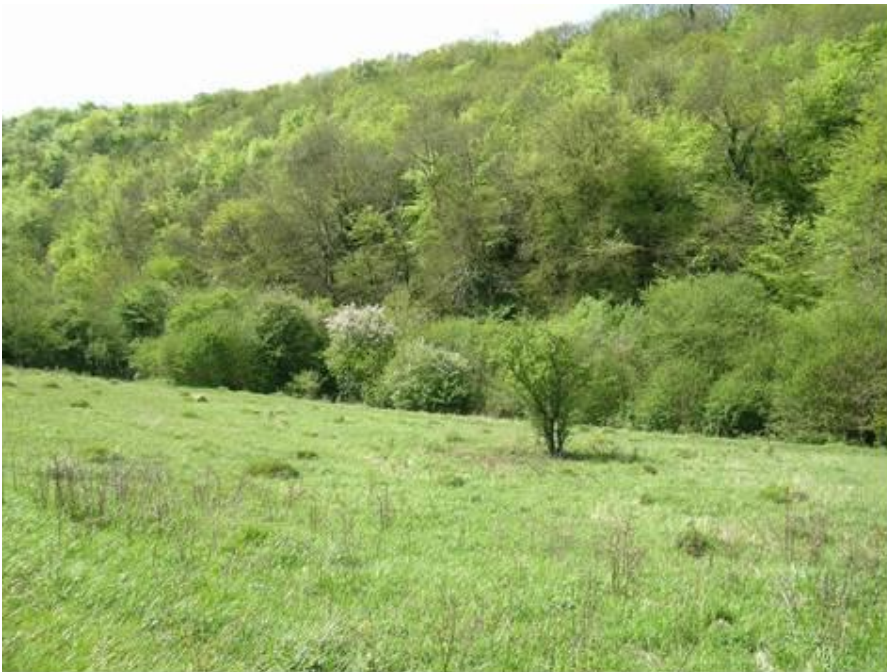
Walking back through Strawberry Banks NNR, we had a good perspective on the position of the stream between the flower-rich limestone grassland and the woodland trust reserve (Figure 13). The colony of marsh fritillaries were just emerging (Figure 14) – we saw around 40 on the wing.

Figure 13. The view of the stream valley from Strawberry Banks NNR, with the Woodland Trust reserve in the background.
