Specialist site visit – Teme tributaries, 8 and 9 June 2016

We visited sites in the Clun and Onny catchments, to get a feel for their potential in terms of beneficial extensions to the River Teme SSSI (particularly in relation to connecting with headwater mires) and mapping priority river habitat, and to characterise and discuss management issues and their resolution.

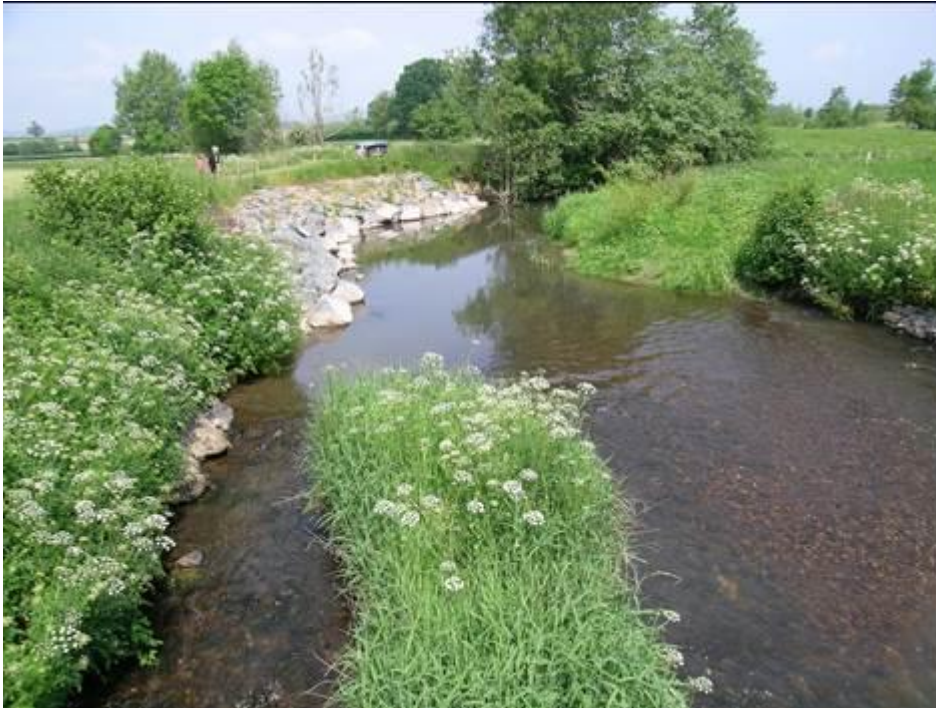
At Jay's Bridge (NGR SO 394 497), works have been undertaken to prevent further lateral erosion into the road (Figure 1). Attempts at securing a strategic solution by setting the road

back could not secure sufficient land to allow natural processes to continue in parallel with a set-back tree-planting scheme. The result has been significant expenditure on minor road relocation but with conventional rock armouring of the bank. The case highlights the importance of securing a long-term strategic solution so that natural habitat function can be properly restored, for the benefit of both the pearl mussel population and the wider characteristic biological assemblage of the channel and riparian zone.

Figure 1. The Clun looking upstream from Jay's Bridge.

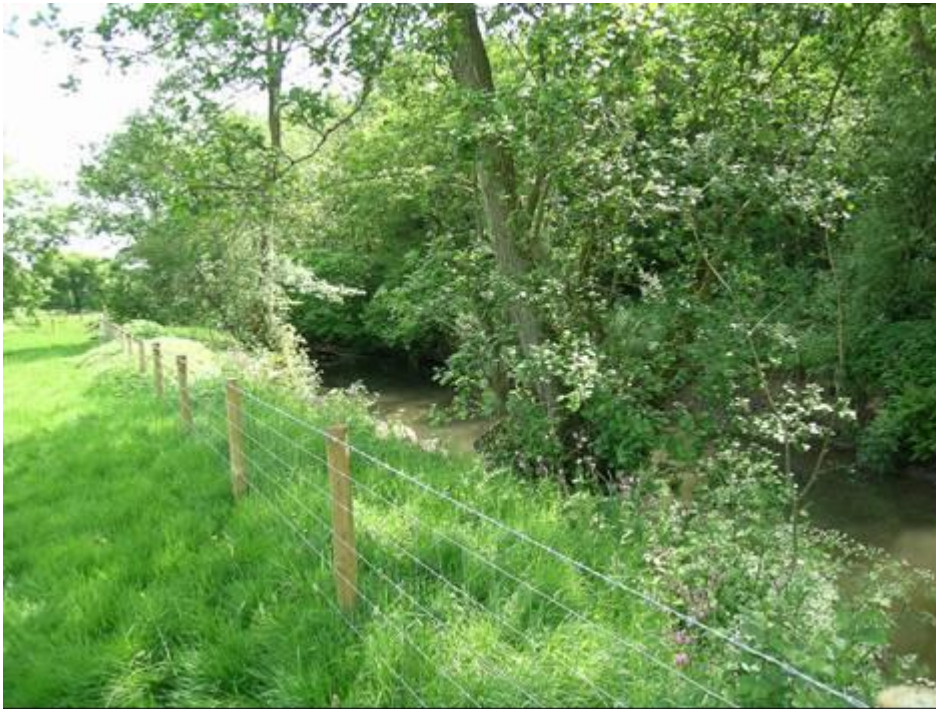
At this site (Figure 2), bankside fencing has been installed prior to determining which in-channel measures would be most appropriate. The site is challenging because the channel has historically been pinned to the side of the floodplain, and perched above the floodplain (Figure 3) to provide head for an old watermill further downstream. The desired long-term strategic option in such circumstances is to restore the channel to its dynamic meandering behaviour within the floodplain, which would generate the characteristic habitat mosaic within which pearl mussels would find their niche (as far as the river at this point would naturally provide for the species).

Figure 2. Close bankside fencing at Lawn Farm.

The fencing has been located close to the bank top, with little space for the development of riparian habitat. Large woody material (a fundamental building block of natural river habitat mosaics) has apparently been removed from the channel. A large trunk remains fallen across

However, in this instance a mitigation option has been adopted, which because of the perched nature of the channel requires that the planform of the river is fixed (otherwise the channel would erode its retaining bank and drain to the lowest point of the floodplain where it used to be).

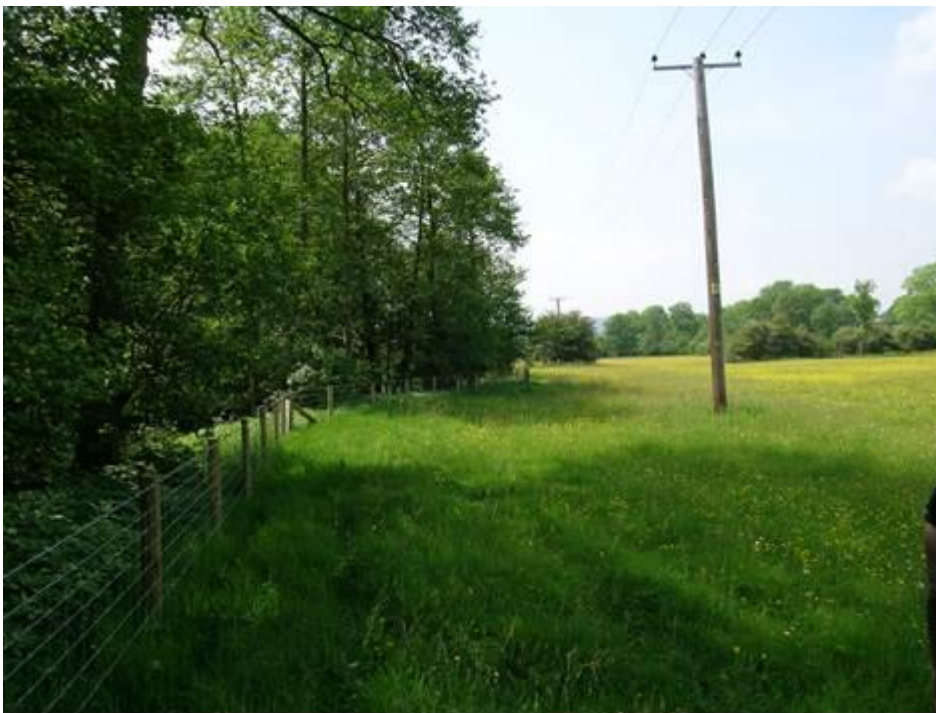
Figure 3. The perched channel (left) sitting above the floodplain meadows.

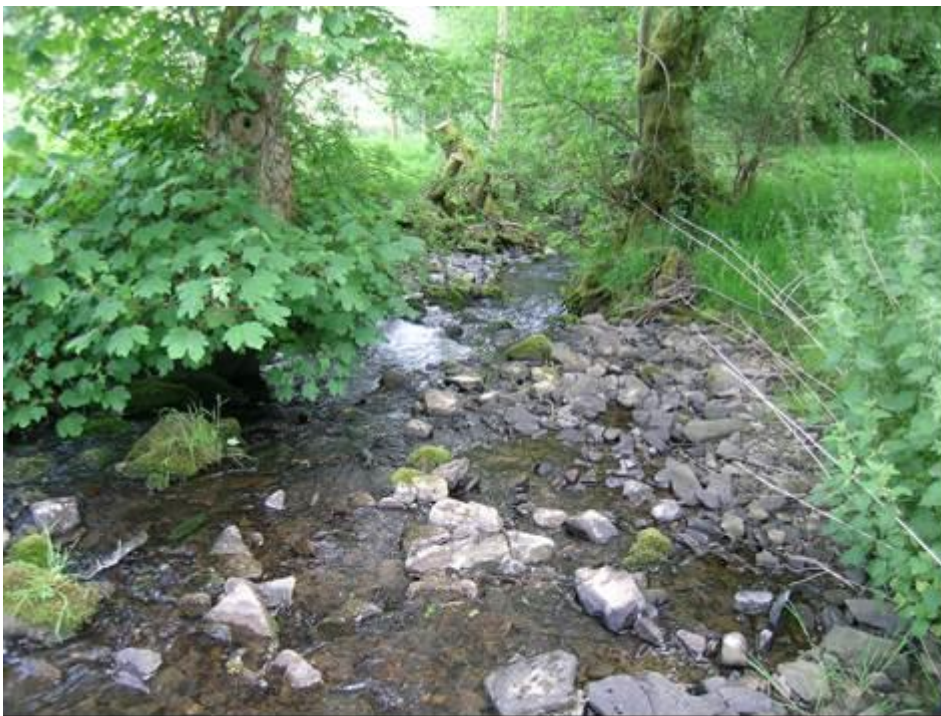
We inspected Folly Brook approximately halfway up its length. This is reported to be the most naturally functioning headwater of the Clun system, which was apparent at this point (Figure 4). The brook has a good gradient with high riparian tree cover, generating an excellent habitat mosaic dominated by cobble/boulder substrate, exposed tree root systems, good depth variation, exposed sediments, moss-covered boulders and woody material in the channel. A brief kick-sample recorded a good diversity of invertebrates reflecting the swift-flowing nature of the brook: river limpets (*Ancylus fluviatilis*), caseless caddis-flies (*Hydropsyche siltalai* and at least one other Hydropsychid, probably *H. pellucidula*; *Ryacophila* sp.), cased caddis-flies (Odontocerids, Limnephilids), stoneflies (the predatory *Chloroperla torrentium* as well as Leuctrids, probably a mixture of *L. hippopus* and *L. moselyi*), mayflies (*Ecdyonurus torrentis*, *Rithrogena semicolorata*, *Seratella ignita*, *Electrogena lateralis*? Baetids), numerous blackfly larvae (Simuliids), freshwater shrimps (*Gammarus* sp.), alder-flies (Sialidae) and Elmids beetles. Some of these species clamp onto larger cobbles and boulders whilst others inhabit the interstices within coarse substrates. The net-spinning Hydropsychid species form part of a known longitudinal sequence of species within the family from source to mouth in large British rivers – other species are typically found upstream of them (*Diplectroma felix* and *H. instabilis*) and downstream of them (*H. contubernalis* and *Cheumatopsyche lepida*) and may well be present in the Clun/Teme system.

Figure 4. Middle reaches of the Folly Brook.

The Folly Brook is worthy of its inclusion on the priority river habitat map. It would be worth considering what might be done to improve the connectivity of the brook to Rhos Fiddle by restoring the seepage zones on the valley side. The mire-stream transition at the southern end of Rhos Fiddle could be restored to create a natural transition catering for all wetland elements of the transition zone. This would involve blocking the channel below the boundary line to a point at which natural stream formation is likely, and removing the stone structure. This may be achievable by the use of native large woody material in the channel.

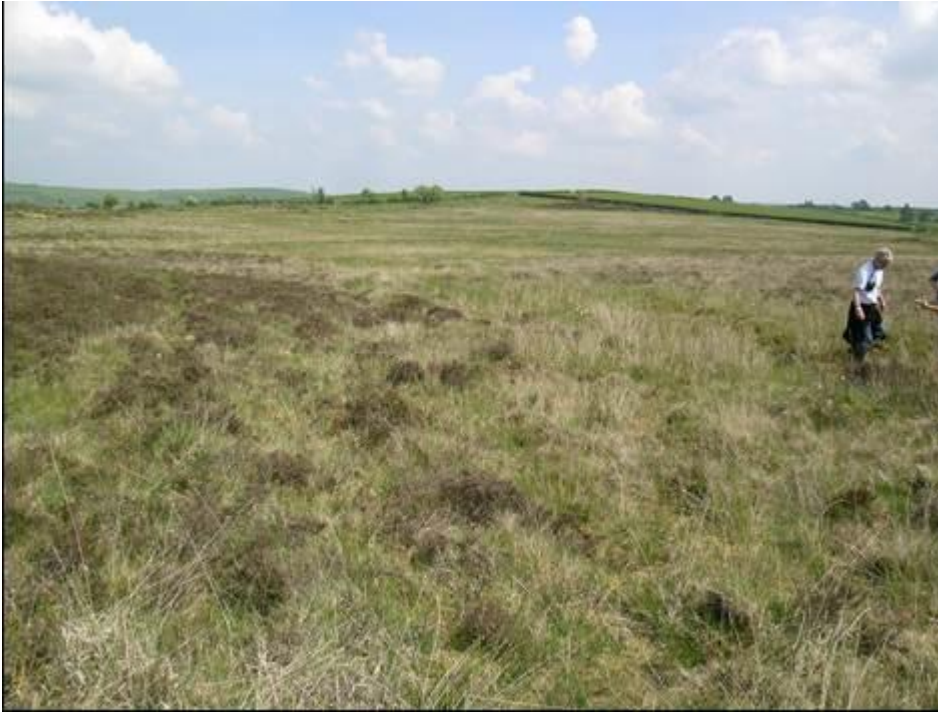
At the top of the Folly Brook, at the watershed between the brook itself, the upper Clun and other headwaters flowing westwards away from the Clun catchment, Rhos Fiddle is an area of common land (Figure 5) that is recovering from decades of overgrazing and burning an uncontrolled hot burn some years ago. The vegetation across the site is increasingly being recolonized by *Sphagnum* species, which intriguingly are not those of 'wet heath' (which may have been expected given the site's previous appearance as 'dry' heath) but rather those of mires, such as *S. cuspidatum* and *S. fallax*, and some of which are peat-building species, such

as *S. papillosum*. It is anticipated that this natural recovery will continue and *Juncus* will be outcompeted by *Sphagnum* will continue to increase in cover over time due to the lack of trampling and grazing pressure. Some historical drains are apparent which need to be blocked to allow full restoration of mire habitat and peat formation.

Figure 5. Rhos Fiddle looking north from the centre.

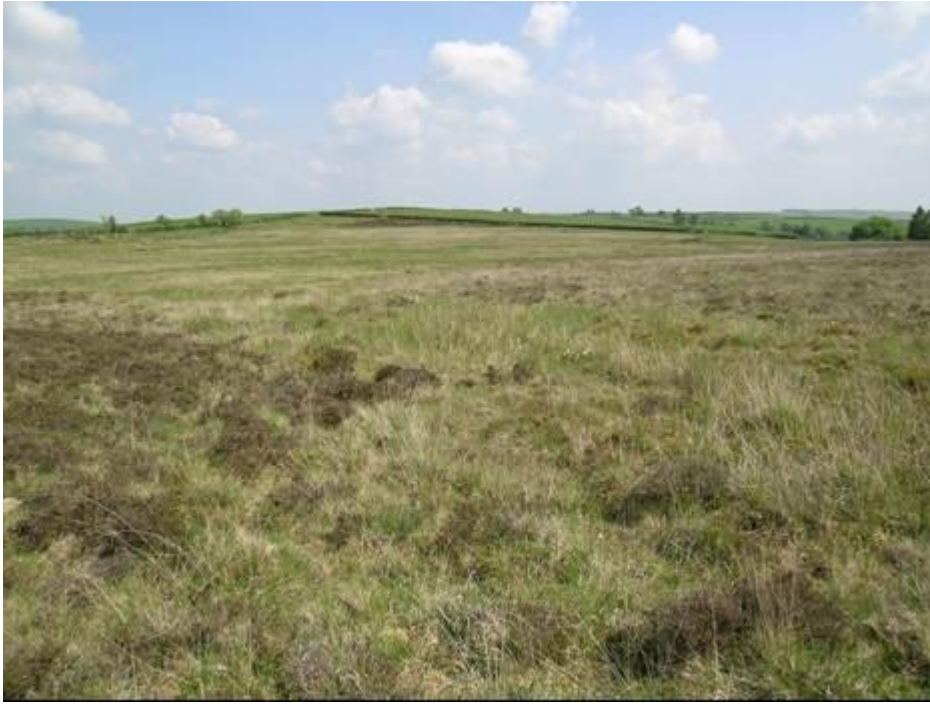
In the southern area of Rhos Fiddle, hydrological pathways coalesce to form the wettest part of the site (Figure 6), draining into a channel on the southern boundary. Within the site the beginnings of the mire-stream transition appear natural (Figure 7), but at the boundary of the site there is a historical stone structure (Figure 8) marking a transition between the upstream flush habitat and a downstream drainage channel that eventually becomes a natural headwater stream of the upper Clun. This channel, though dominated by coarse substrates (Figure 9), would appear to have been created to drain the valley sides to the south of Rhos Fiddle. It is likely that the natural stream head would form further downstream after a more extended mire-stream transition.

Figure 6. The southeast corner of Rhos Fiddle, looking southeast down the flush which turns right to exit the site near the trees on the right.

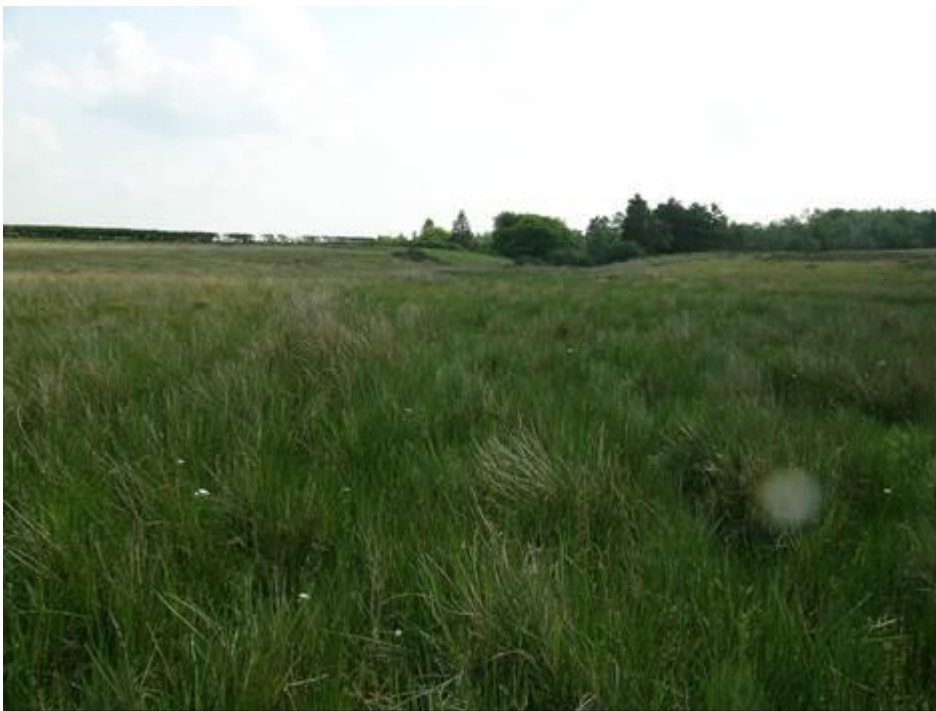
Figure 7. The flush heading off towards the trees.

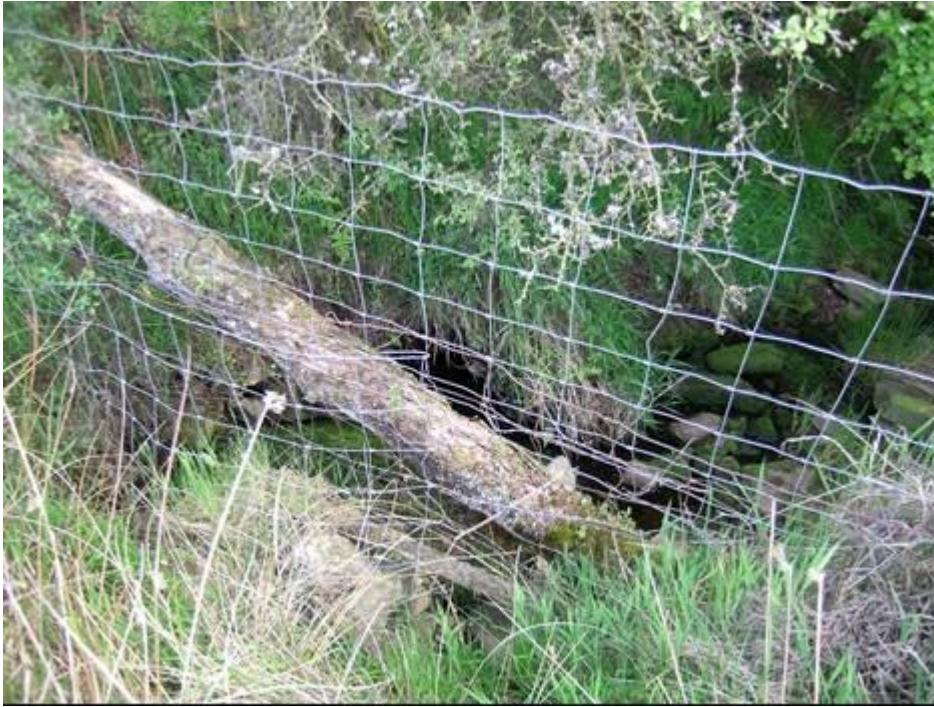
Figure 8. The man-made exit of the flush into the channel.

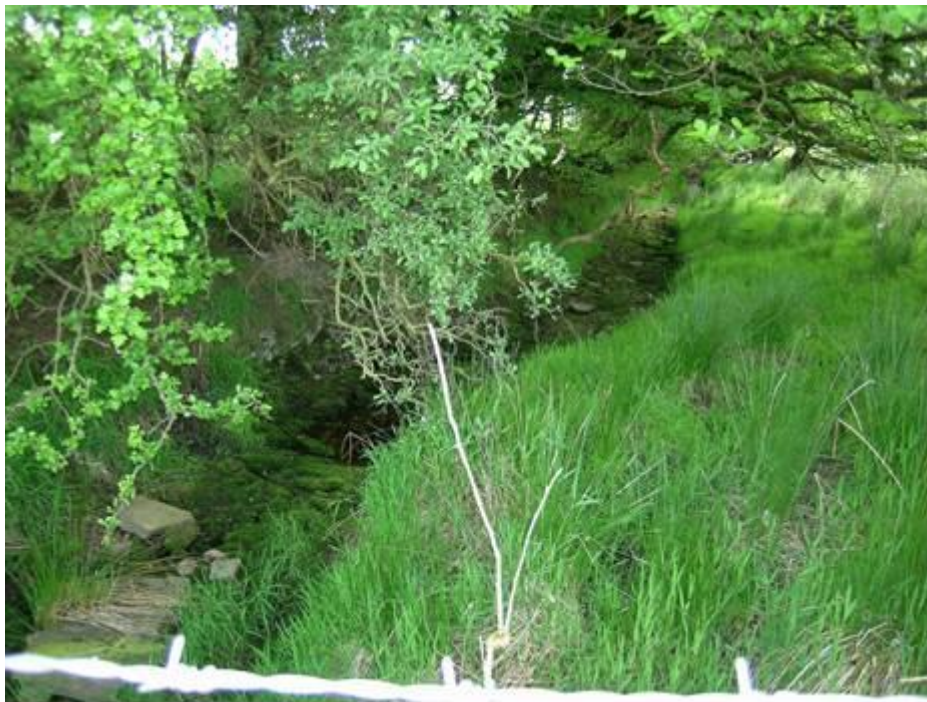
Figure 9. The channel draining Rhos Fiddle to the south.

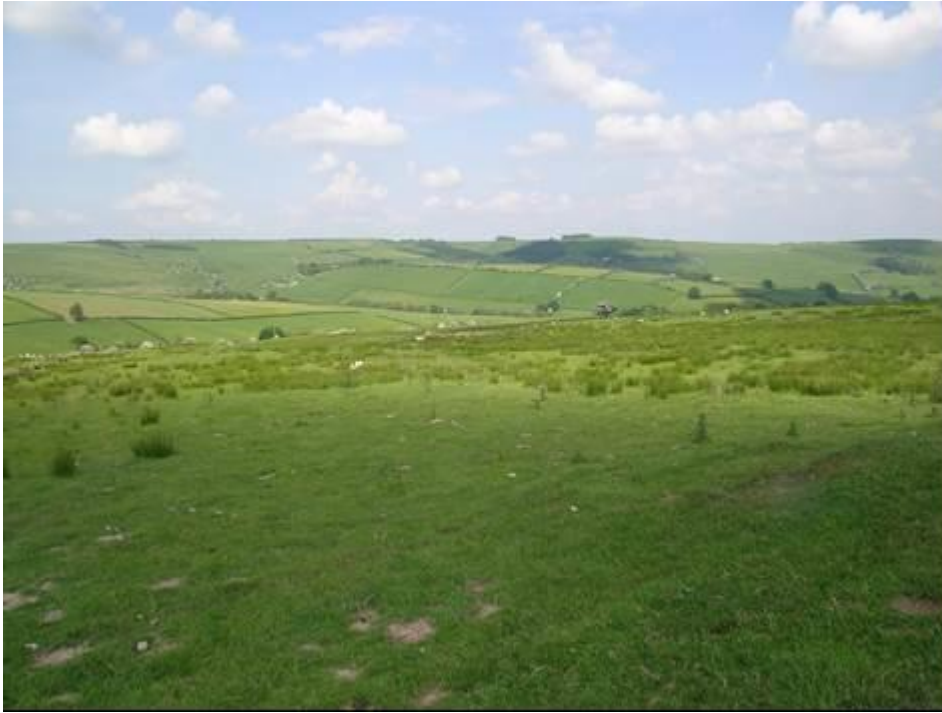
The headwaters of the Folly Brook are not surface-connected to Rhos Fiddle due to the topography of the mire. Instead seepages coalesce down the valley side to the east of the mire (Figure 10). These seepages have been drained for grazing.

Figure 10. The Folly Brook catchment, looking eastwards downslope from Rhos Fiddle.

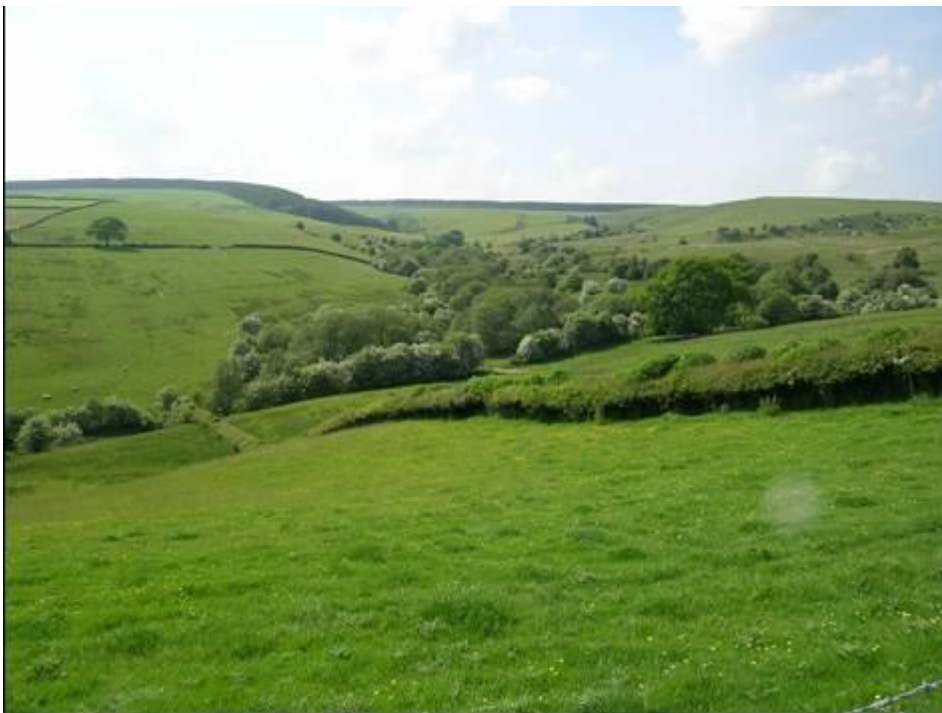
We drove across the top end of the Folly Brook catchment, looking across to the headwaters Long Pike Hollow and Cwm Moch (Figure 11). These streams run through heavily wooded ghylls that appear to be highly natural, although it was not possible to inspect the streams.

Figure 11. The headwaters of the Folly Brook, looking directly up Long Pike Hollow.

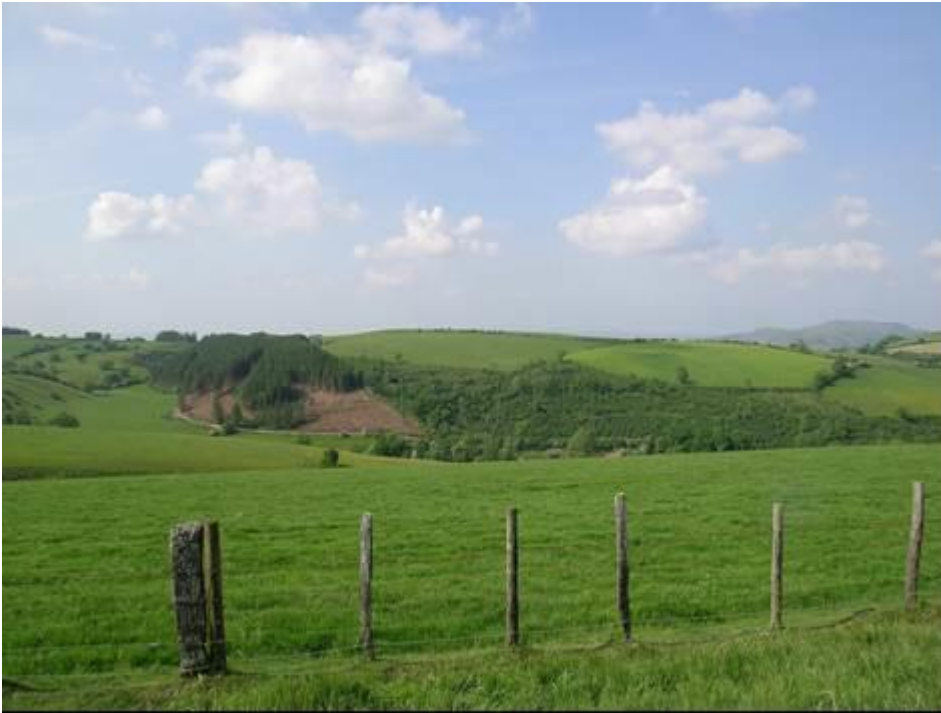
We drove eastwards over the watershed into the Unk catchment. Some unsympathetic clear-felling was immediately apparent (Figure 12), adjacent to recent conifer planting on what appeared to one of the only areas of semi-natural vegetation in the area. Further down the

Figure 12. Conifer felling and planting at the top of the Unk catchment.

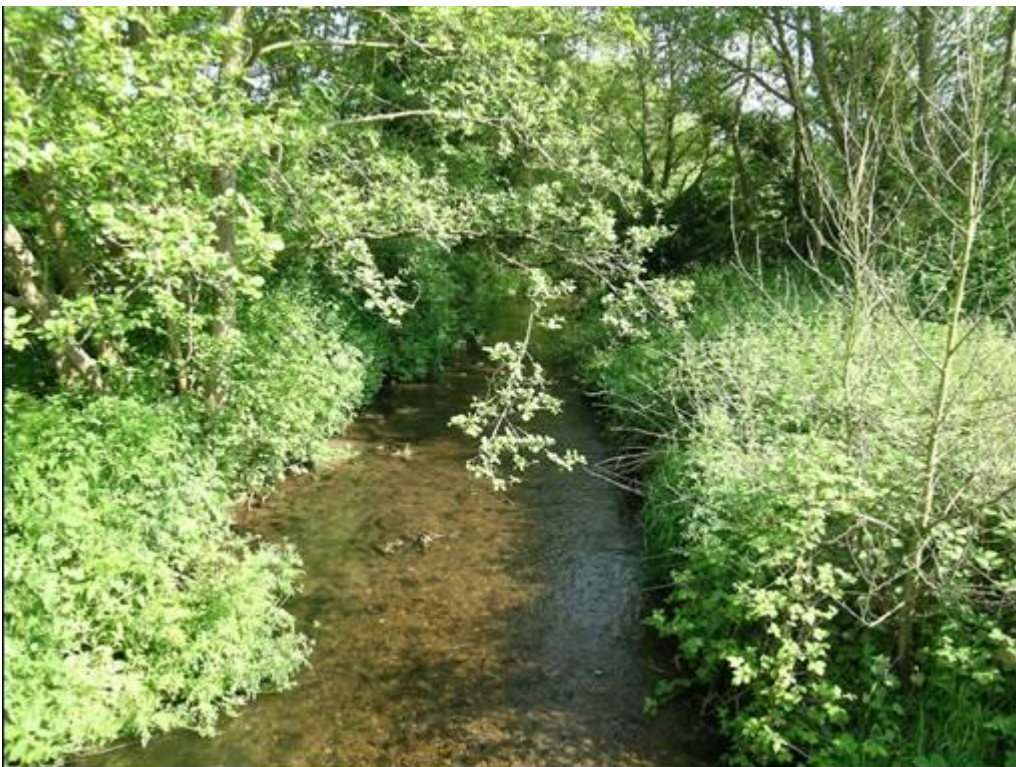
system the river appeared to be moderately natural (Figure 13), although there was no time for proper inspection.

Figure 13. The lower reaches of the River Unk.

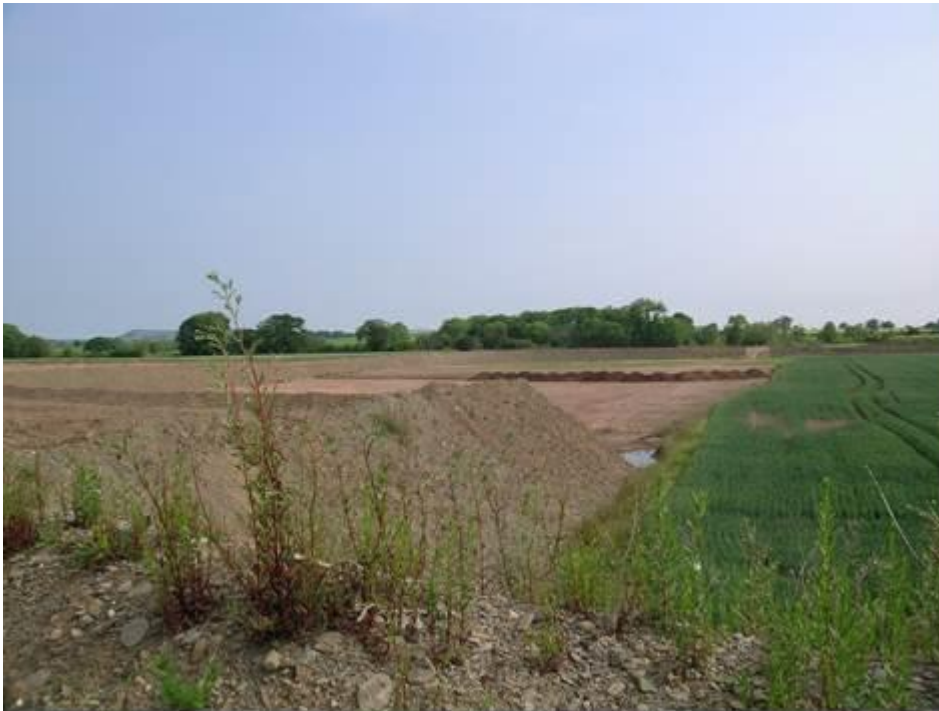
The lower Onny runs through a floodplain with significant man-made constraints, including a trunk road, a railway line, residential development (Craven Arms, Onnibury) and mineral extraction. Despite this, the river appears to be of reasonable habitat quality. Mineral extraction at the lower end of the river (Figure 14) is increasing, and is a constraint on restoring habitat natural function in terms of planform movement (although at this point the channel seems naturally constrained by woodland). Further up at Craven Arms, an excellent meander feature (Figure 15) has been artificially cut off to reduce erosion pressure on the bank adjacent to the eastern boundary of the town. This bank has been heavily reinforced to protect dwellings (Figure 16), and the river bed is lower than the bed of the cut-off meander (either from associated engineering works or bed incision due to the bank reinforcements). Given the low intensity of the adjacent agricultural use, some strategic restoration of natural river function along this stretch would appear to be feasible. Despite all of this engineering work, the channel exhibits reasonable habitat quality (Figure 17), and even supports isolated beds of *Ranunculus*.

Figure 14. Gravel and sand extraction adjacent to the lower Onny (the river lies beyond the trees).

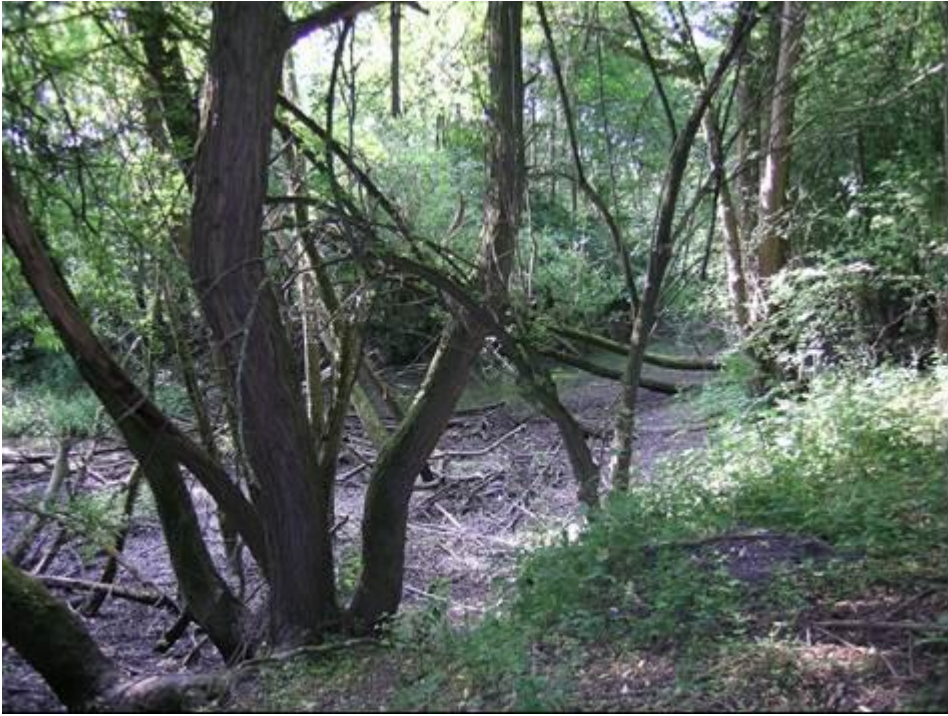
Figure 15. The meander cut off from the lower Onny by flood defence works.

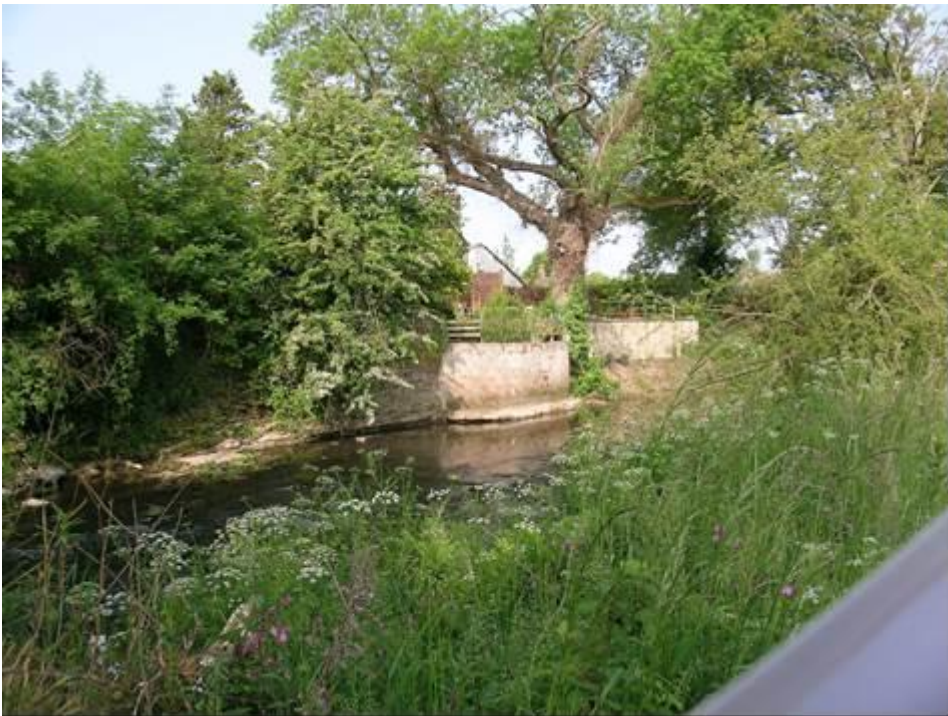
Figure 16. Concrete bank reinforcement adjacent to the cut-off meander (note the erosion visible under the toe of the reinforcement).

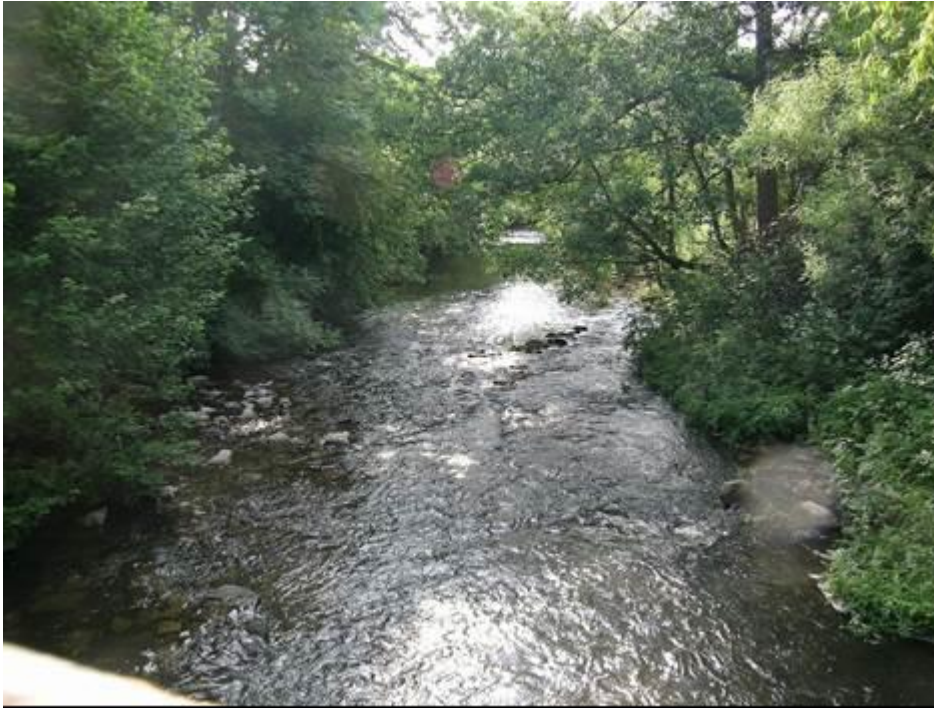
Figure 17. The Onny downstream of Craven Arms.

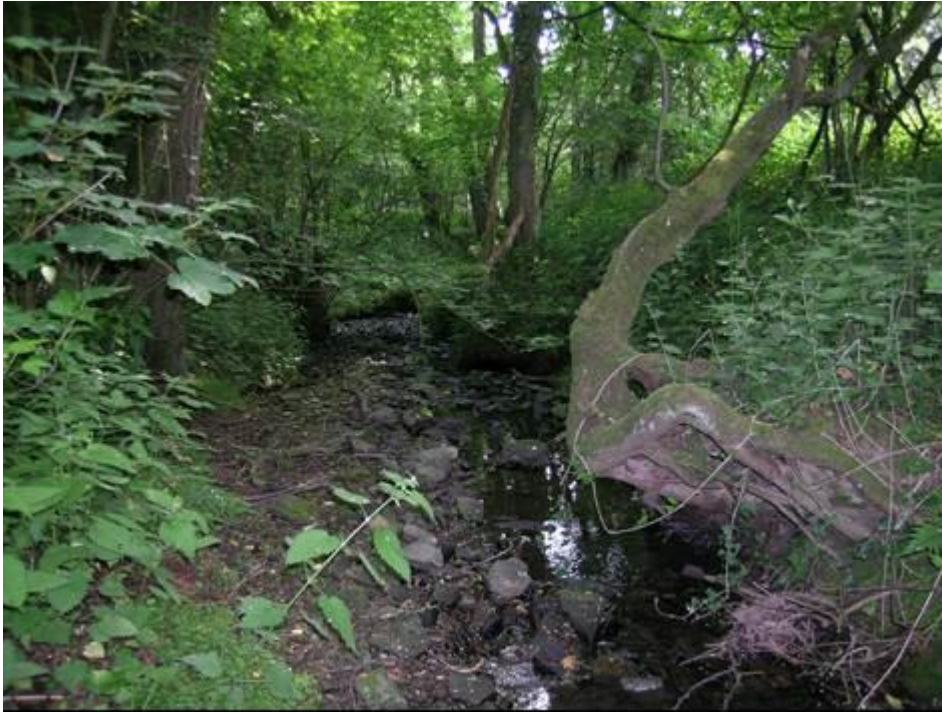
Some small steep streams running eastwards into the lower Onny (see the red oval on the site map) were briefly inspected (Chris Mainstone only). These are all unnamed on OS maps but flowed out of steep-sided ghylls called Stubbs Coppice, Ferneyhall Dingle and Duxmoor Dingle. The most obviously high quality of these was in Stubbs Coppice (Figure 18), and has an excellent habitat mosaic formed by natural processes, including good interactions with bankside trees and large woody material. A brief kick-sample captured very large numbers of freshwater shrimps (*Gammarus* sp.) and good numbers of caddis-fly larvae, both caseless (*Plectrocnemia* sp, probably *geniculata*, and *Wormaldia occipitalis*) and cased (Glossosomatidae and Limnephilidae). *Plectrocnemia* species are headwater specialists, giving way to *Polycentropus* species further downstream. One stonefly (*Isoperla grammatica*), a water-cricket (Veliidae) and beetle larvae (Hydrophilidae) were also caught. The species found reflect the diversity of the habitat mosaic – *Wormaldia* species favour high current velocities with vertically running water, whereas *I. grammatica* favours riffle habitat and *Plectrocnemia* species require lower velocities associated with the exit and entry points to pools to maintain the nets they spin. Glossosomatid larvae require cobbles and boulders as attachment surfaces, whilst water-crickets require relatively still water associated with pools on which to skate, and hydrophilid larvae tend to frequent vegetation and woody debris.

Unfortunately further downstream these streams then flow through intensive arable land before reaching the main Onny, and are heavily physically degraded through these reaches as a result.

Figure 18. The ghyll stream in Stubbs Coppice (NGR SO 447 764), running off the slope down towards the Onny.

The small streams running into the lower Onny require further examination but at least some appear worthy of priority habitat status. Owing to the heavily degraded nature of their channels in their lower reaches it would be difficult to justify extending the river SSSI notification to include them. In the future it would be possible to consider a composite headwater-only SSSI that is associated with, but not directly linked to, the Teme SSSI – this type of notification is allowed for in the revised GB selection guidelines for river habitat.

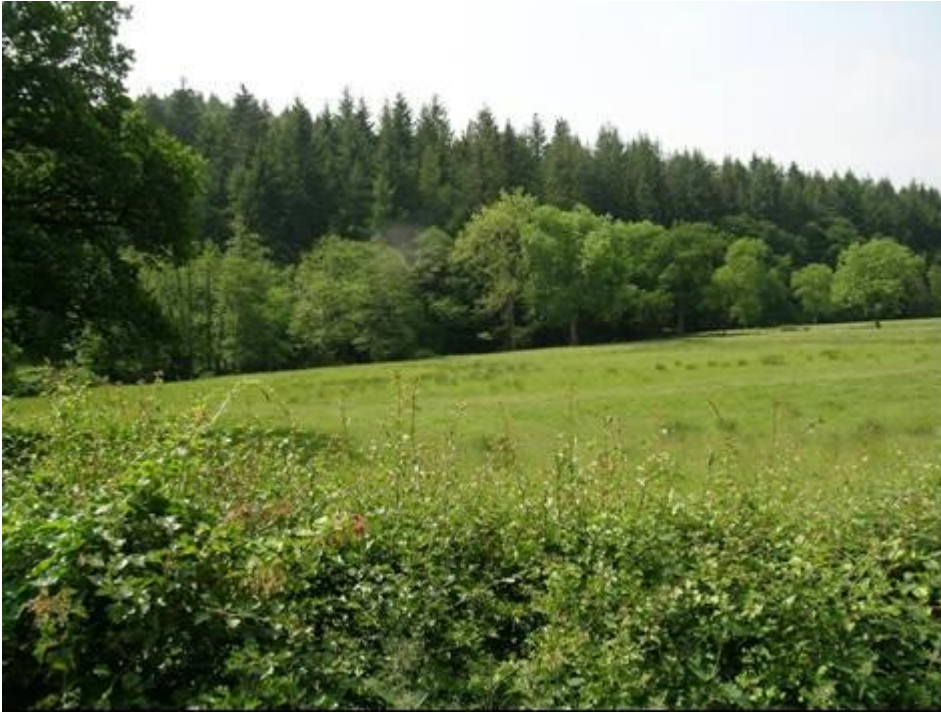
The lower sections of the East Onny were somewhat disappointing. The channel has been moved over to the edge of the floodplain and straightened (Figure 19), and lacks any energy or diversity (Figure 20). There is no large woody material in the channel to initiate natural recovery of channel form. As a result the channel substrate is heavily silted and seems unsuitable for characteristic biota.

Figure 19. The lower East Onny, straightened against the valley side. Note the outline of a meander cut-off by the historical engineering works.

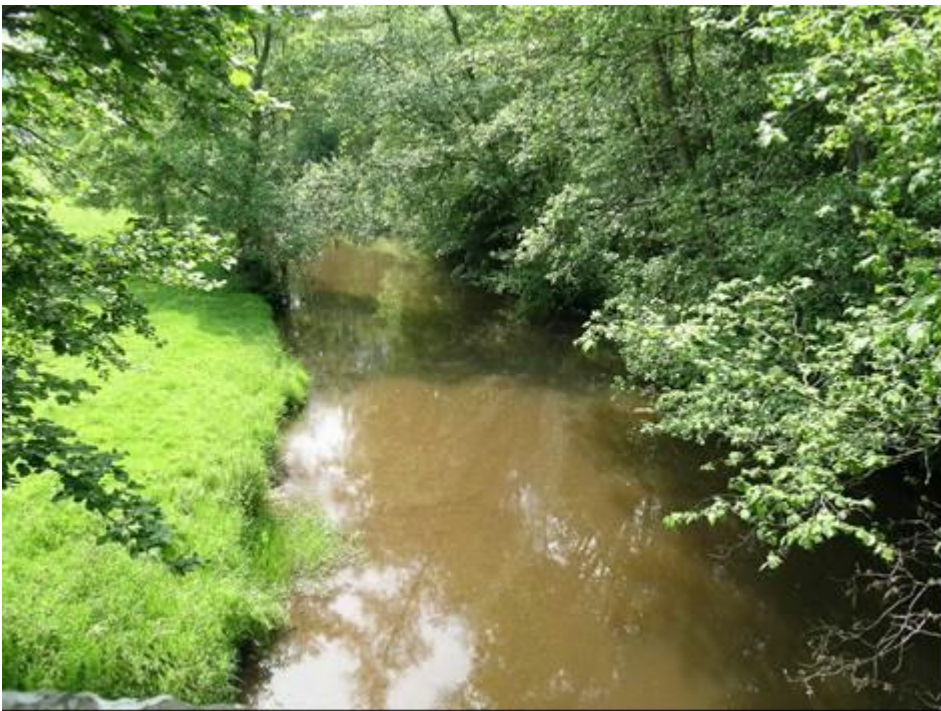
Figure 20. The straightened lower East Onny.

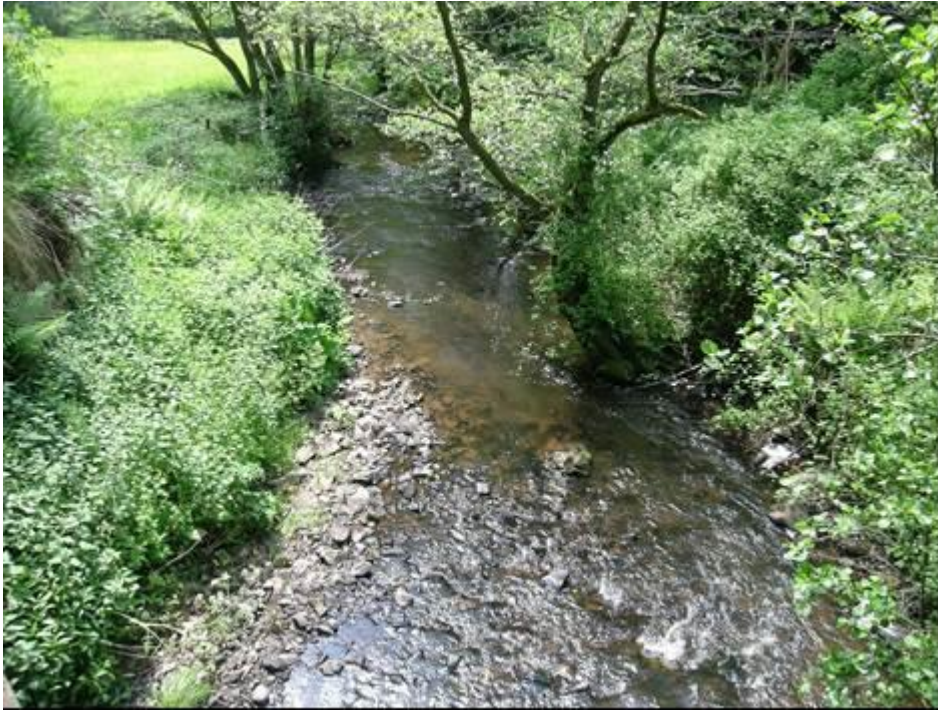
Further upstream the river retains its natural planform, despite being intertwined with the road, and habitat provision is much improved as a result (Figure 21). Small riparian meadows have also survived along this stretch, generating an excellent habitat mosaic within the river corridor. A brief kick sample revealed a high diversity of invertebrate species, particularly those associated with riffle habitat. This included stoneflies (*Isoperla grammatica*, *Chloroperla torrentium*), mayflies (*Ecdyonurus insignis*, *Rithrogena semicolorata*, *Heptagenia sulphurea*, *Serratella ignita*, *Baetis* sp, and *Ephemera danica*), caddisflies (the caseless *Hydropsyche siltalai* and *Ryacophila* sp and cased Glossosometidae and Limnephilidae). Gammarid shrimps, Elmids beetles and pea mussels (Sphaeriidae) were also present in small numbers, as were Bullheads. The macroalgae *Lemanea* was quite abundant – this is indicative of fast-flowing and circumneutral oligotrophic stream and rivers.

Figure 21. Upper East Onny, with small riparian meadows.

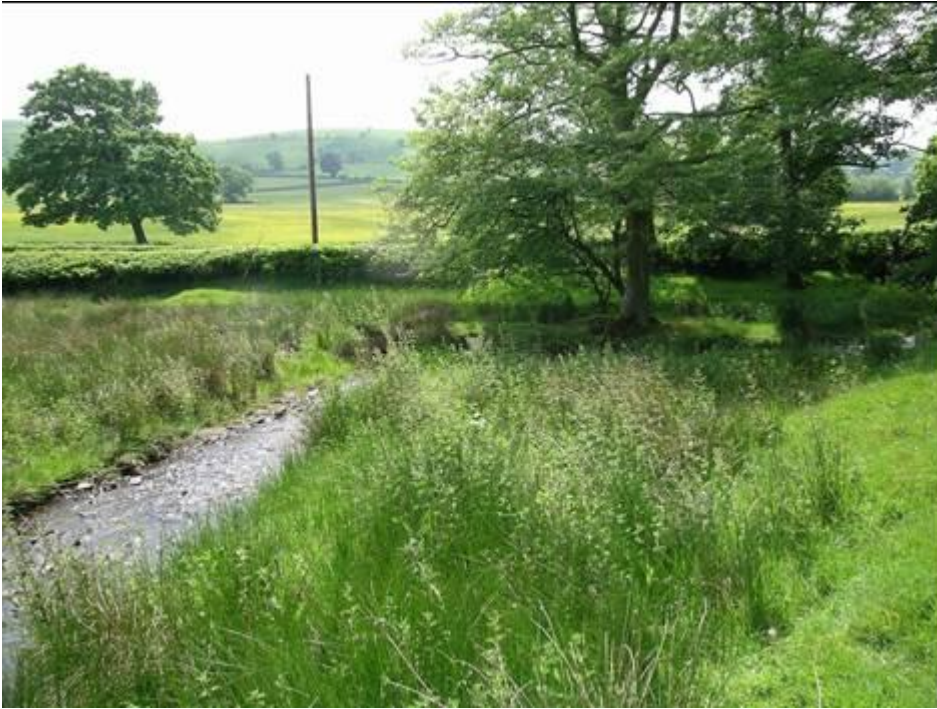
Above Bridges we inspected the Darnford Brook. This has a more open character, running through improved pasture with scattered trees. The brook is behaving naturally and has reasonable levels of diversity (Figure 22). Looking north westward into the headwaters, the catchment has an appearance of relatively extensive management (Figure 23), although to the west under the Stiperstones sheep grazing is very intensive. Moving up onto Wildmoor, the brook gives way progressively to mire in a natural longitudinal transition (Figure 24). The mire is of excellent quality, with base-rich, neutral and acidic water inputs. This gives rise to an impressive diversity of mire types within the valley system, and overall a large (relative to the others on the hill) and very important relatively natural wetland complex (Figure 25). It also supports a number of stands of the Habitats Directive Annex 2 moss *Hamatocaulis vernicosus*. The more acidic areas, which tend to support abundant soft-rush, appear to be becoming dominated by *Sphagna*, which is beginning to suppress the rush and *Polytrichum* commune that have dominated following past periods of over-grazing and burning/wildfire. This is returning the vegetation to higher quality mire types, as well as holding back greater volumes of water.

Figure 22. The Darnford Brook upstream of Bridges (note the natural vegetated berm on the right hand bank).

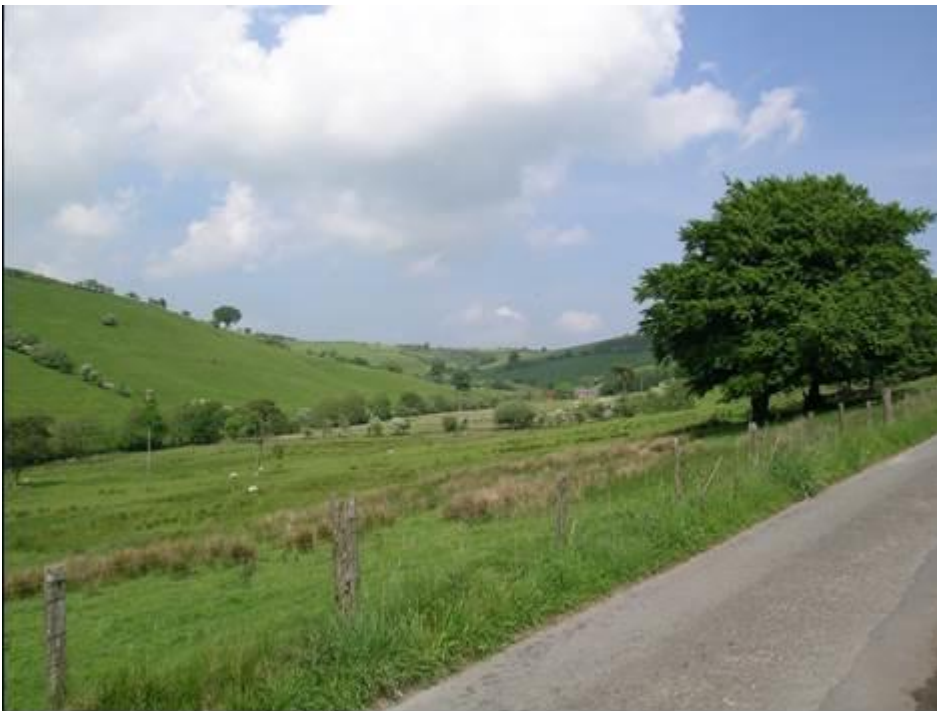
Figure 23. Catchment of the western tributaries of the East Onny.

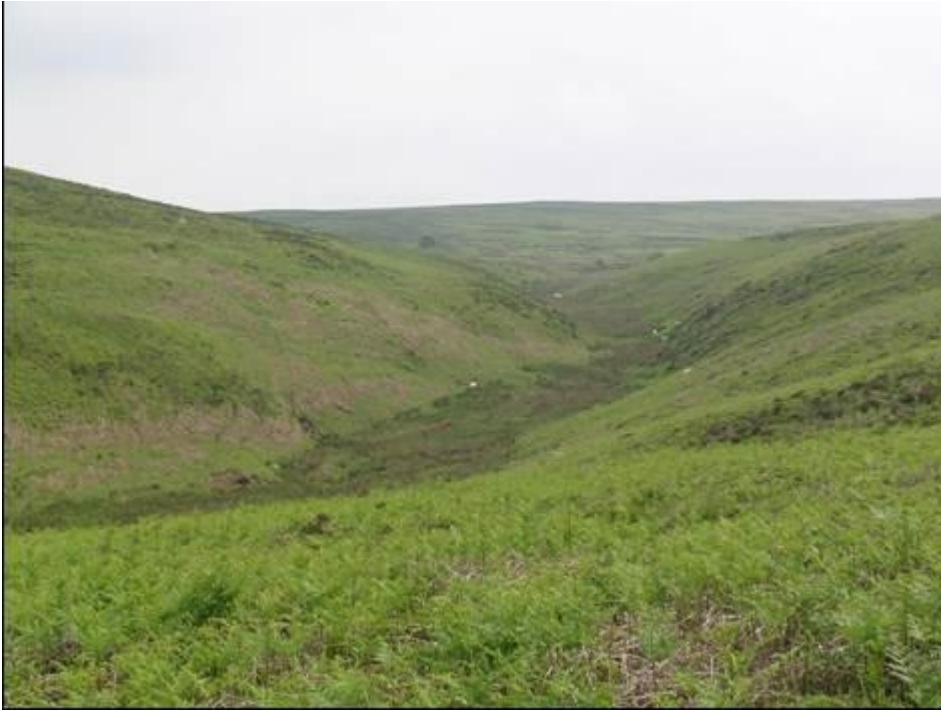
Figure 24. The upper Darnford Brook looking upstream to Wildmoor, progressively giving way to valley mire.

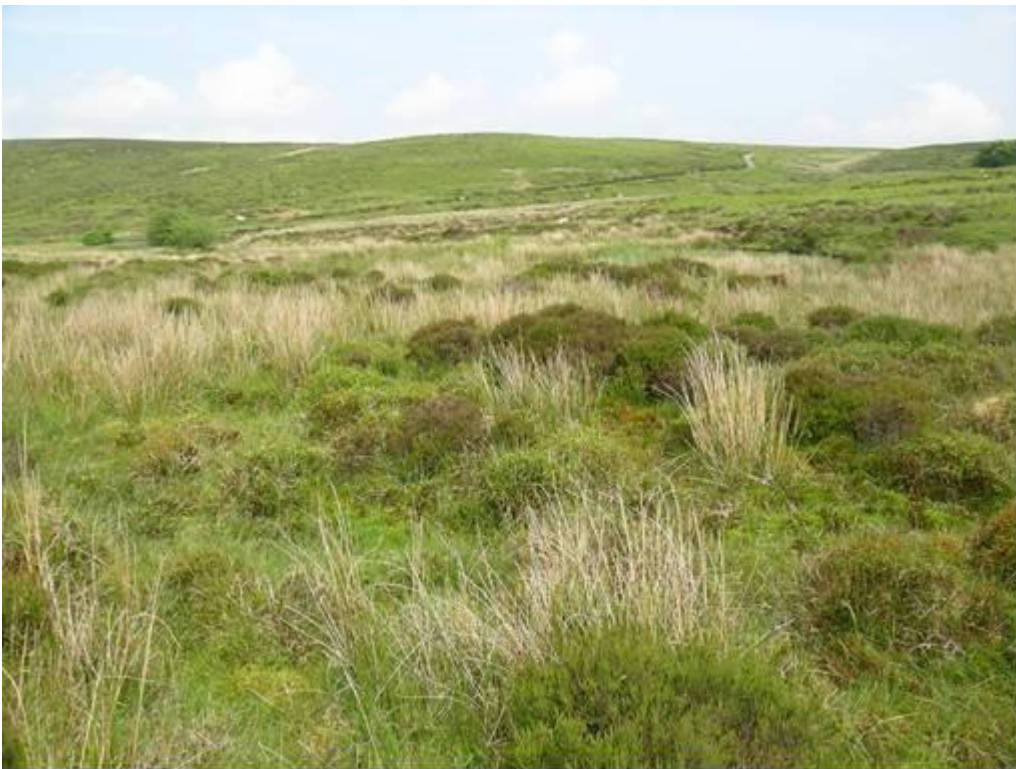
Figure 25. Mire vegetation at the top of the Darnford Brook on Wildmoor

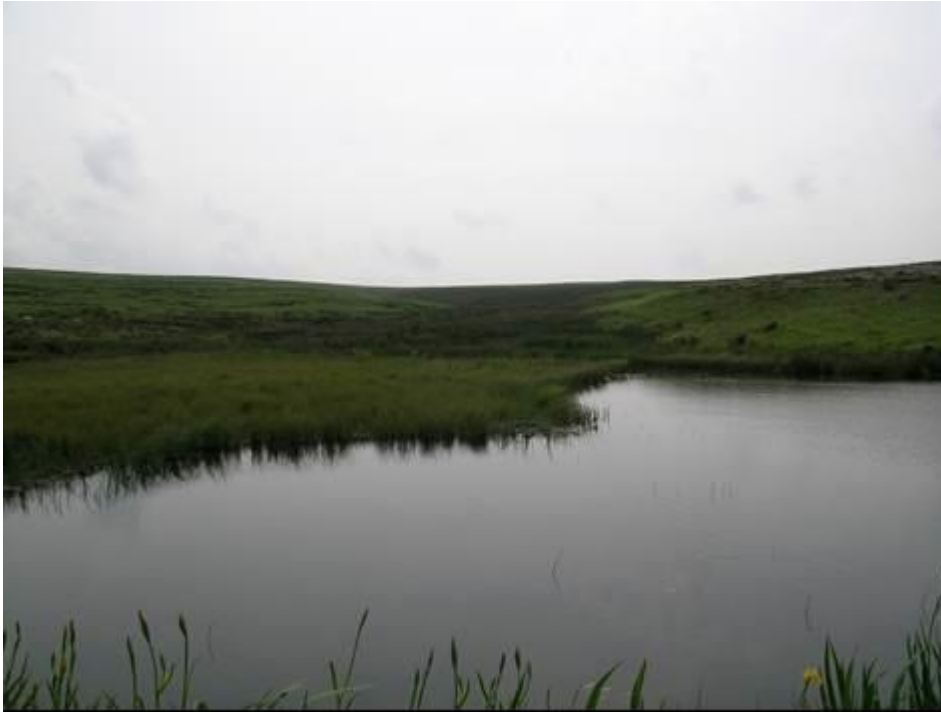
The main artificial interruption to the natural mire-stream transition is a pond created by the road (Figure 26), either as an aesthetic feature for visitors or for livestock watering. Further up the mire, the brook remains as a small channel cutting through the surface peat (Figure 27), becoming progressively more obscure. It is unclear whether the hydrological pathway at this point would be sufficiently strong to generate a defined channel if the mire were in a completely

Figure 26. Artificial pond in the mire/stream transition on the upper Darnford Brook, at the lower boundary of Wildmoor.

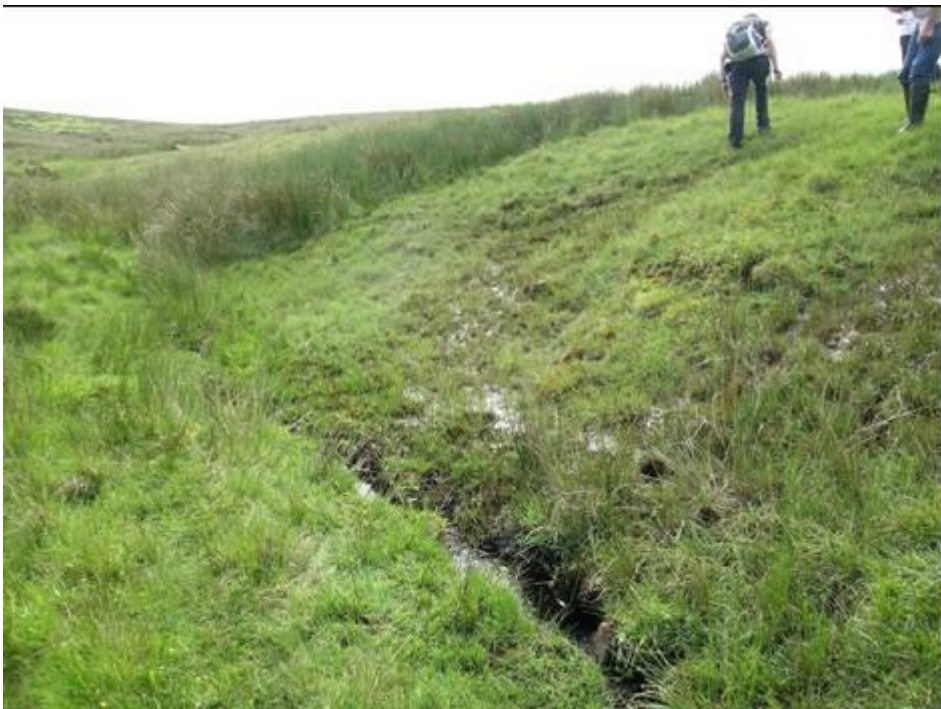
Figure 27. Channel cutting through the peat on Wildmoor.
