Specialist site visit – Teme tributaries, 8 and 9 June 2016

We visited sites in the Clun and Onny catchments, to get a feel for their potential in terms of beneficial extensions to the River Teme SSSI (particularly in relation to connecting with headwater mires) and mapping priority river habitat, and to characterise and discuss management issues and their resolution.

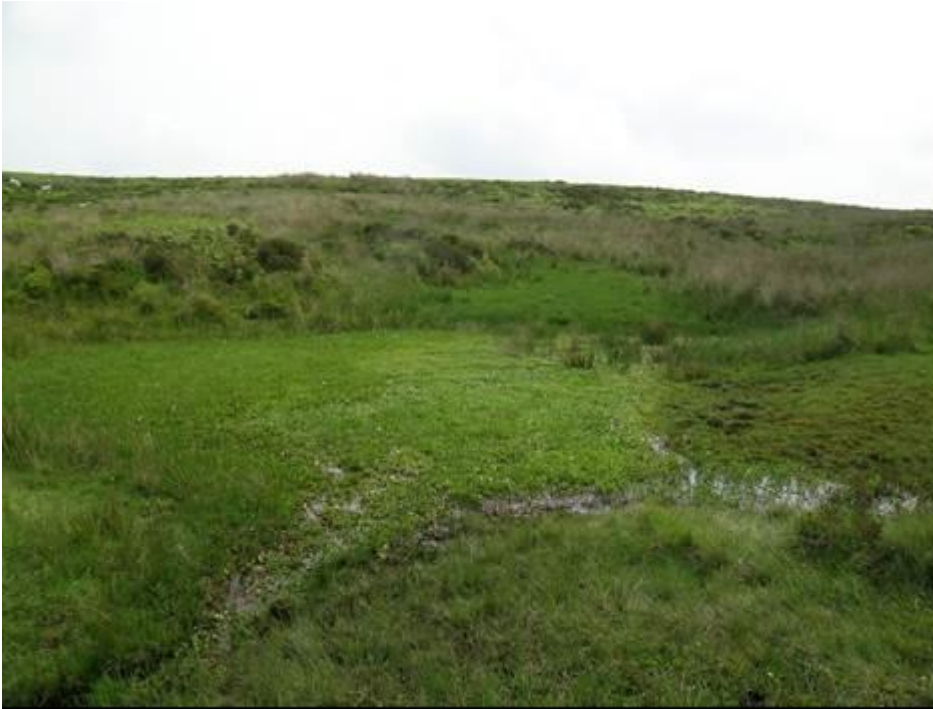
natural state. There has been some more obvious interference with the mire-stream transition, involving mineral soil bunds set across the nascent valley (Figure 28). It is unclear whether these were established to stabilise the mire, but in the absence of any trees and associated root systems for natural binding they probably perform this function. Some small pools are present in the mire (Figure 29), often behind small bunds rather than as truly natural features resulting from the topography of the land. It is unclear at what point bedrock control of the mire would be established in the absence of the bunds. Some elements of the mire stream transition appear very natural, however (e.g. Figure 30).

Figure 28. A bund (bottom of picture) set across the hydrological pathway within the valley mire. Note the bund is now partially cut through.

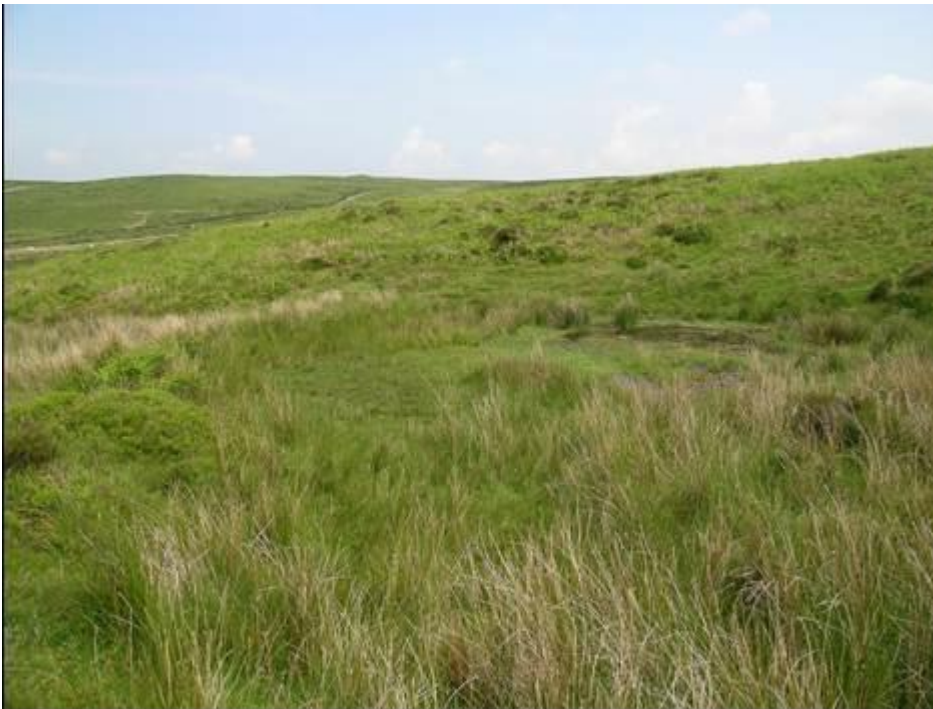
Figure 29. A pool in the valley mire at the top of Darnford Brook.

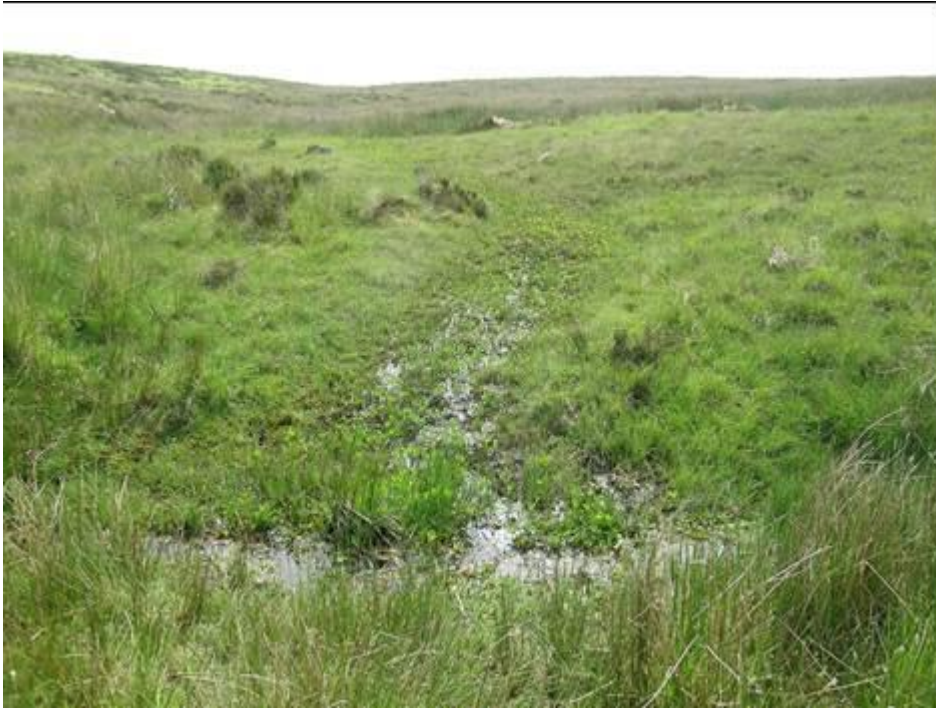
Figure 30. Unmodified flush habitat coalescing into open water.

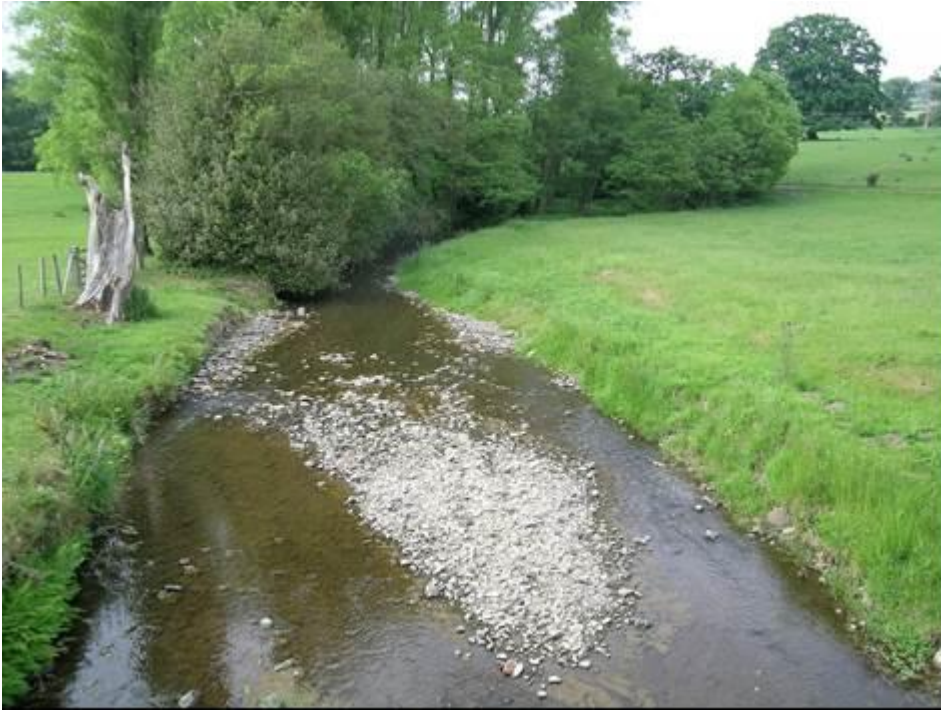
Further down we were able to inspect the river at close quarters. At this point the habitat mosaic was heavily degraded by intensive cattle grazing, with high densities of livestock having free access to the banks and river bed (Figure 31). However, again the potential for restoring the habitat mosaic seemed high.

Figure 31. Degraded habitat mosaic of the lower West Onny.
