Gloucestershire headwater streams – site visits, May 2015

Toadsmoor

Chris Mainstone (Senior Freshwater Habitat Specialist), Iain Diack (Senior Wetland Specialist), Natural England

April 2017

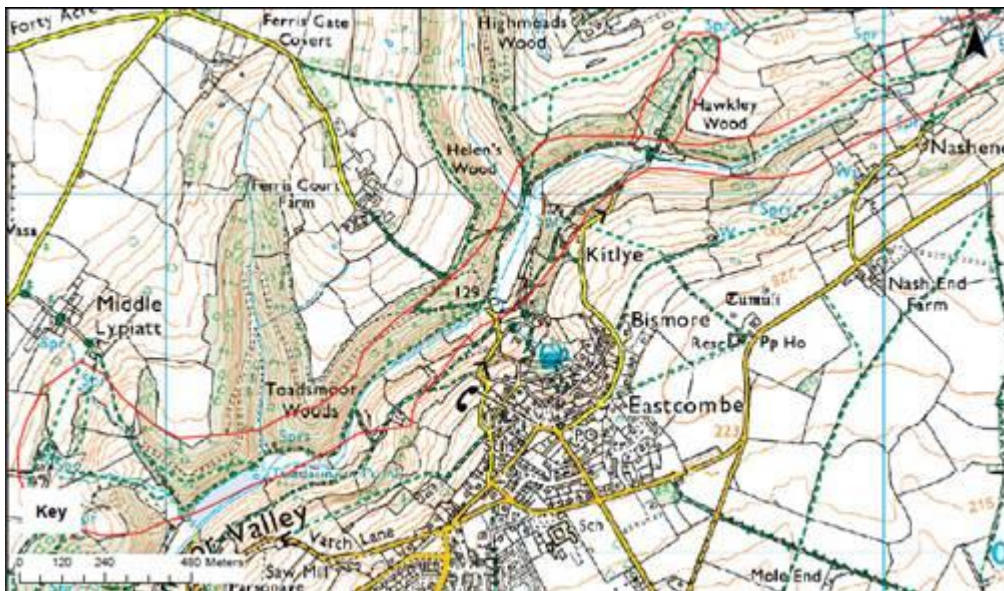
The headwater system running through Toadsmoor Valley has extensive naturally functioning stream/spring/flush habitat. We only had time to inspect one of the stream heads fed by tufa springs, near Middle Lypiatt from SO 879 041 to SO 877 042.

Figure 1. Toadsmoor valley. Red line indicates the extent of naturally functioning stream/spring/flush system.

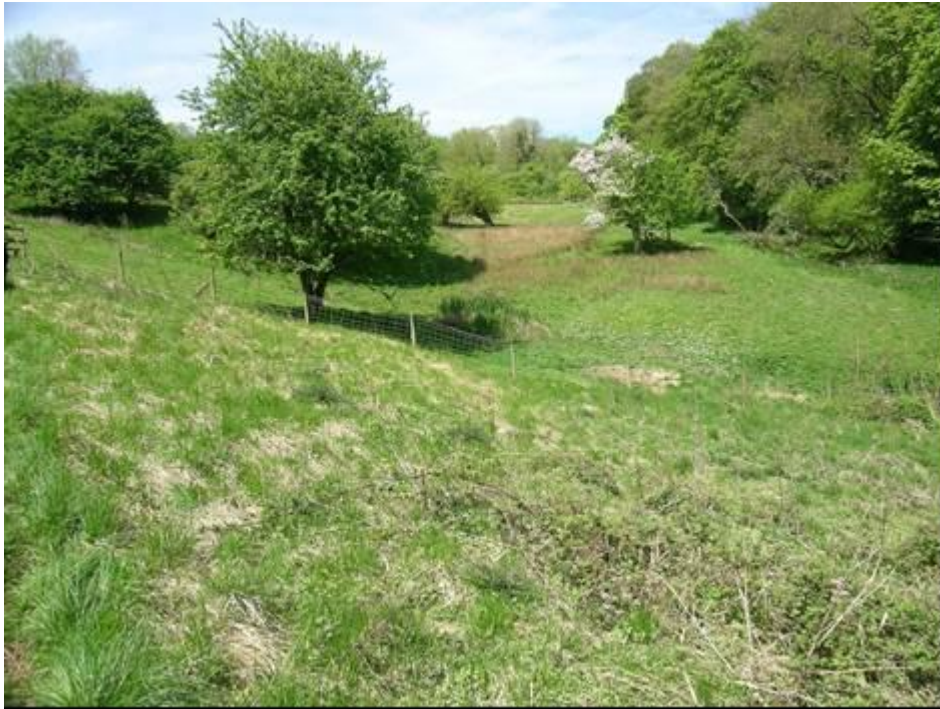
The parts of the catchment we could see contain a mixture of woodland and semi-improved pasture (Figure 2), a benign landscape for naturally functioning headwater stream systems.

Figure 2. Surrounding landscape.

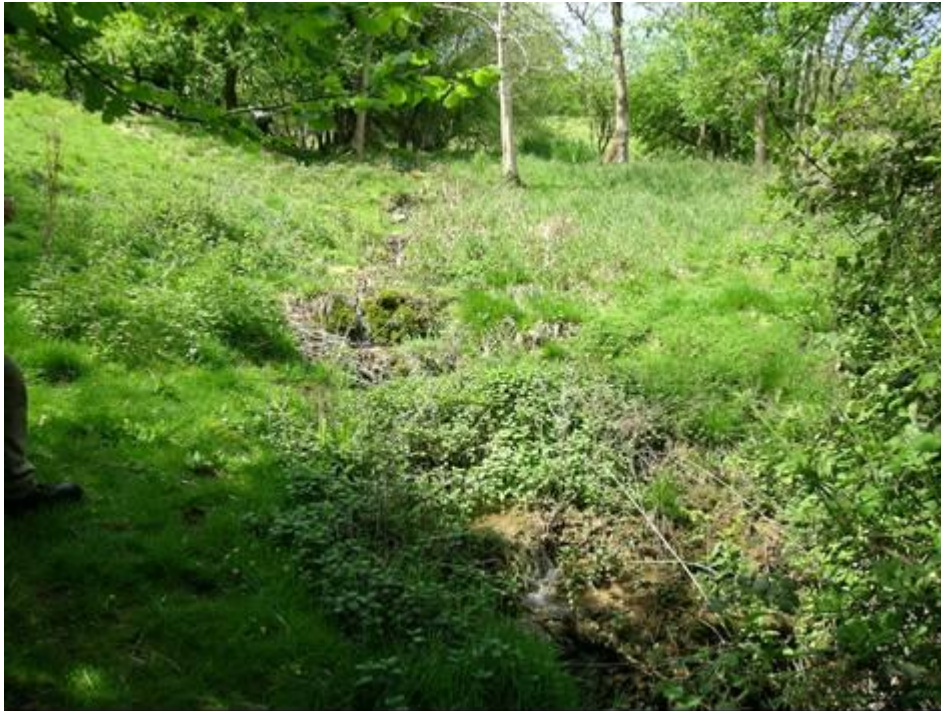
The stream head we visited is located in open rough pasture on a huge tufa mound formed over a long period of time (Figure 3). Stream margins and slopes below the springheads contain extensive and diverse flush vegetation (probably with greatest resemblance to M22 *Juncus subnodulosus-Cirsium palustre* fen meadow, although the eponymous rush is not present), including an abundance of marsh valerian and small sedges, areas of lesser pond-sedge dominance, and runnels with fool's water-cress. The main stream channel consists of tufa cascades, providing a varied habitat mosaic including fine and coarse substrates, woody material and leaf litter, variations in water depth, and exposed humid cascades with an abundant lower plant flora (Figure 4) including the moss *Palustriella commutata* (previously *Cratoneuron commutata*) and the liverwort *Pellia endivifolia*.

Figure 3. Intact stream/spring/flush mosaic.

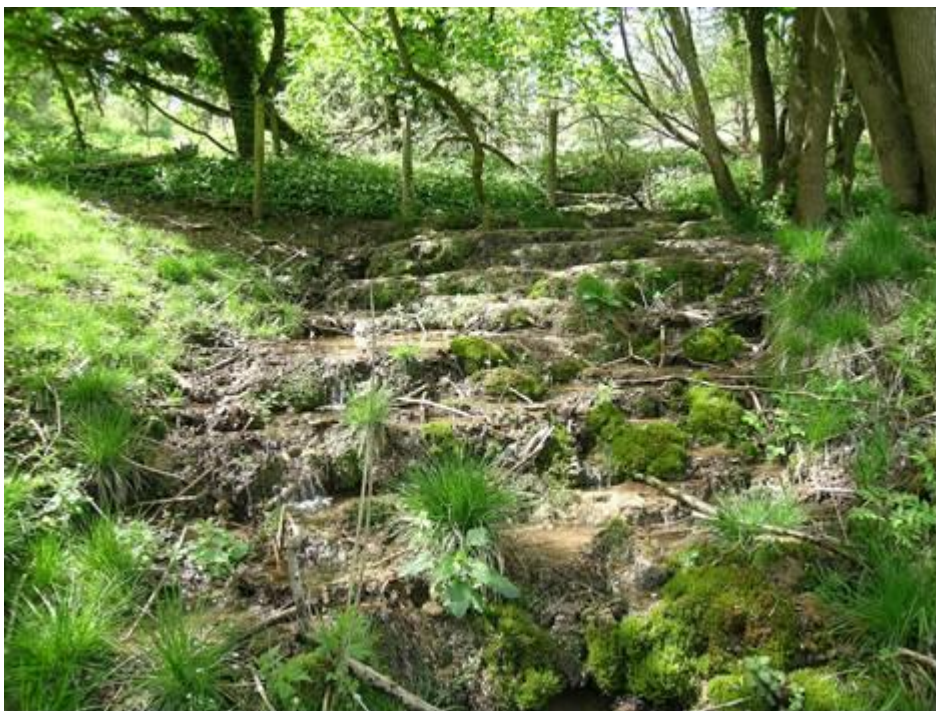
Figure 4. Tufa cascade with *Cratoneuron* and other mosses and liverworts.

Unlike many woodland streams visited in the area, the morphology of the channel in the stretch we visited seems primarily dictated by the tufa formation, in the absence of significant amounts of woody debris. However, the tufa cascades may have formed over the sparse woody material available.
