## Specialist site visit - headwater streams running off the South Downs

Tuesday 2 June 2015

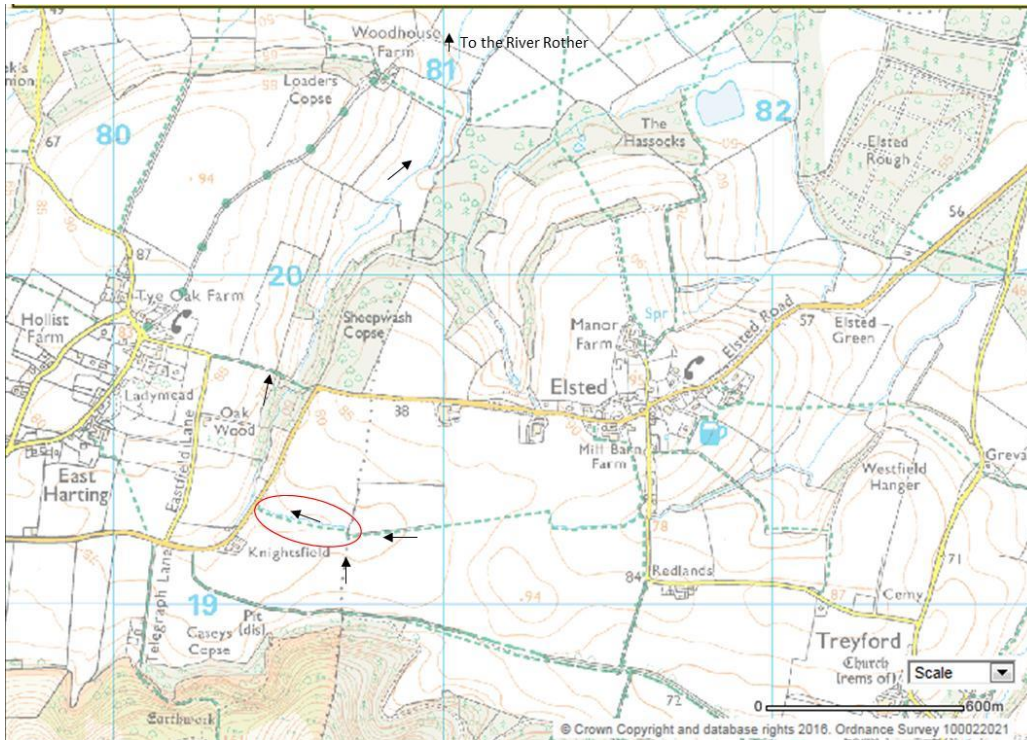
This stream is labelled as Harting Number 4 in Nigel Holmes' headwater survey report (Holmes 2010). It rises from a series of springs at the base of the northern fringe of the South Downs, running over greensand and then flowing north for some kilometres before discharging into the Rother (an east-flowing tributary of the Arun). See map below. We walked along the streambed adjacent to the public footpath at the upstream end of the watercourse, from the Elsted to East Harting Road at SU 804 192. The stream was dry at the time of the visit.

The main stream is hidden within an incised channel covered in a dense canopy from a thin zone of riparian trees. The channel is very geomorphologically active, with a bed of greensand cobbles and a very sinuous planform (Figures 1.1 and 1.2). The stream clearly experiences high flows and considerable hydraulic forces in the winter and early spring.

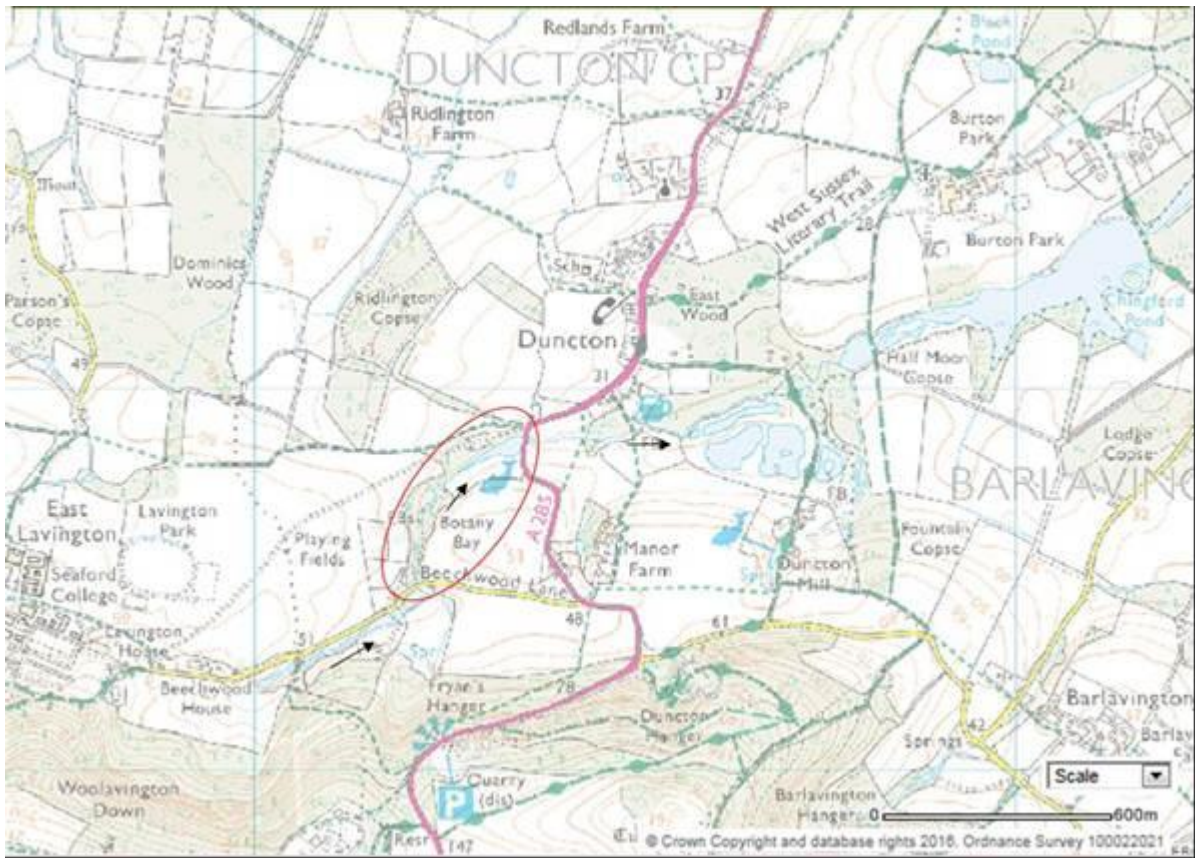
**Map of Botany Bay showing stretch visited (circled in red)**

This stream has suffered from a range of physical modifications along the stretch we visited, which have damaged natural habitat function. The current owner is doing excellent work in trying to restore the stream through removing those modifications as far as possible.

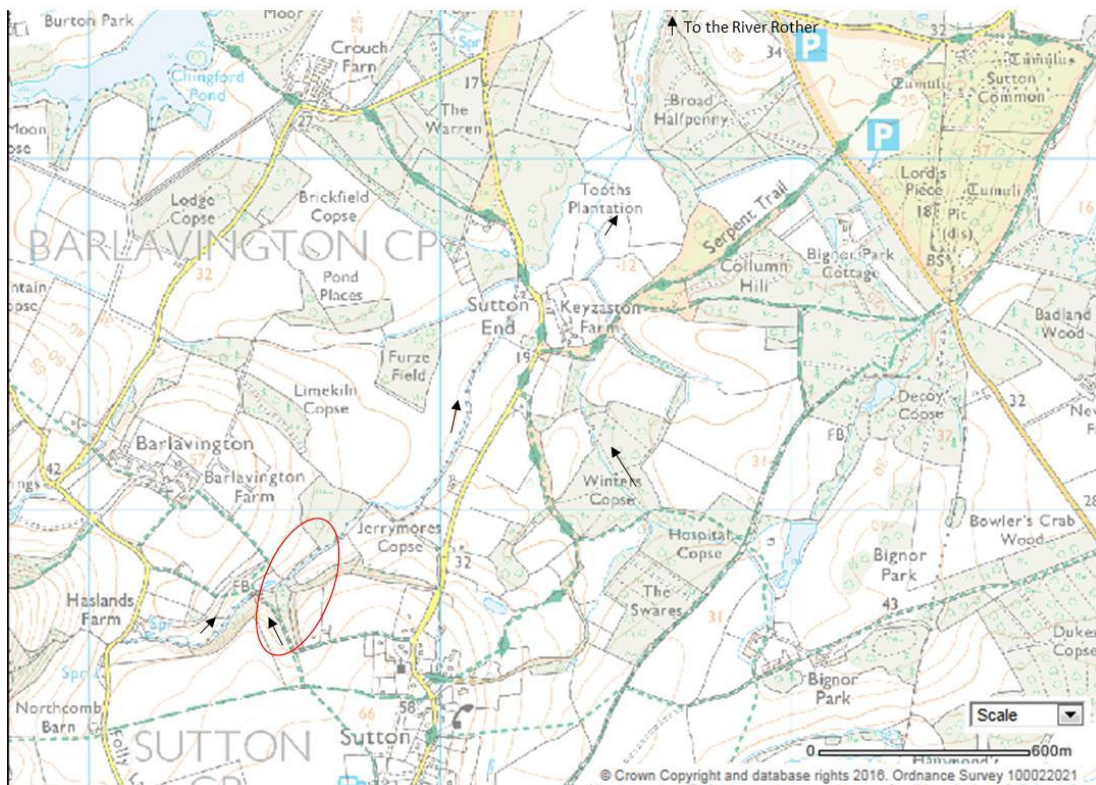
**Map of Sutton Stream showing stretch visited (circled in red).**

The small tributary had a steep gradient and incised channel, with abundant woody debris. The main stream along the section we walked had abundant gravel substrate but relatively limited habitat diversity (Figure 3.1). This was possibly due to the limited amount of woody debris in the channel. However, areas of exposed gravel substrate were evident (Figure 3.2), which is a rare biotope in chalk streams generally.

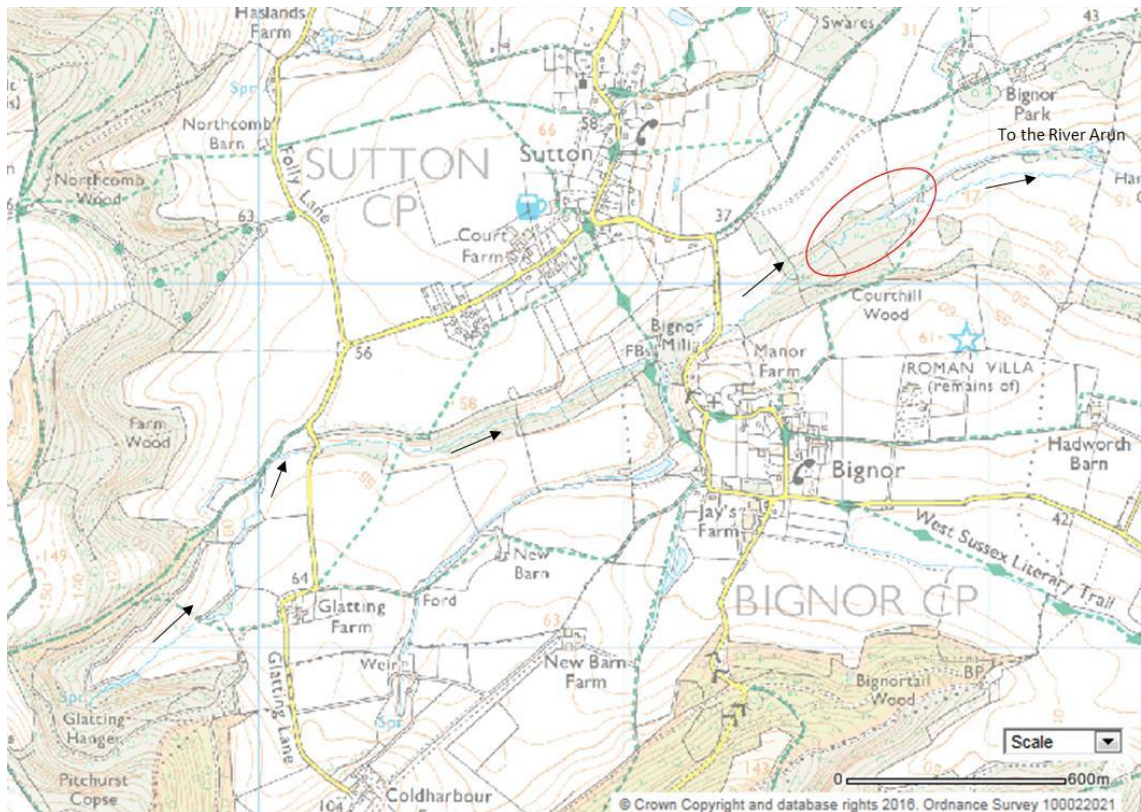
**Map of Bignor Stream showing stretch visited (circled in red).**

This is a naturally functioning stream running through a mixture of ancient broadleaved woodland and organic grassland, with good levels of woody material and habitat diversity (Figure 4.1). It is relatively low energy through the reach we walked, with considerable amounts of finer sediments. This is a function of relatively low stream gradient and does not prevent the evolution of a varied biotope mosaic (Figure 4.2). Further upstream stream gradient and therefore hydraulic energy is higher, but we did not walk that far upstream.

The stream should be added to the new priority habitat map, unless there is a serious impact on the natural flow regime caused by abstraction from the aquifer (if

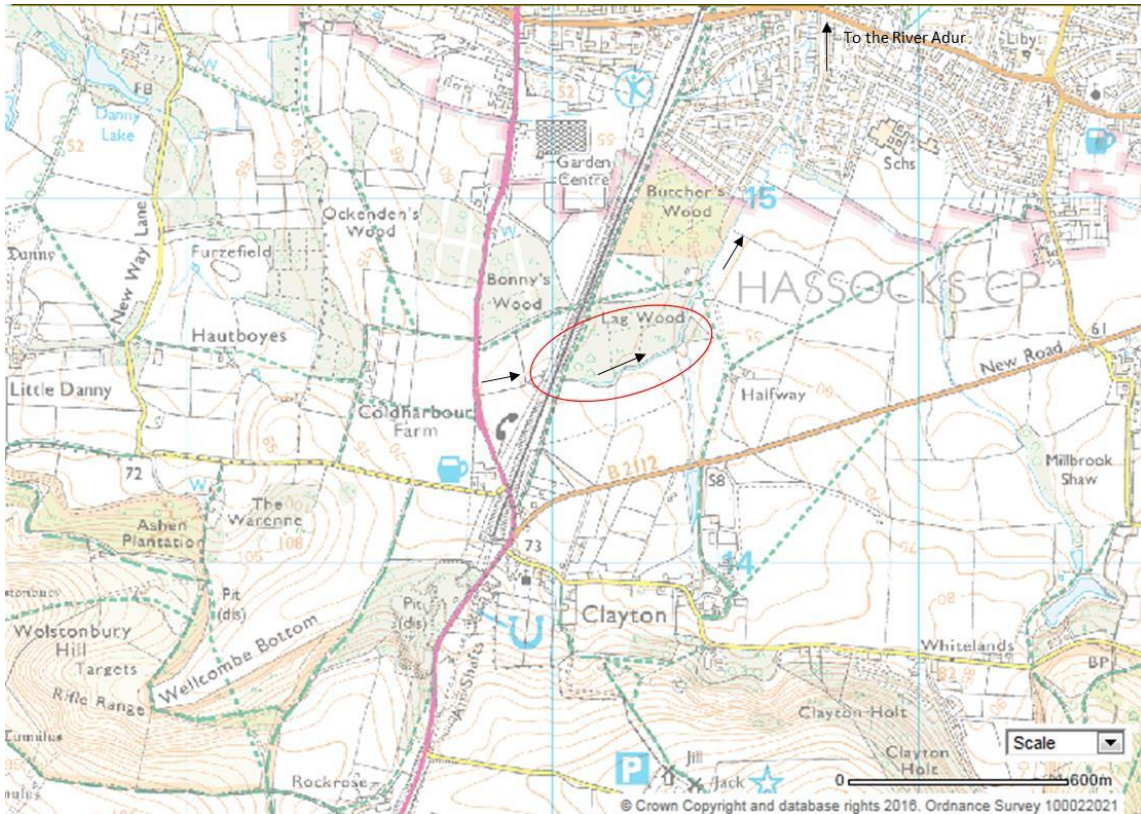
**Map of Lag stream, showing stretch visited (circled in red).**

The stream through this section is naturally functioning and very close to its source running off the Downs. The channel has high levels of interaction with tree root systems and fallen wood, creating a physically diverse channel (Figure 5.1 and 5.2).

Management through Lag Wood is highly sympathetic to the natural function of the stream – continued non-intervention is recommended, including leaving fallen wood *in situ*. Not much can be done about the public use of the stream sides without restricting access to the wood. A sign advising of the importance of the stream and its banks and encouraging responsible behaviour may help.

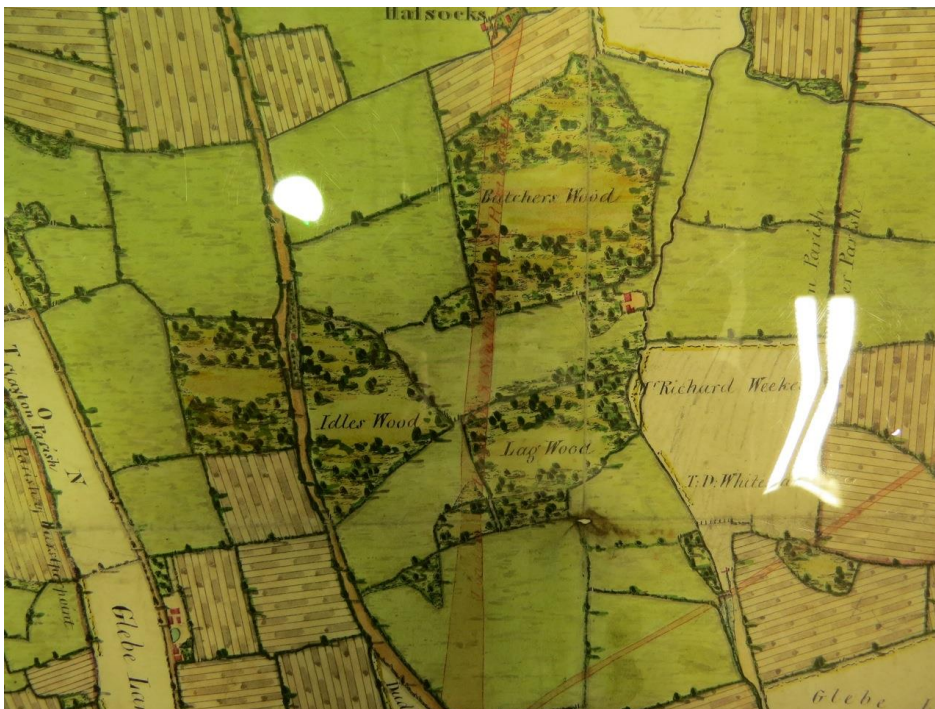
On the other side of the railway line, the stream has been ditched and then ponded. The degraded nature of this section is a shame as it destroys continuity of natural stream function up to the top of the springline, so that the natural section through Lag Wood is isolated from the wider landscape. It is thought that there is a significant spring directly underneath the railway line, because the flow through Lag Wood is much greater than the flow in the ditch on the other side of the line. Chalkiness is also observed in waters of the Lag Stream following rainfall, when none is apparent in the ditch. From a map of 1823 showing the planned line of the railway (Figure 5.5, it is clear that the ditch and amenity grassland of the green cemetery replace woodland and naturally functioning stream and flush habitat, which would presumably have been similar to the existing section through Lag Wood.

**Figure 5.5 1823 map showing the proposed line of the railway (shaded red) and the woodland upstream of the present-day Lag Wood.**

landowners, and options for restoration considered. The pond has poor water quality and is of limited aesthetic appeal. In-filling the ditch to restore flush habitat, allowing a natural channel to form if there is sufficient flow, would provide a wetland area of flower-rich grassland and a more attractive landscape for visitors. This would however require restricting access to this small area, particularly in the winter, depending on ground conditions.
