NATURALNESS PRACTICE IMAGE GUIDE

POOR NATURALNESS EXAMPLES

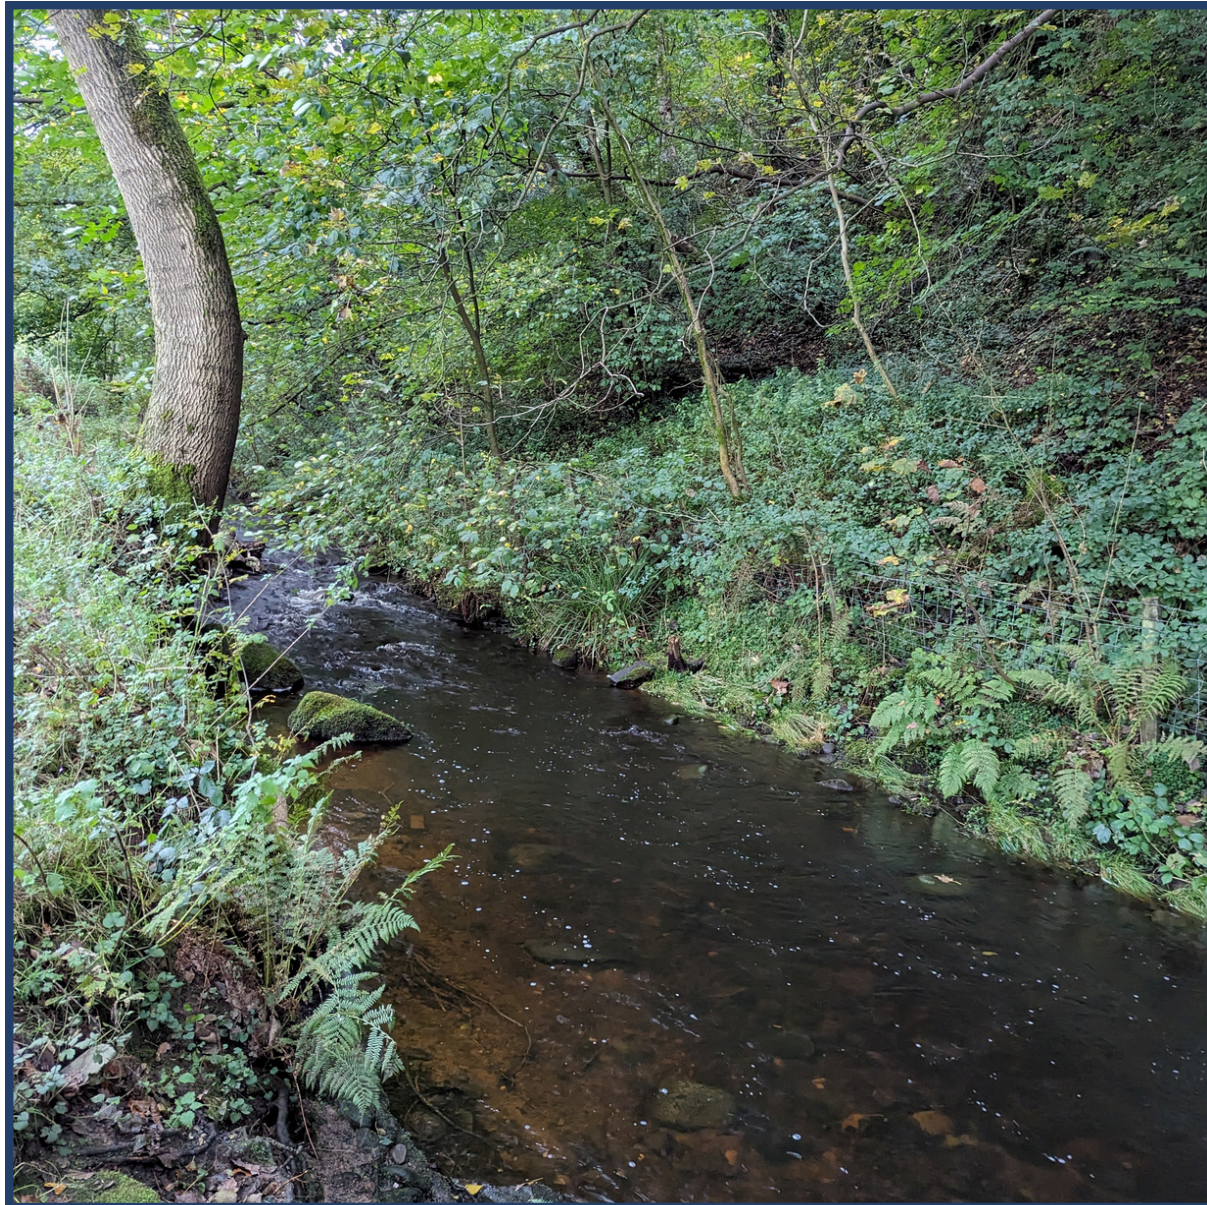
PHYSICAL

4

HYDROLOGICAL

2

CHEMICAL

1

BIOLOGICAL

The beck is heavily straightened but no embankments are visible. Tree cover is high and the riparian zone is not degraded. The hydrology of the channel will be slightly impacted by the straightening. The water is peat-stained (note the 'see-through black tea' colour), so although dark still scores highly natural. No invasive species are visible.

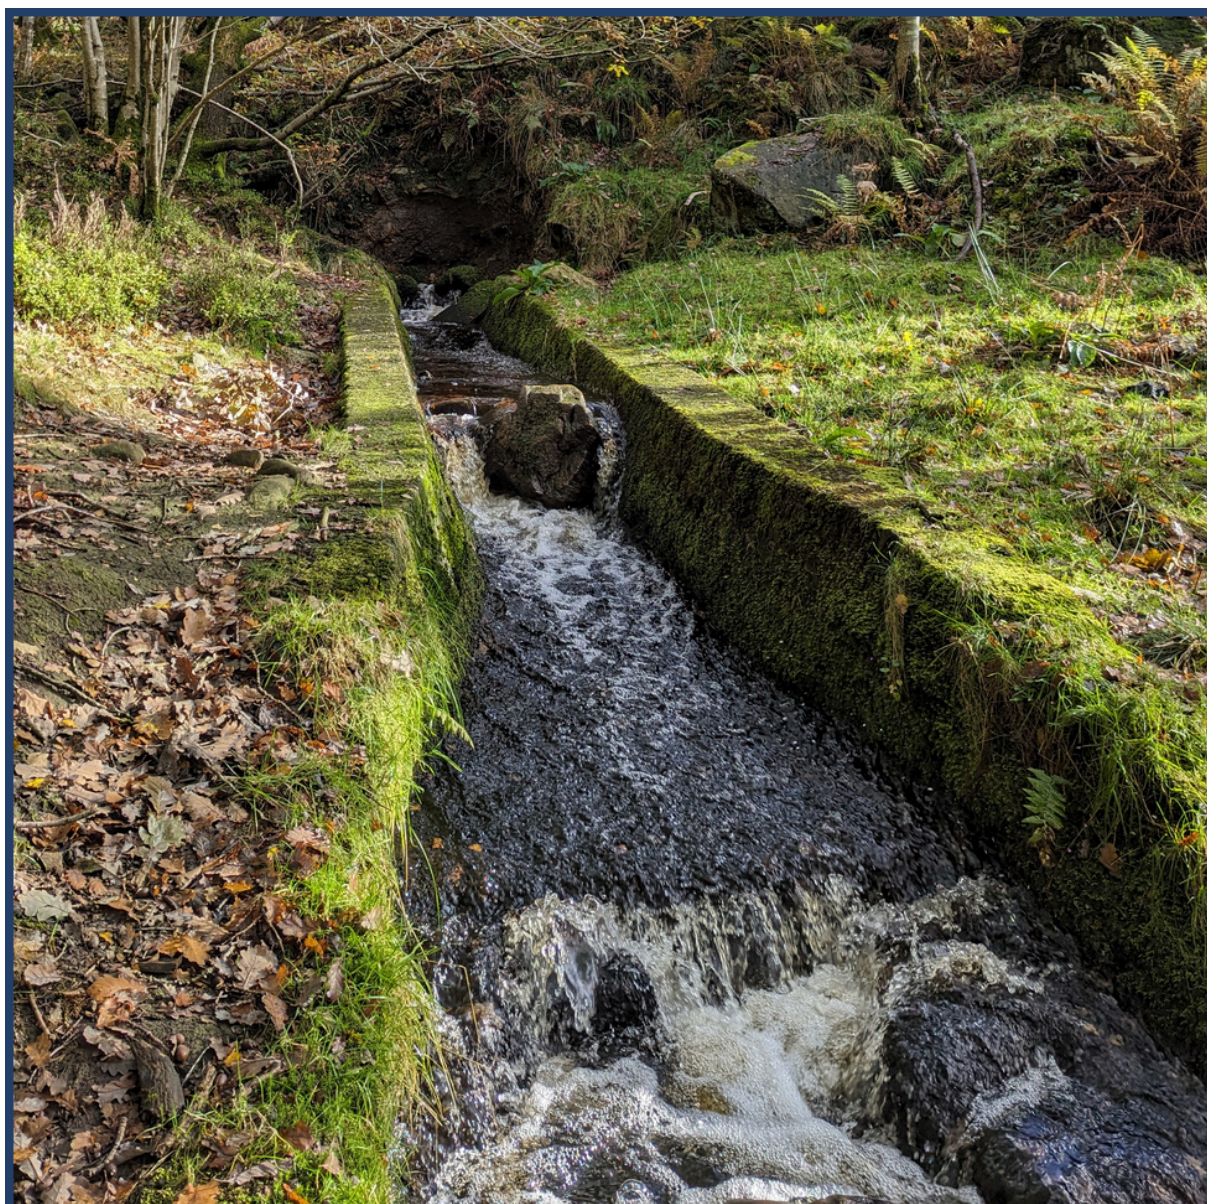
PHYSICAL

5

HYDROLOGICAL

3

CHEMICAL

1

BIOLOGICAL

The upland stream is heavily straightened with a large concrete channel. This acts as an intensive water diversion channel that will moderately impact hydrology. Water is clear (but slightly peat-stained). No invasive species are visible.

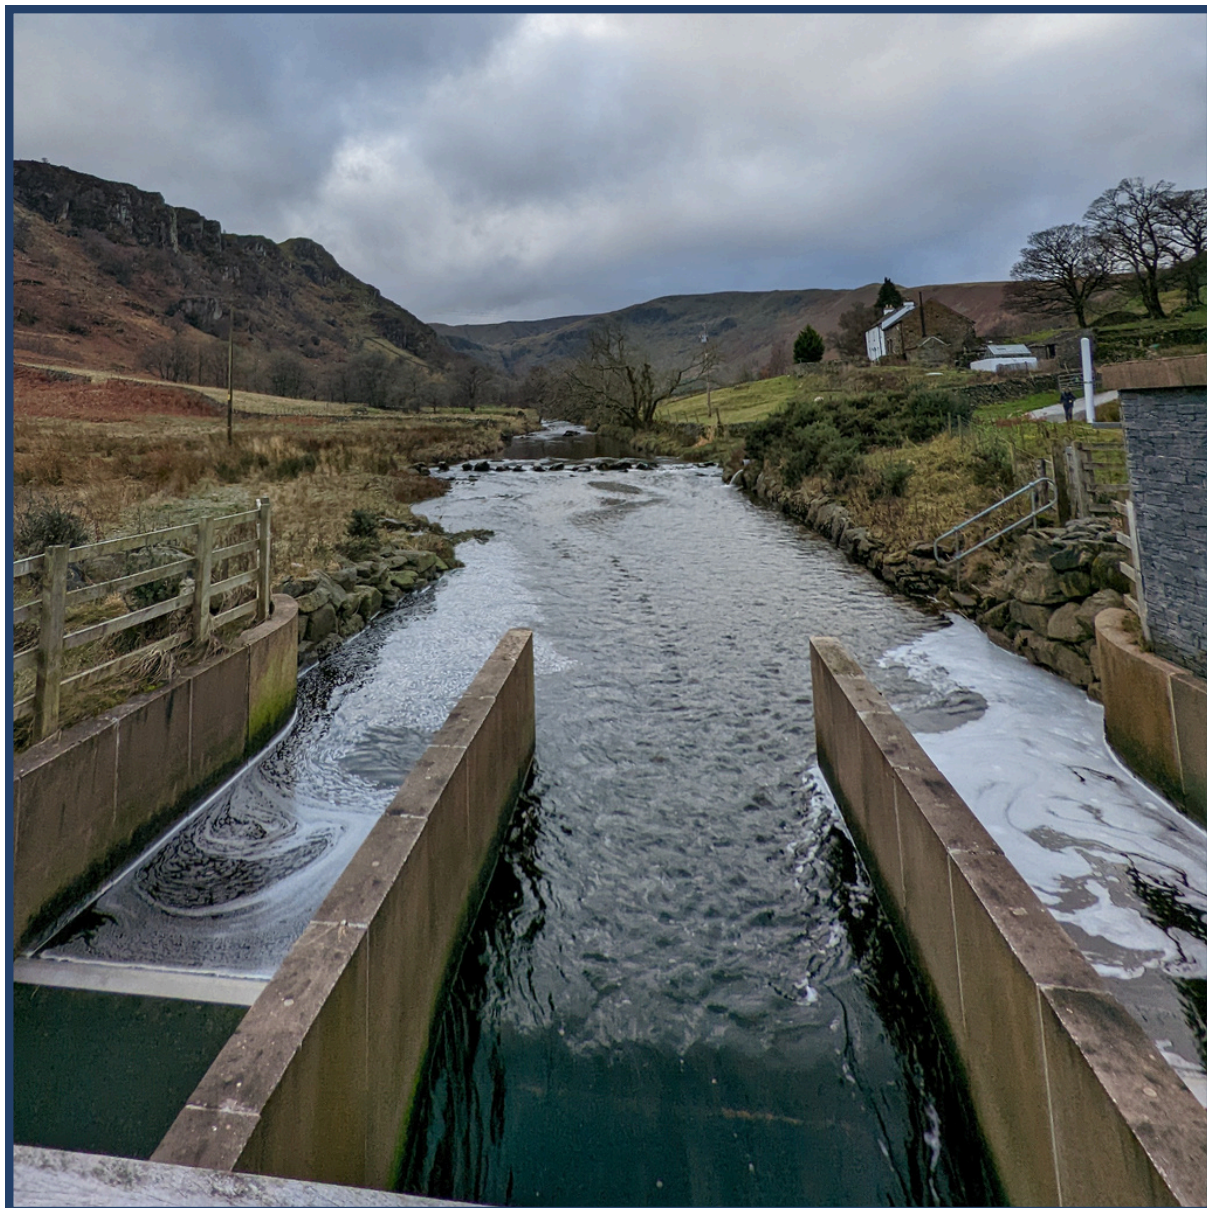
PHYSICAL	5
HYDROLOGICAL	4
CHEMICAL	1
BIOLOGICAL	1

The beck is straightened with abstraction diversion channels (foreground) and a small weir (background). The hydrology of the channel will be significantly impacted by abstraction and the impoundment structures present. The water looks clear and the white foam does not count towards chemical scoring- this is naturally occurring from the turbulence of artificial structures. No invasive species are visible.

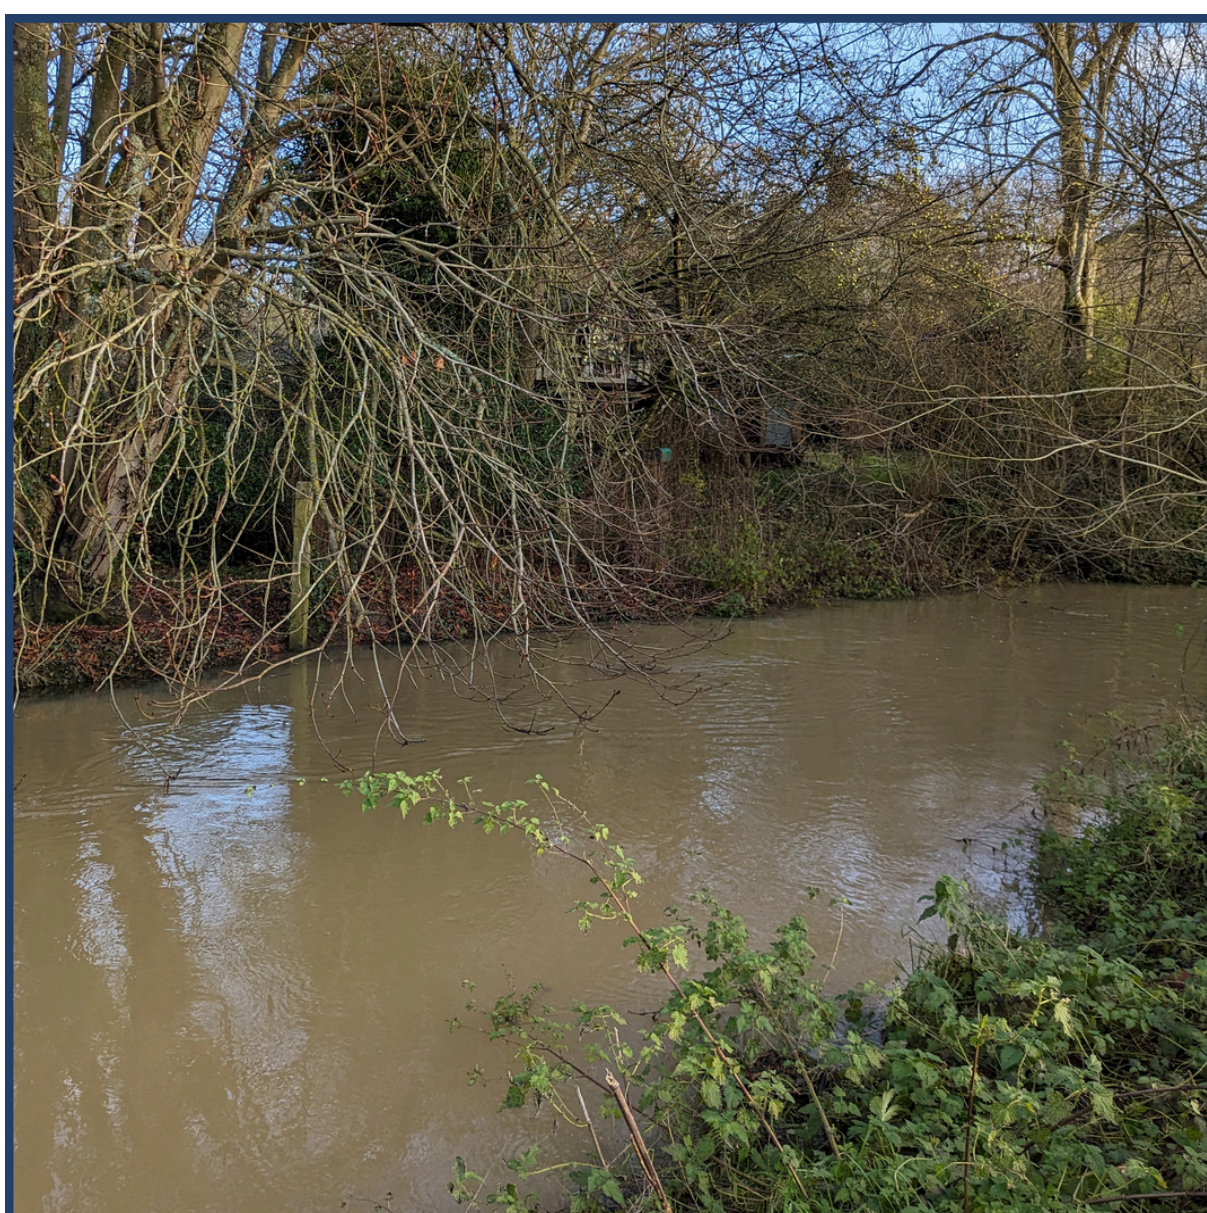
PHYSICAL	4
HYDROLOGICAL	2
CHEMICAL	5
BIOLOGICAL	1

A heavily straightened mill stream- but raised water levels make it difficult to see the bank sides. The tree cover is moderate on the far bank. The hydrology of the channel will be slightly impacted by the straightening. The water displays major sedimentation, reducing visibility to 1-2cm. This will make it difficult to check for filamentous algae/sewage fungus (so you may lower your confidence). No invasive species are visible.

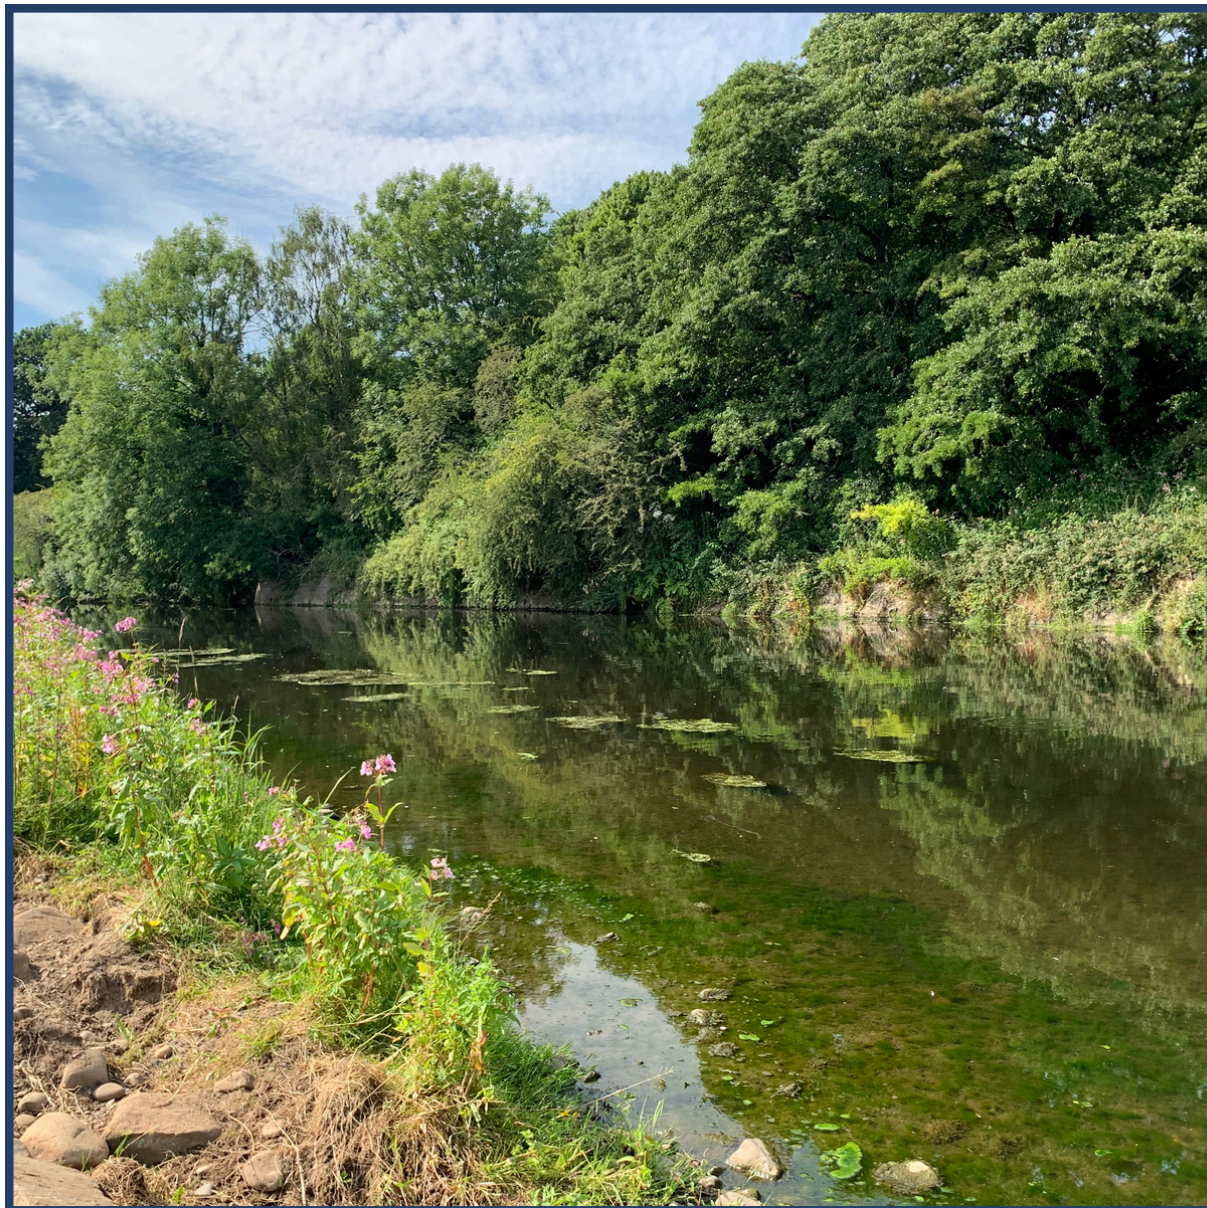
PHYSICAL	4
HYDROLOGICAL	2
CHEMICAL	4
BIOLOGICAL	4

The river is heavily modified to be straighter and wider. This will slightly impact hydrology (but the impact is less compared to that of an impoundment/abstraction point). Severe presence of filamentous algae visible both on the channel bed and floating as mats along the surface. Himalayan balsam present on both banks with a high percentage of ground cover (up to 60%).

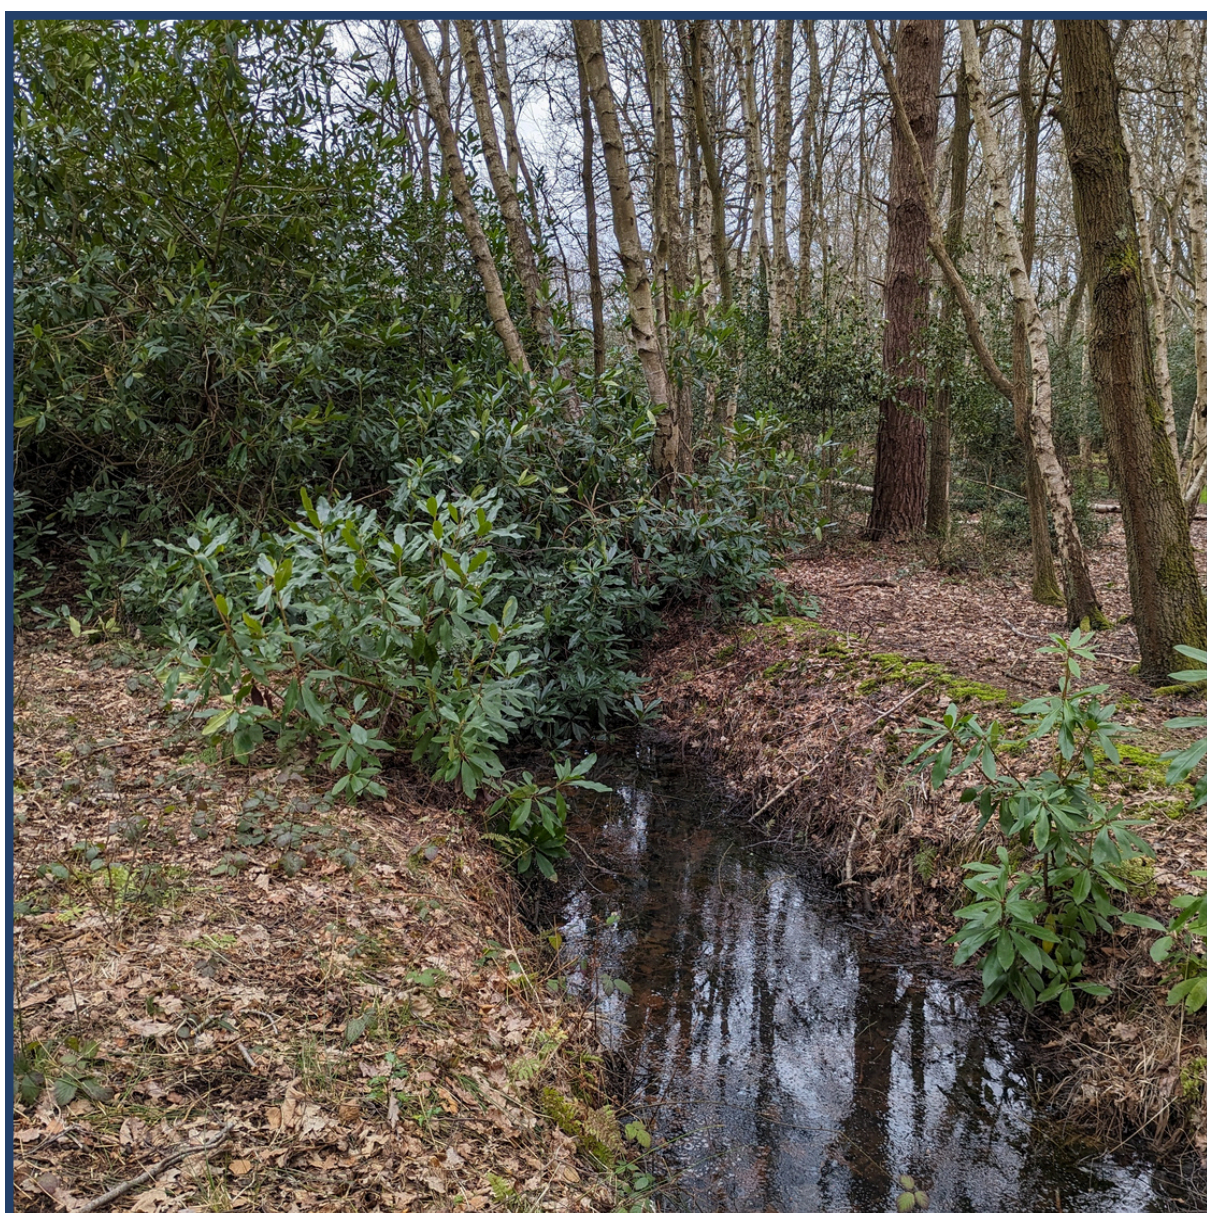
PHYSICAL	5
HYDROLOGICAL	2
CHEMICAL	3
BIOLOGICAL	4

The stream is heavily straightened and likely a man-made drainage ditch. The hydrology of the channel will be slightly impacted by the straightening. The water looks discoloured and murky suggesting sedimentation. Rhododendron is present across both banks and with a high percentage of ground cover (up to 60%).
