# Fish Live in Trees Too!

# River Rehabilitation and Large Woody Debris

Mott, N. (2010) Fish Live in Trees Too! River Rehabilitation and Large Woody Debris. Staffordshire Wildlife Trust, Stafford, UK. [n.mott@staffs-wildlife.org.uk](mailto:n.mott@staffs-wildlife.org.uk)

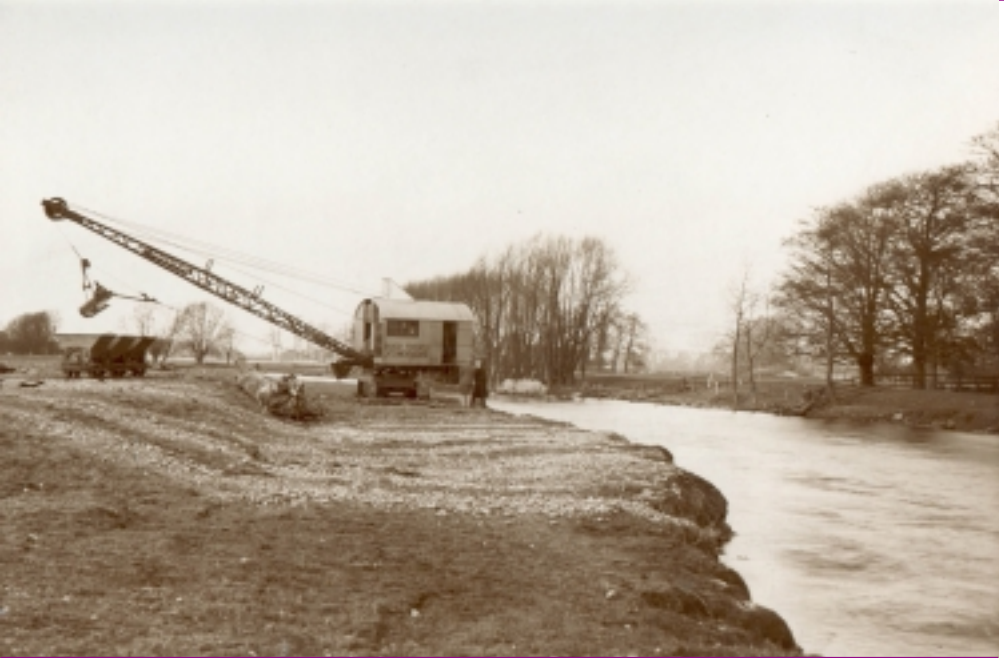
**Gutted. The Trent River Catchment Board carrying out routine maintenance along the River Dove in the 1940s using a drag line. Notice the LWD removal and the creation of a trapezoidal channel.**

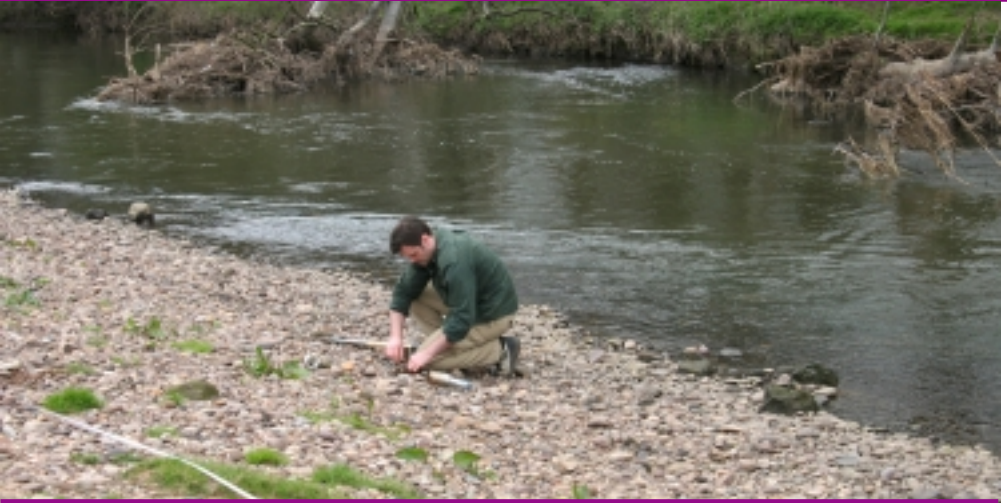
**Monitoring for shingle beetles, spiders and flies at a river rehabilitation site on the Trent. Follow up surveys that study 'indicator species' help to gauge the success of restoration works.**

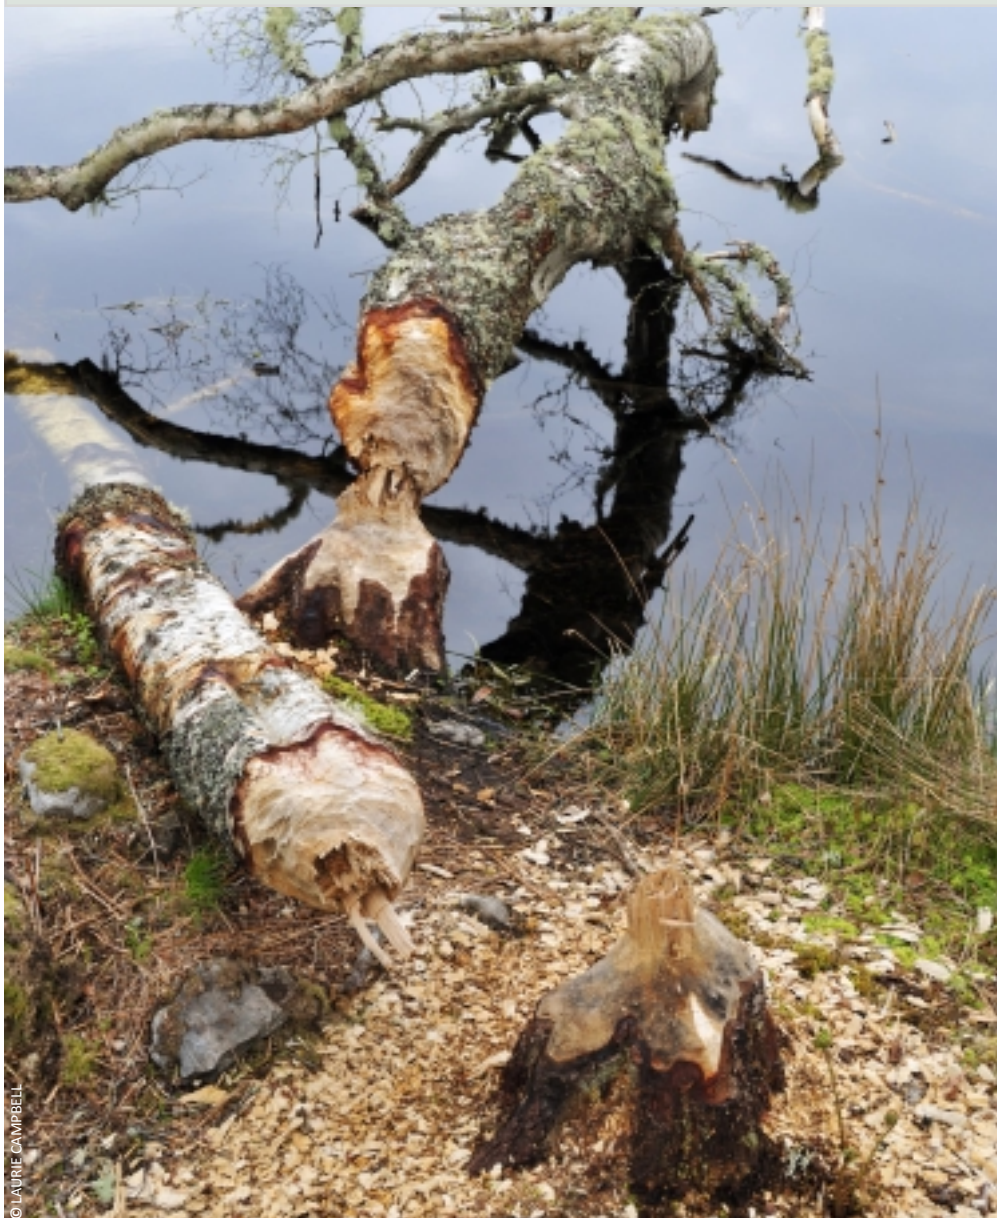
**The Scotch Brook, Staffordshire.** As unmanaged willows shed large limbs and collapse across streams, channel complexity increases and, correspondingly, habitat niches are generated for an increased range of species.

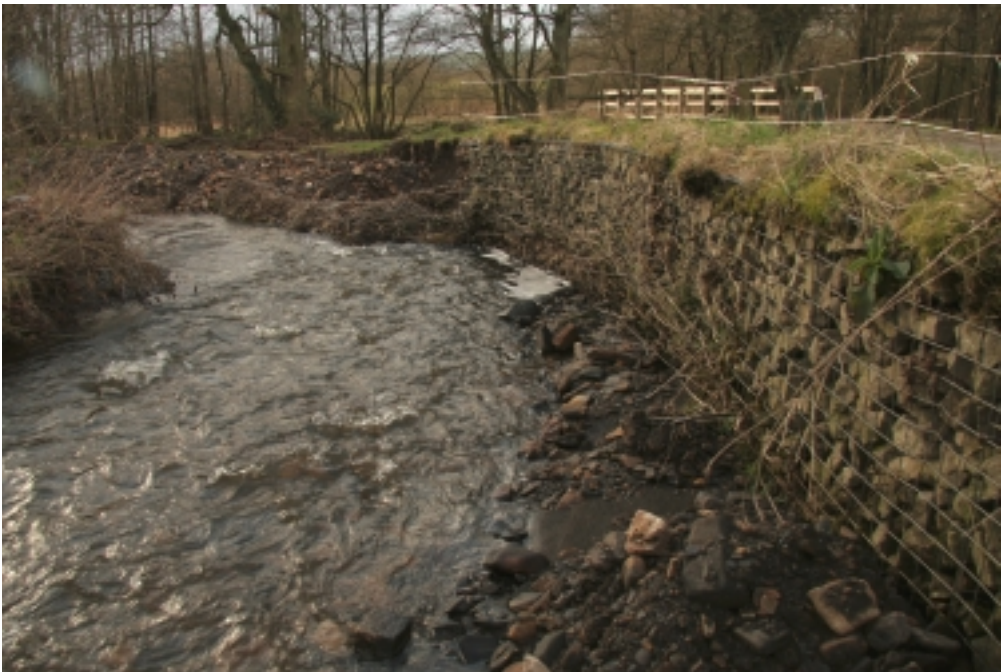
View of the collapsing gabions in 2008

Severn Trent Water owns and manages the Tittesworth Water estate. In the 1980s a section of the River Churnet's banks was reinforced with gabions (steel baskets filled with rock) to help protect a nearby road and footpath. The energy and power of the River Churnet soon undermined the gabions. Staffordshire Wildlife Trust offered to trial a more sustainable option: the use of an Engineered Log Jam and bank support using living willow tree trunks.

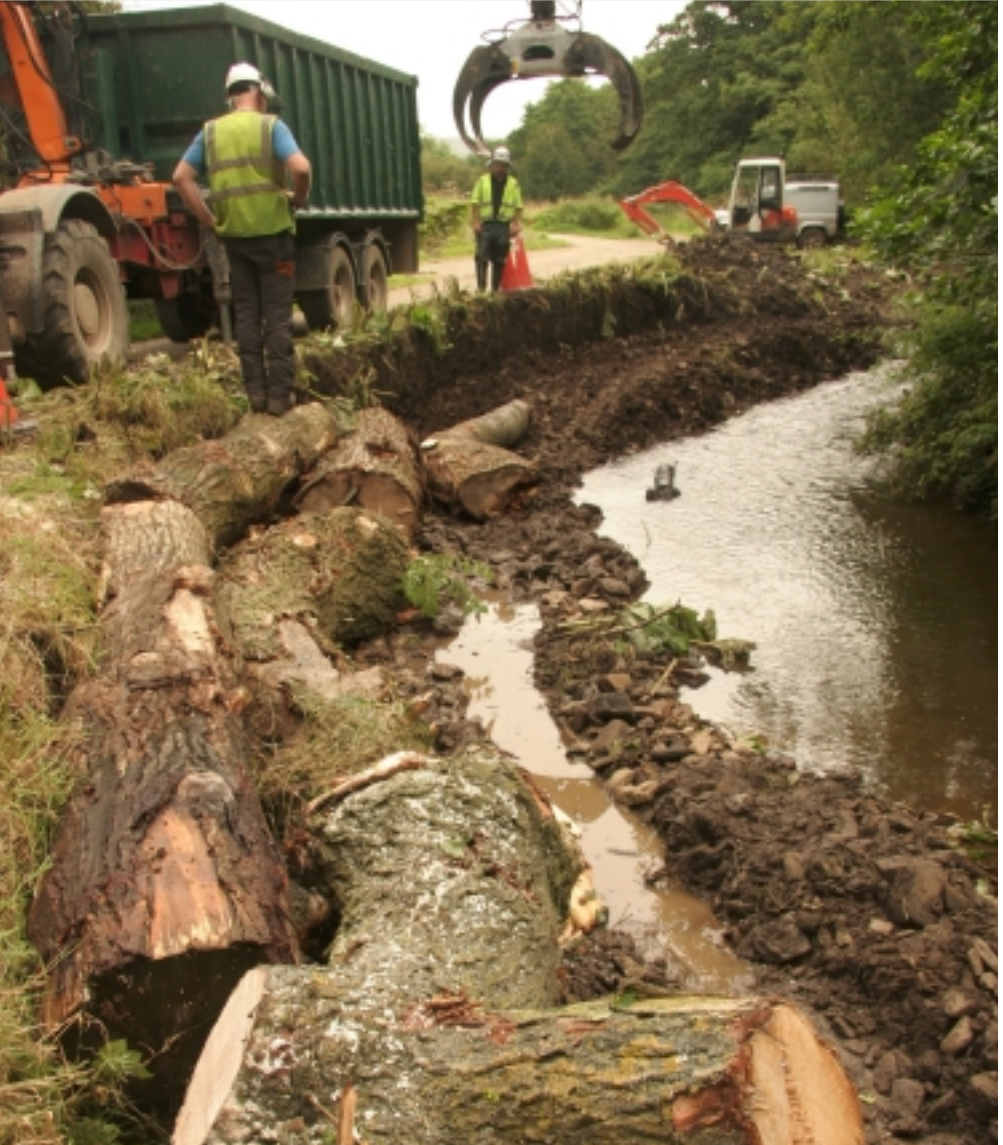
**August 2009. The gabion baskets were removed and replaced with living, sprouting willow trunks.**

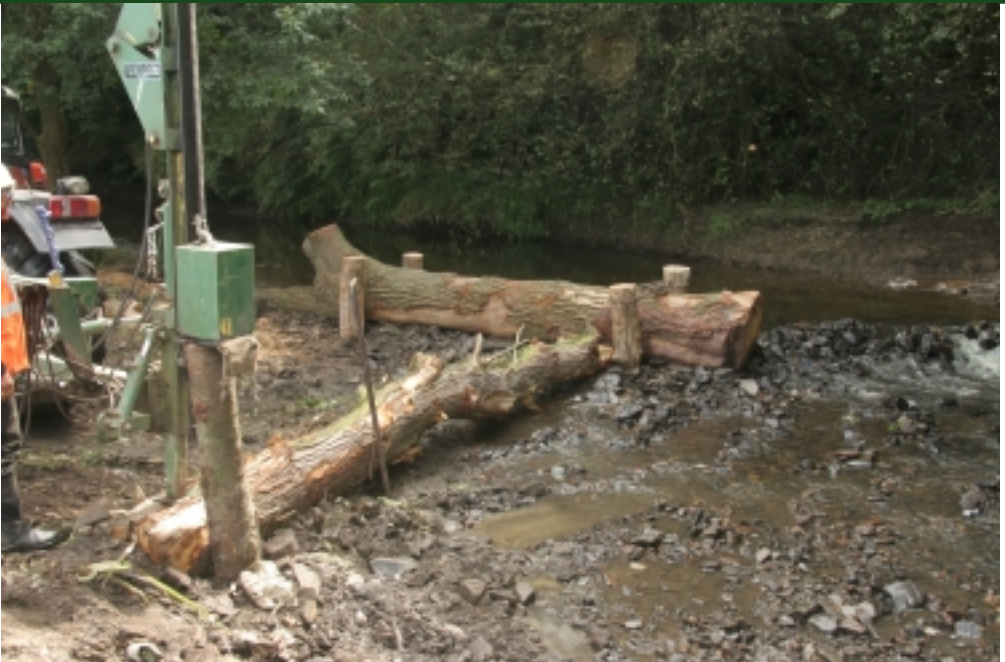
The 'Key Piece' of the ELJ was a 5 tonne oak tree trunk. This was 'keyed' into river bed and supported with oak posts driven deep into the substrate. Further strength was created by adding a 'T piece'.

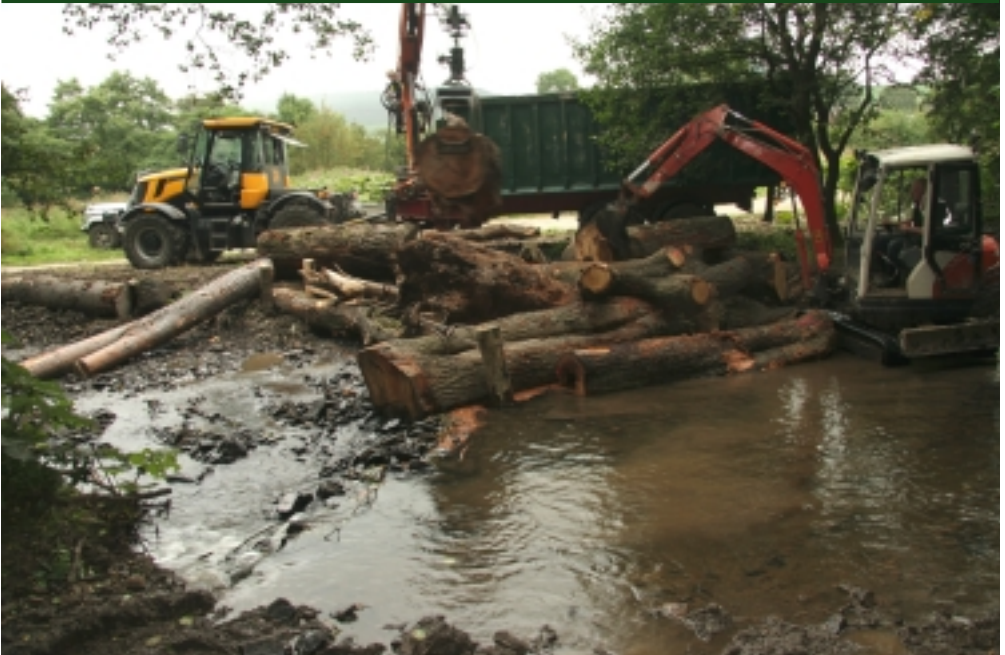
A further 22 tonnes of trunks and root plates were used to construct the ELJ.

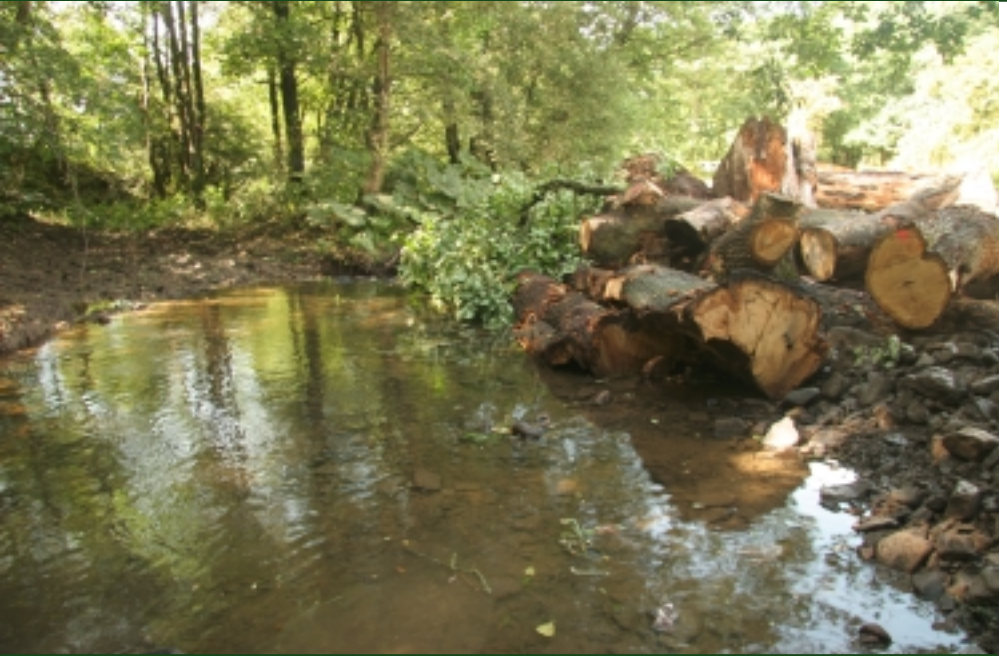
**View of the completed ELJ and the entrance to an old side channel.**

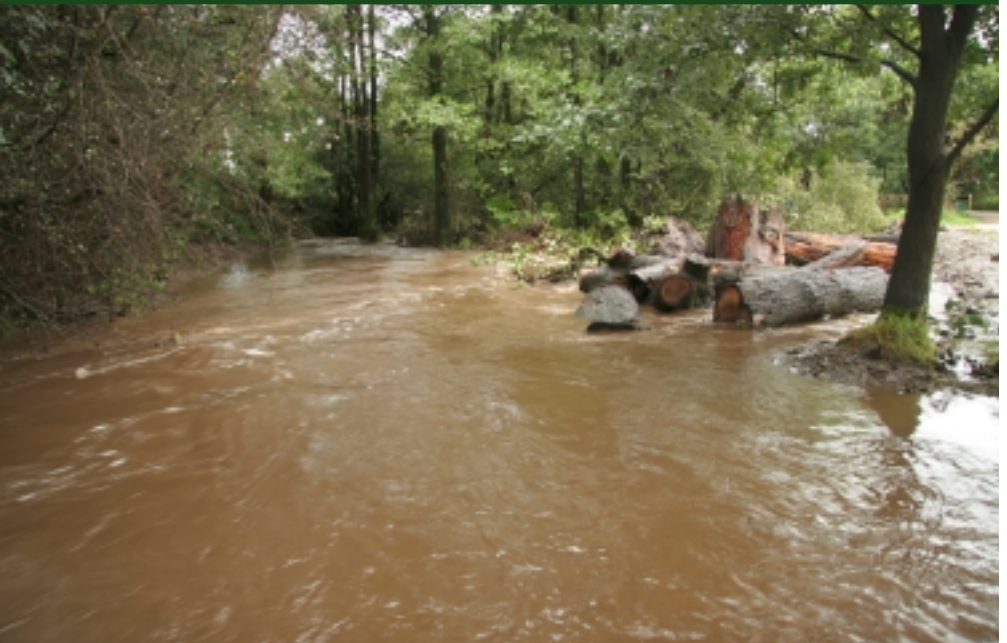
**September 2009. It works! Just two weeks after the ELJ had been completed, a late summer storm resulted in spate conditions. The position of the ELJ re-activated an old channel. It is estimated that, at the peak, a third of the River Churnet's flow was diverted into this former channel.**

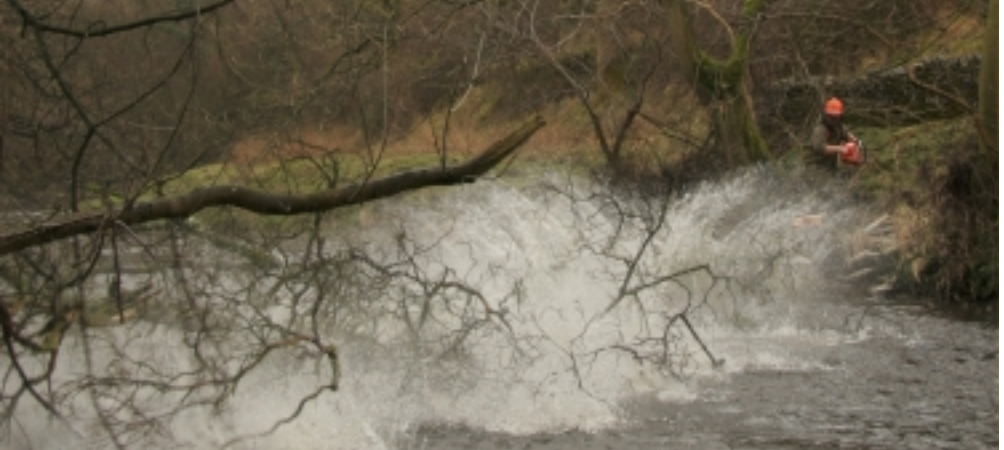
**Chop & Drop. A sycamore becomes LWD in the Upper Dove. Introduced material needs to be longer than the channel width.**

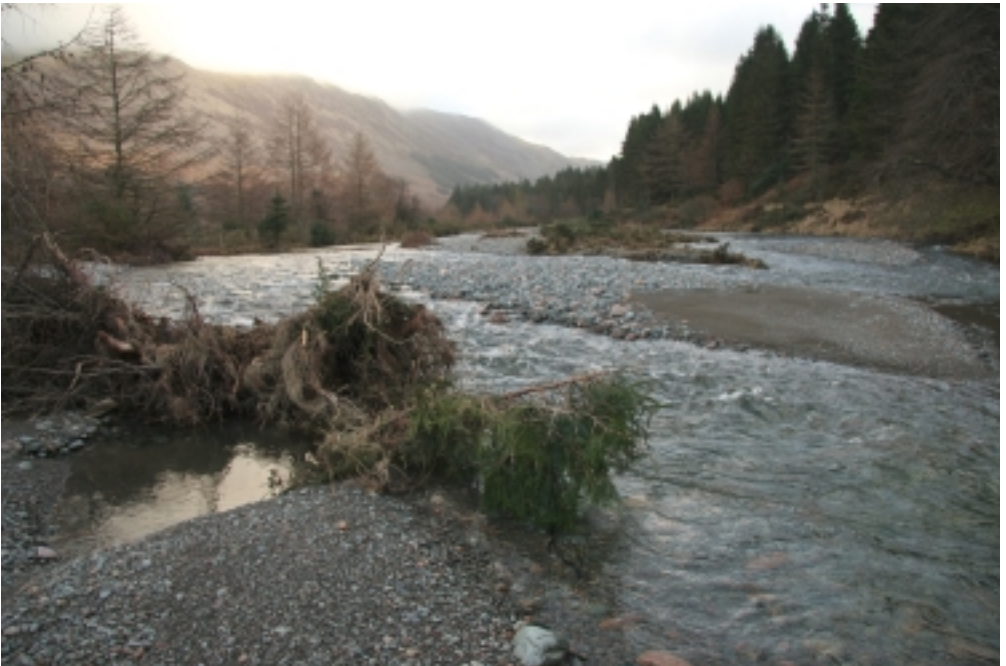
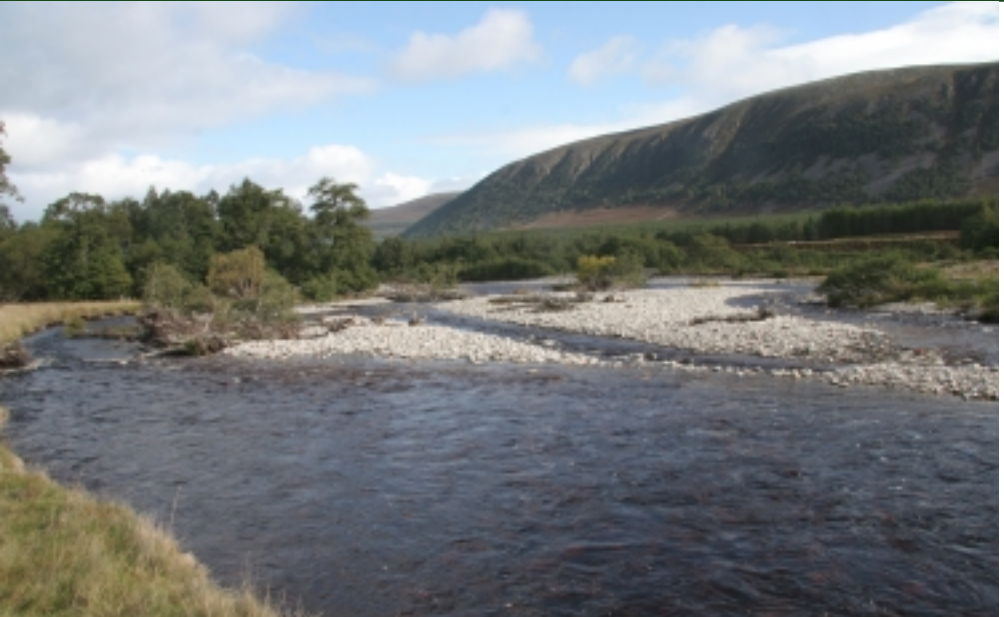
### Channel braiding on the Feshie

LWD and sprouting driftwood often becomes embedded in the river's substrate. This results in the development of additional features such as ephemeral pools, germination zones and islands.

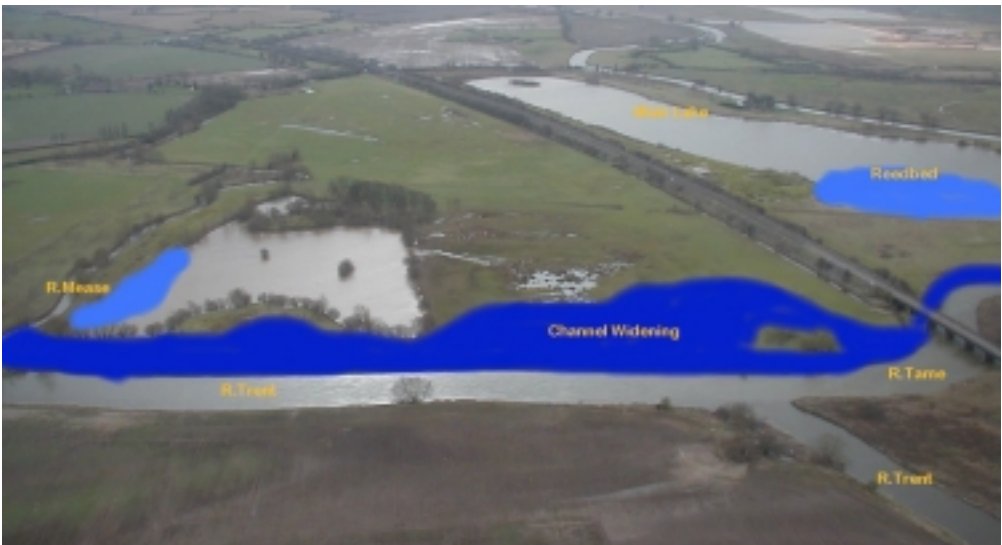
Aerial view showing the location for the river widening project.

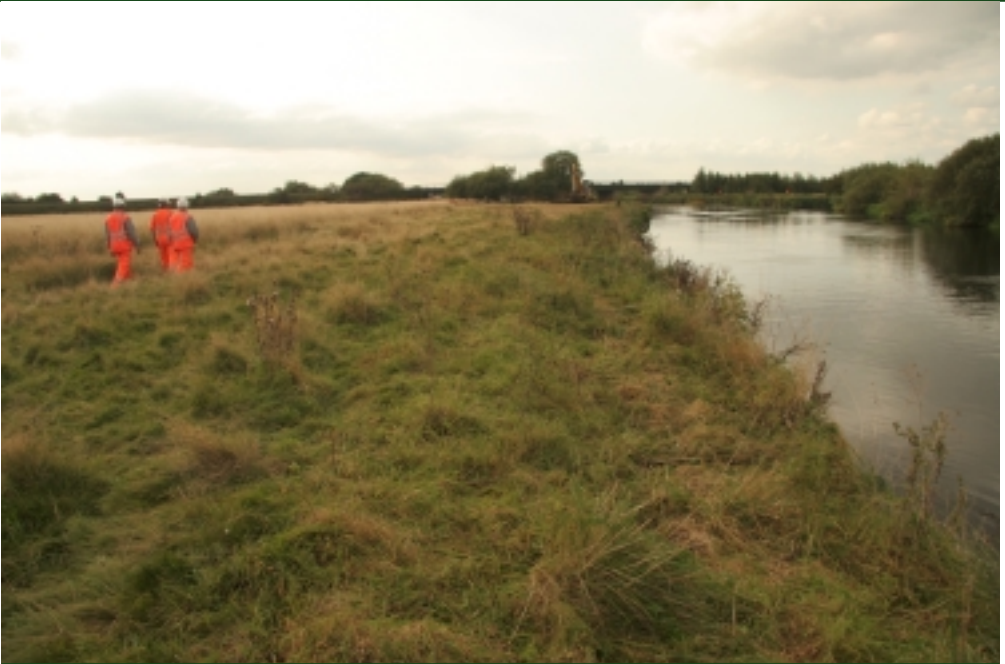
**September 2009. The River Trent at Croxall prior to the works.**

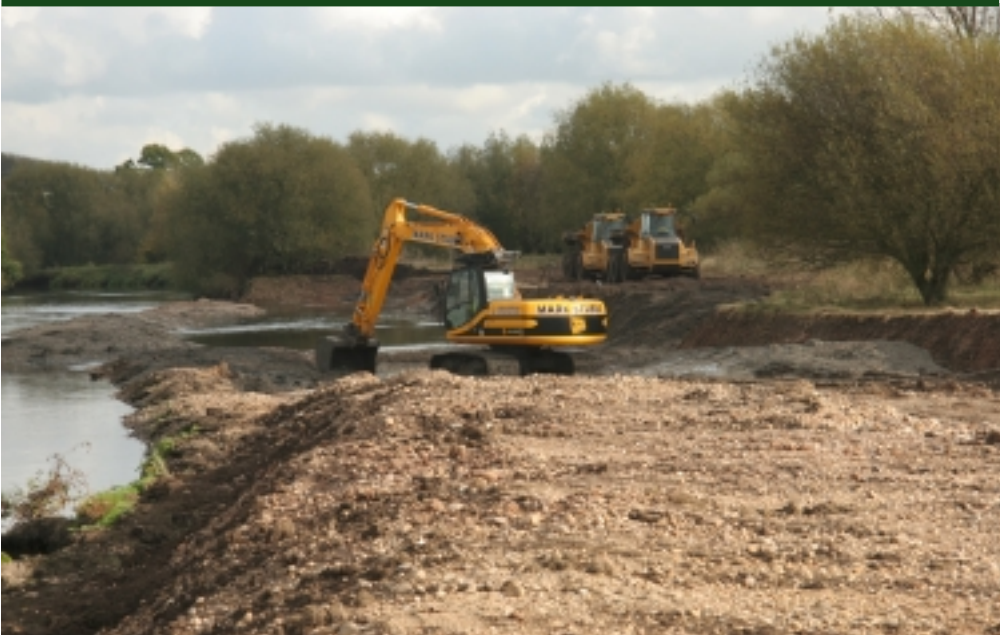
**43,000 cubic metres of soil were removed during the channel widening scheme and deposited in the two lakes at the site to create substrate and shallows for new reedbeds. Gravels were retained and used to create river islands and mid-channel sediment bars.**

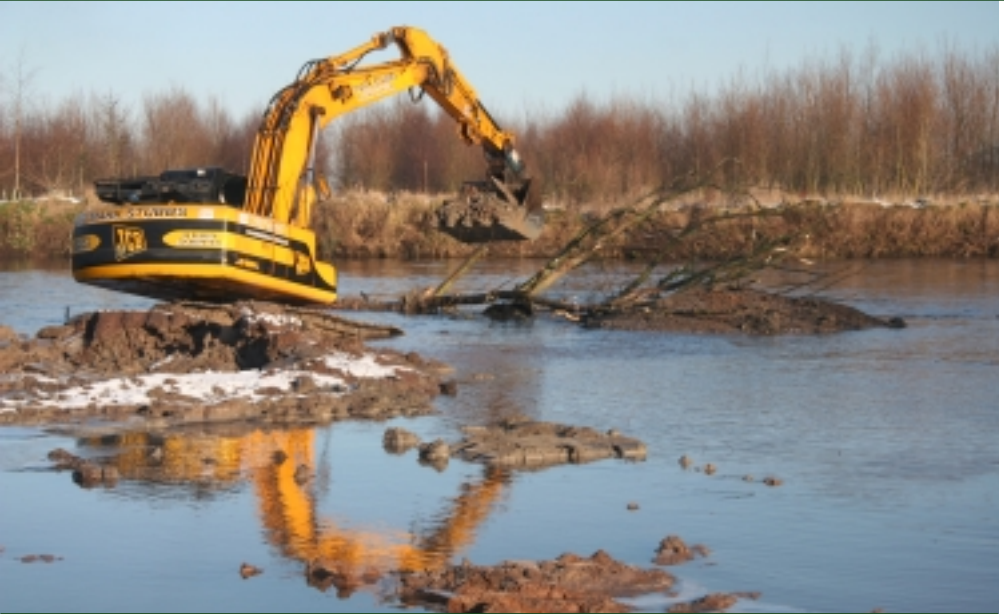
Several new willow river islands were created within the widened channel.  
(i) a scrape was excavated in the river substrate, (ii) live willow trees were placed into the scrape with their root plates facing in an upstream position, (iii) clay and gravels were placed on top of the LWD, (iv) ...and the island is left to develop and strengthen naturally as the willow grows adventitious roots into the river bed.

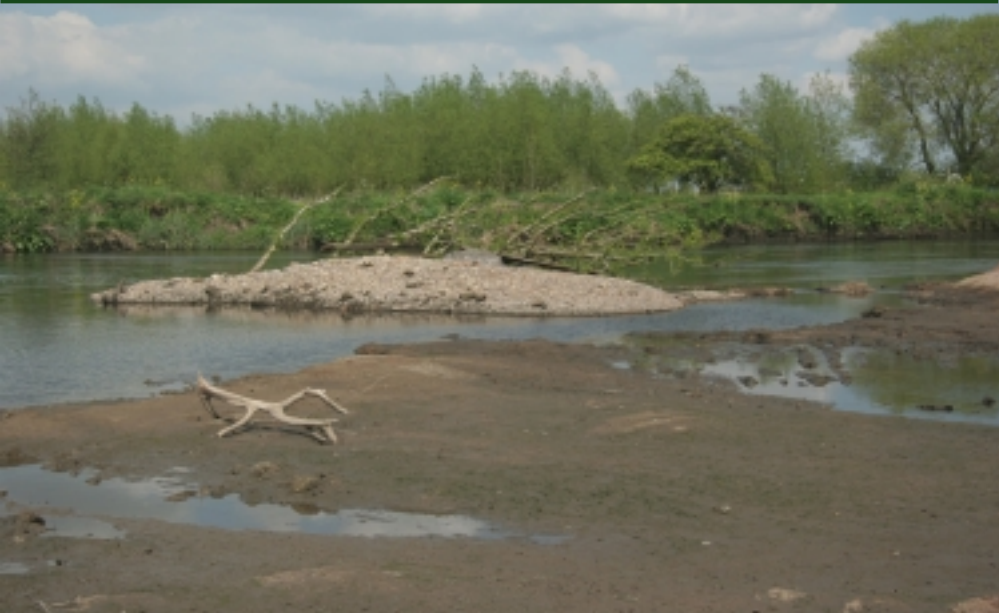
May 2010. A view of one of the newly created river islands - note the leaves.

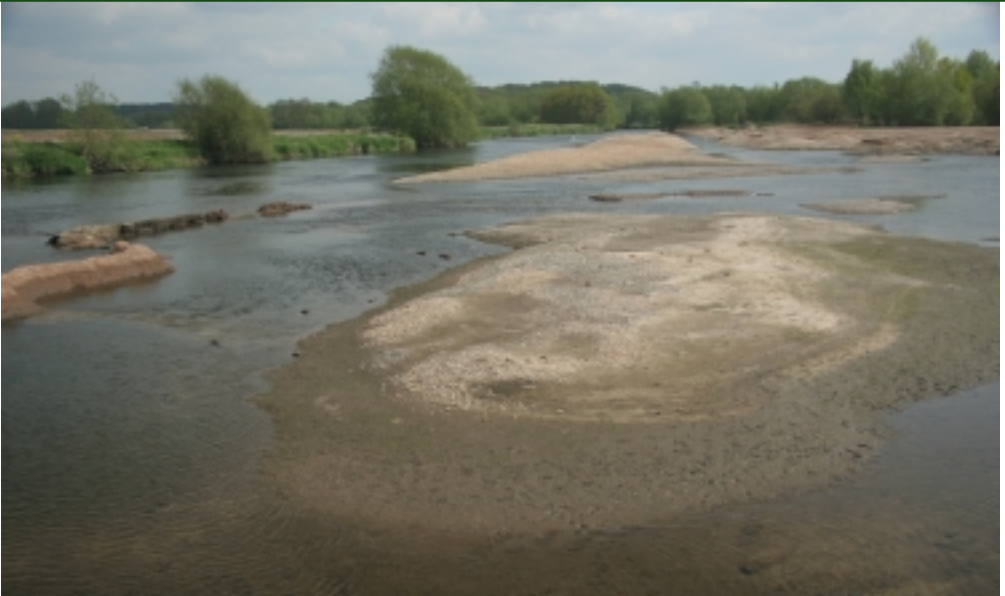
May 2010. A view of the completed river widening scheme with islands, sediment bars, backwaters and lagoons.

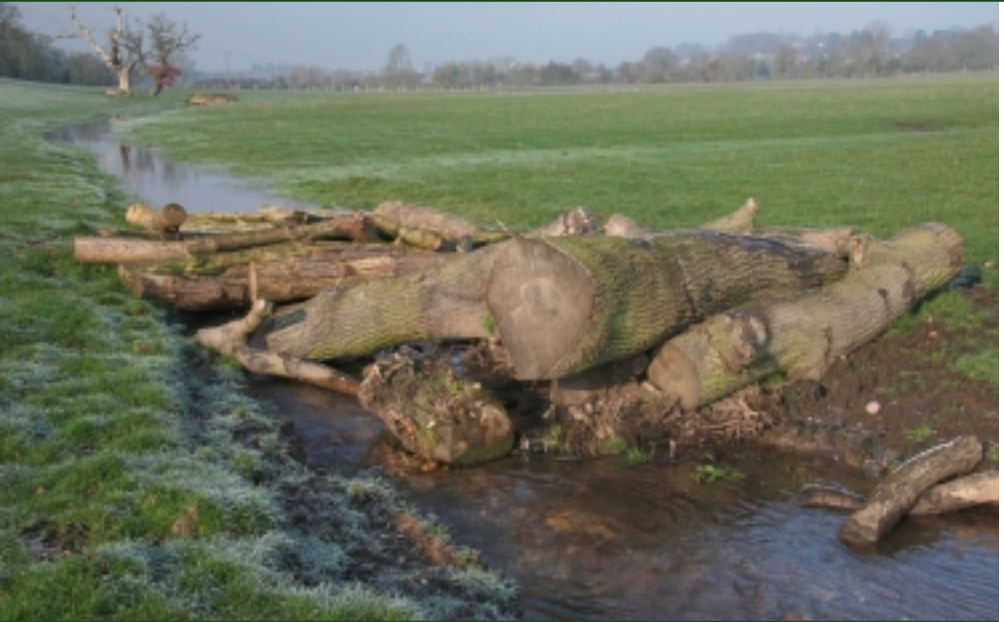
**One of the constructed log jams along the newly diverted brook.**

Two streams, which had historically crossed the site, were diverted back across the floodplain. Water in these streams has been impeded using log jams as 'leaky barriers'. These have provided habitat for foraging lapwing chicks, as well as cover and full access for aquatic species along the length of the watercourse.

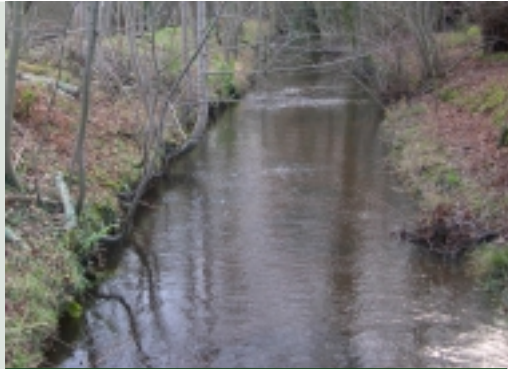
**Dockens Water in 2004 shortly before the project was undertaken.**

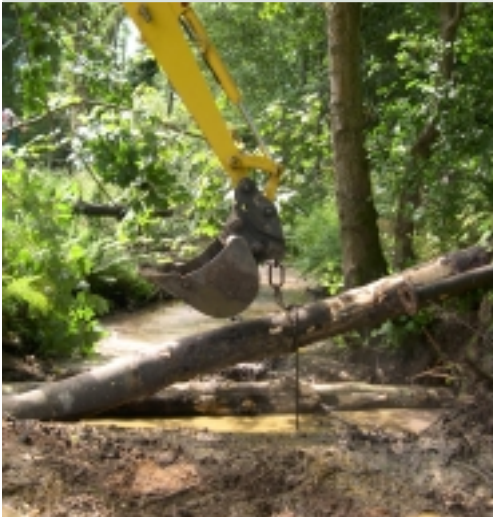
**LWD was installed at a number of sites to raise riverbed levels and create additional habitats in the channel.**

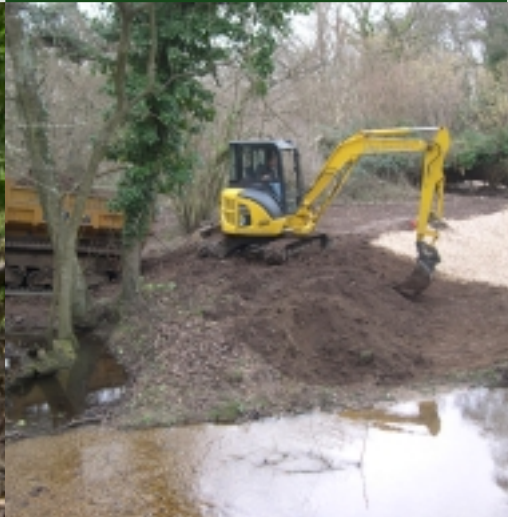
**A new channel was excavated and river re-profiling carried out.**

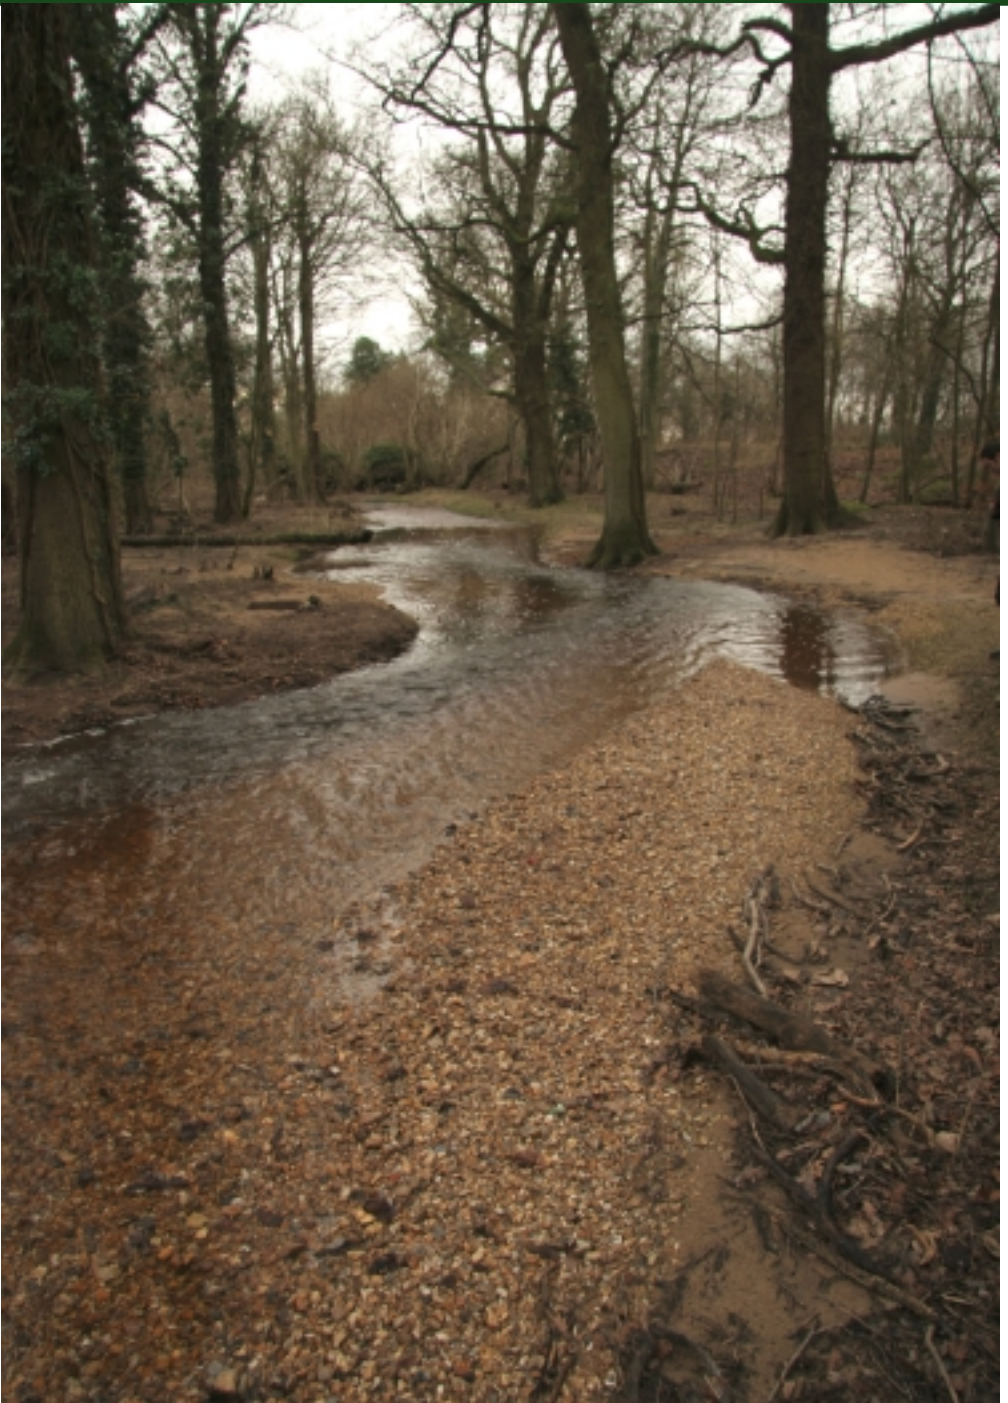
**January 2008, three years on. The restoration work has been very successful. There is now a much better link between Dockens Water and its floodplain.**

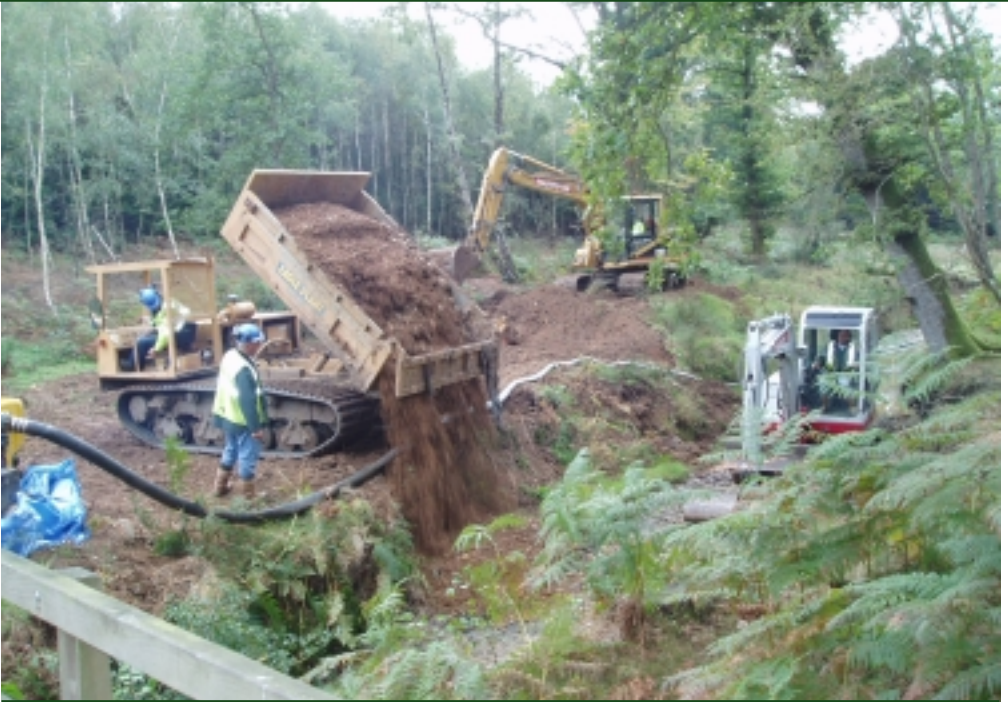
**Life3 scheme at Highland Water to raise bed levels.**

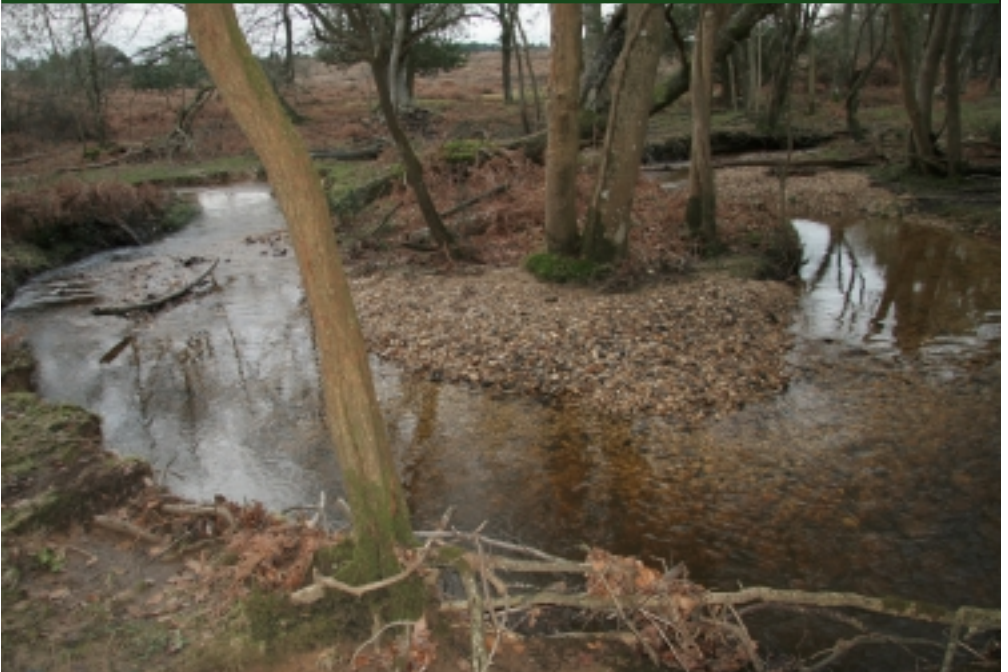
**Highland Water after the restoration works.**
